Determination 2005/149

Refusal of a code compliance certificate for a building with a “log” weatherboard cladding system at 142 Princess Street, Waikeno, Waihi

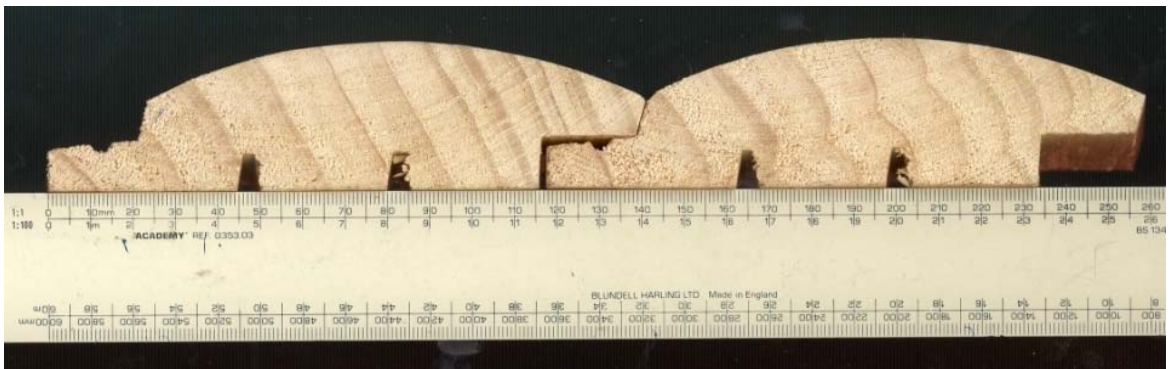
2.1.3 The wall cladding is a form of horizontal profiled timber weatherboard, with rebated lapped joints and a curved outer face that provides a “log” appearance. The weatherboards have a fully machined profile with overall dimensions of 141 mm x 34 mm (ref Figure 1). The laps are approximately 25 mm, with a close fitting joint along the bottom edge of the lapped joint that opens out to form a capillary break, the lap also has a small weathergroove in the under lap. The boards have a stain finish.

Figure 1: Cladding profile showing lapped joint

- There will be cases where a capillary break can be achieved in another way (as is the case in bevel-backed weatherboards) and it may be unnecessary to machine additional grooves into the overlapping joint. In this instance there is one weathergroove provided plus the lapped joint opens out to provide a capillary break above the bottom tight joint.
- The weathertight performance of the external walls is likely to be limited more by leakage paths through defects in the weatherboards and corner joints, than by the absence of weathergrooves in the lap joints.
- The cladding is thicker than the 19 mm specified for bevel-backed weatherboards in E2/AS1. The weatherboard is 34mm thick spanning studs at 600mm centres. The cladding is unlikely to deflect between supporting framing.

6.3.4 I believe these comments to be relevant in this particular case, and taking into account the factors described in 6.3.2 above, I decide that the absence of one weathergroove in the weatherboard cross-section does not render it noncompliant
