Determination 2006/23

Refusal of a code compliance certificate for a house with a monolithic cladding system at 43 Waverton Terrace, Churton Park, Wellington

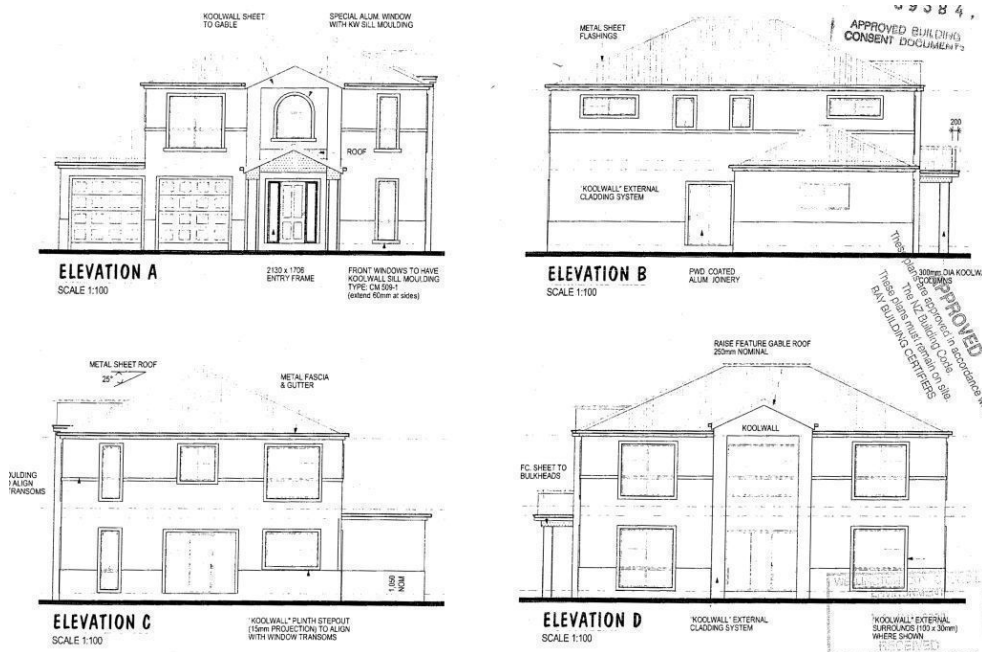
Figure 1: External elevations

- 2.1 The building is a two-storey detached house, with a small single-storey garage extension, situated on an excavated sloping site that is in a very high wind zone in terms of NZS 3604³. The building is of a simple shape on plan and the main pitched roof has hip and valley junctions, and the small hipped lower roof has wall-to-roof junctions. The eaves and verges lack projections. The exterior walls are of conventional light-timber frame construction built on concrete ground floor slabs or intermediate timber-framed floors and are sheathed with monolithic cladding.
- 2.2 A narrow projection supported on two full-height monolithic clad timber-framed columns is constructed on elevation D. A portico with a pitched roof supported on

circular columns extends over the main entrance and the roof extends into a recess adjacent to the upper stair landing. A timber framed pergola supported on circular columns is situated at each of elevations C and D.
