Determination 2008/25

Determination regarding the weathertightness of a unit in an apartment block at 10 Ruskin Street, Parnell, Auckland

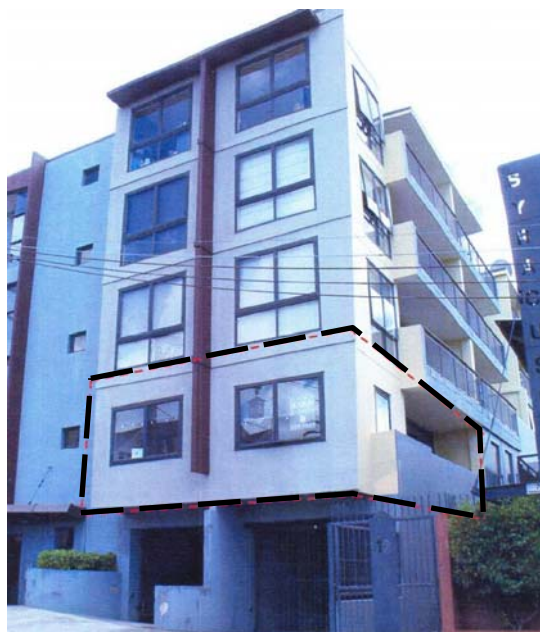
South Elevation (Unit 1A is outlined)
