## Determination 2009/101

### Determination regarding the refusal to issue a code compliance certificate for a 6-year-old block of six semi-detached townhouses at 4, 6, 8, 10, 12 and 14 Gina Avenue, Waitakere City

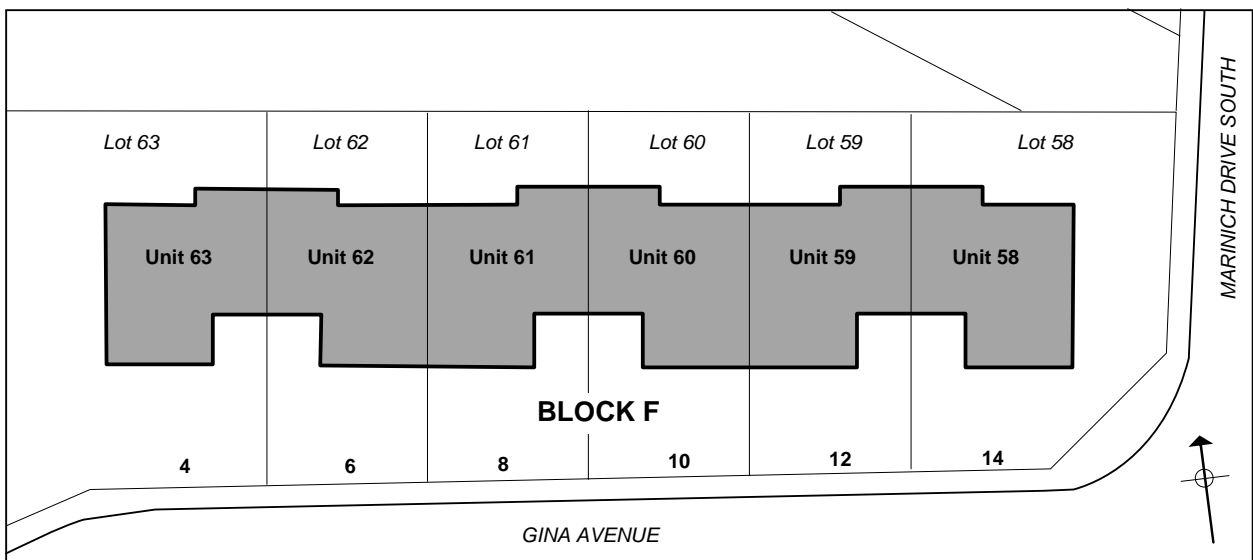
3.1 The following site plan shows Block F:
