## Determination 2009/112

# Refusal to amend a building consent regarding damp proofing to a basement of a house at 75A Awatere Avenue, Hamilton

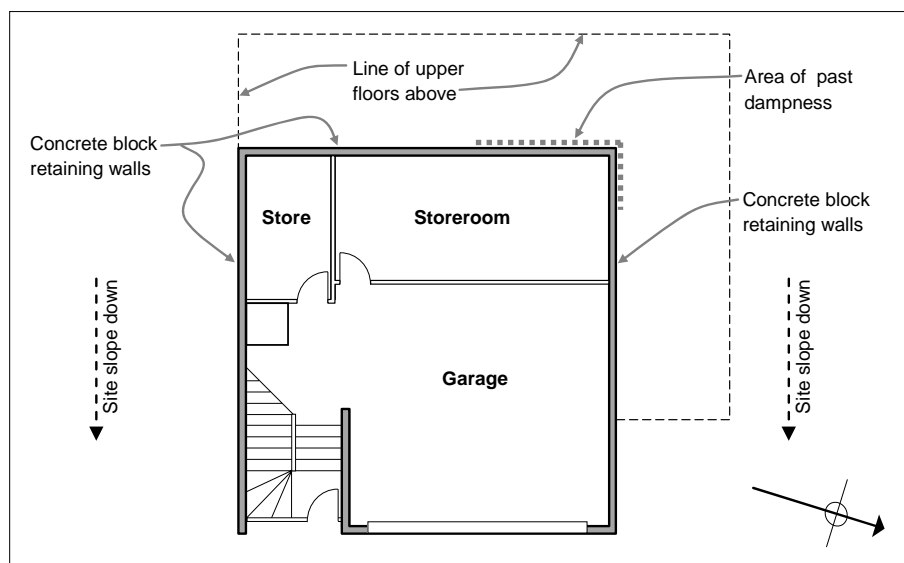
- 2.1 The building work covered by the original building consent consists of a three-storey house on a site that slopes steeply towards the street.
- 2.2 The basement level of the house accommodates a double garage area and two storerooms; and is set into the slope of the site, with a concrete slab and foundations, and reinforced concrete block retaining walls to three sides as shown below:
