Determination 2009/32

The code compliance of the foundations to a relocated house at 146A Barrack Road, Mount Wellington, Auckland

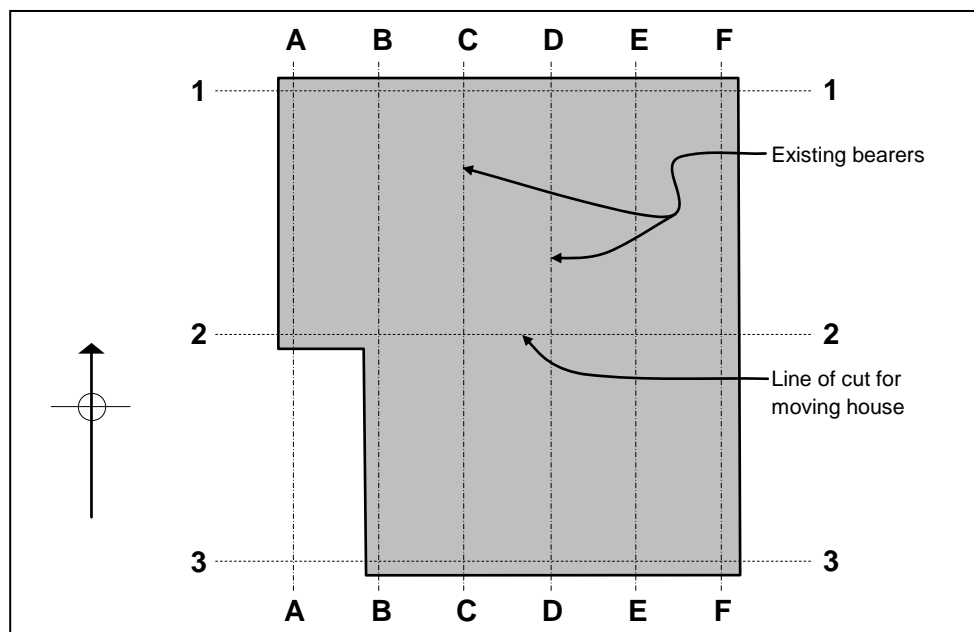
- 2.4.2 An approximate plan (with gridlines A to F indicating bearer positions) is shown below:

- 2.4.3 The original 100mm x 75mm bearers are retained, with new bearers added to the west and east (gridlines A and F). The original bearers were cut (at gridline 2) when the house was moved in two sections. The piles supporting the bearers are 125mm x 125mm timber posts set into concrete footings.
