## Determination 2010/033

### Determination regarding the refusal to issue a code compliance certificate for a 6-year-old block of three semi-detached townhouses at 16, 18 and 20 Kora Avenue, Waitakere City

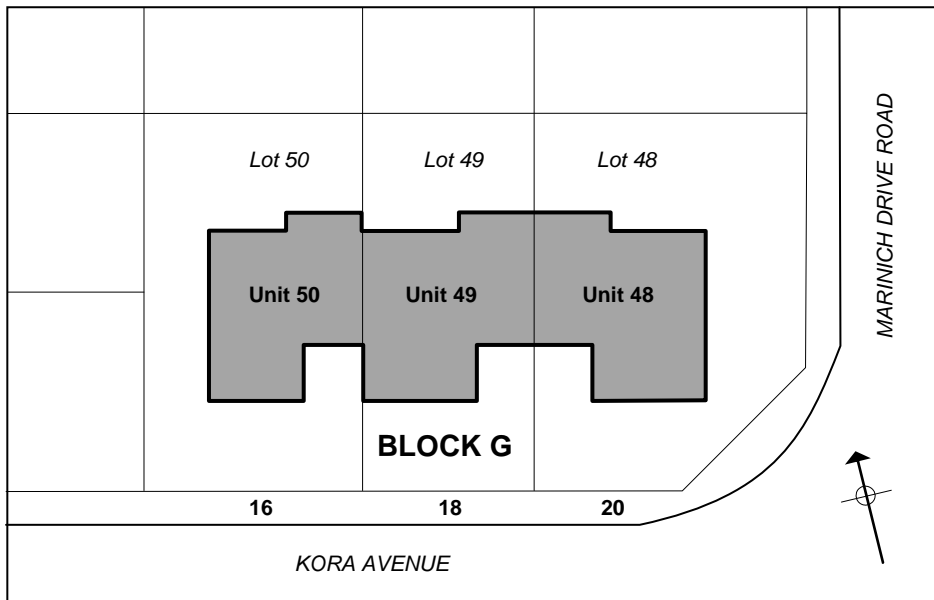
3.1 The following site plan shows Block G:
