Determination 2010/039

The refusal to issue a code compliance certificate for 14-year-old house at 4 Bosun Place, Te Atatu Peninsula, Auckland

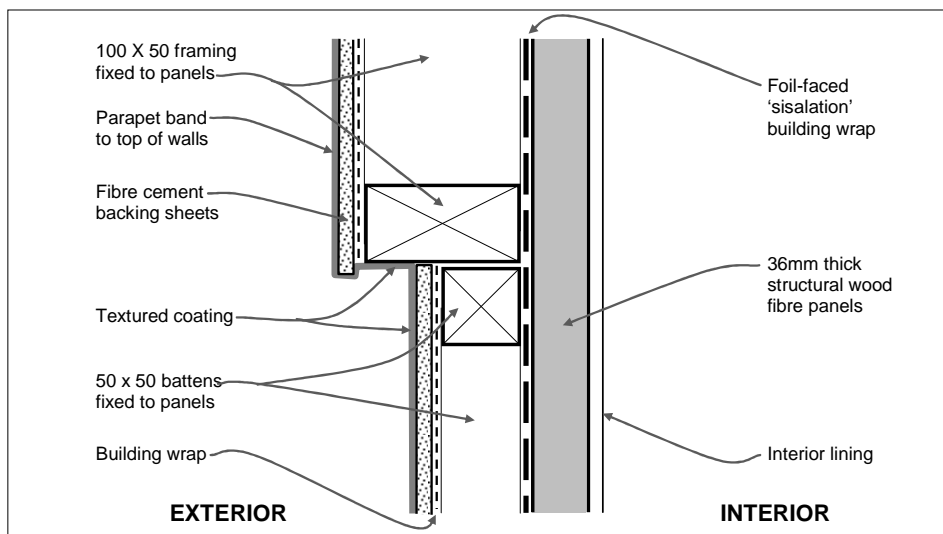
- 2.4.2 The general construction of the external walls is shown in the following sketch (the extend of the panel system itself is shaded):

- 2.4.3 The exterior wall panels are covered by a ‘sisalation’ wrap that incorporates a foil layer to the outer face. 50mm x 50mm horizontal and vertical timber battens are nail-fixed through the wrap to the wall panels. 100mm x 50mm framing is fixed to the top of the external wall panels to form a 600mm high decorative “parapet band”.

- 2.4.4 The wall cladding is a form of monolithic cladding, which consists of 7.5mm thick fibre-cement sheets fixed to the battens and parapet framing; and finished with an applied textured coating system. The timber battens and parapet framing provide 50mm to 100mm deep cavities behind the cladding that allow some air circulation to assist drying, although drainage is restricted by the continuous horizontal members.
