Determination 2010/78

Refusal to issue a code compliance certificate for a house with tiled decks at 42E Rarangi Road, St Heliers, Auckland

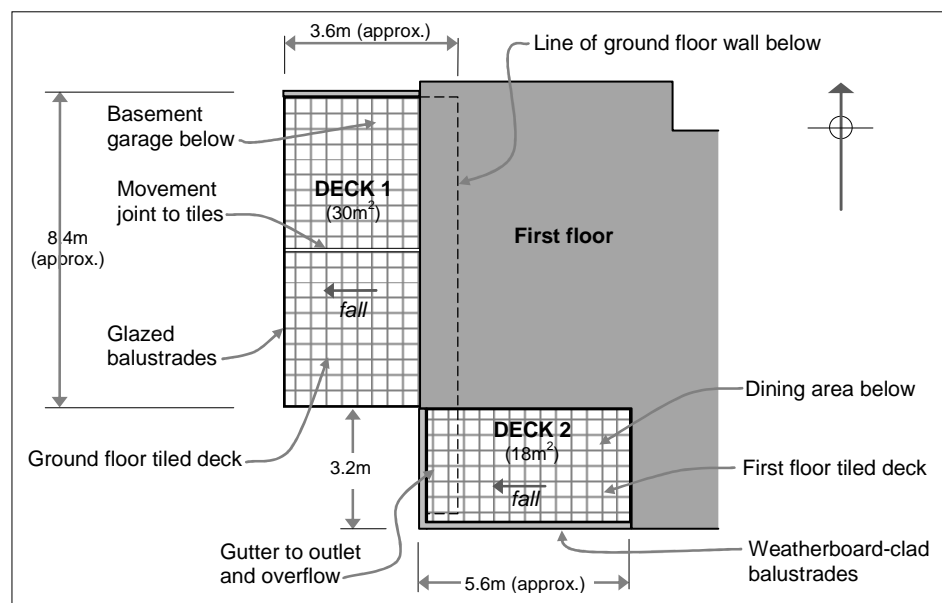
- 2.2.1 The house has two enclosed decks as shown in the following sketch:

- 2.2.2 “Deck 1” is a 30m² ground floor deck situated above the western end of the basement garage. The deck includes an aluminium louver screen to the north and a louver canopy to the north end. The balustrades are glazed, with stainless steel posts side-fixed to the deck edge and a gap under the bottom rail. A movement joint is installed

in approximately the middle, on an east-west line of tile joints within the longer dimension of the deck floor, which falls to the west and drains over the edge.

- 2.2.3 “Deck 2” is an 18m² deck on the southwest corner of the first floor; and is situated above the ground floor dining room. This deck has framed balustrades clad in fibre-cement weatherboards to both sides. The deck floor falls to the western end – into a tiled gutter draining to an outlet and overflow at the southeast corner.
- 2.2.4 Both decks have tiled floors, with the tiles adhered to a membrane applied over a plywood substrate. The specification calls for the deck framing to be ‘H3’ and the plywood substrate to be 18mm ‘H3 type treatment’.

- 5.2.3 Following the hearing, the attendees visited the house to view the decks. It was observed that Deck 1 (the larger deck) incorporated a movement joint within the tiled surface. There had been rain prior to the visit and I was able to observe the effect of rainwater falling onto the deck tiles and also to note a loose tile on Deck 2, where no movement joint had been incorporated into the tiled surface.

- The lack of a central movement joint to the tiles of Deck 2.
- The loose tile to Deck 2. A check to be made of the adhesion of that tile and any damage that may have occurred to the membrane underneath it
- Investigation of the tiles to both decks, to confirm that tiles are fully adhered.
