Determination 2010/102

The code compliance certificate of a deck to a house at 46 Hackett Street, St Mary's Bay, Auckland

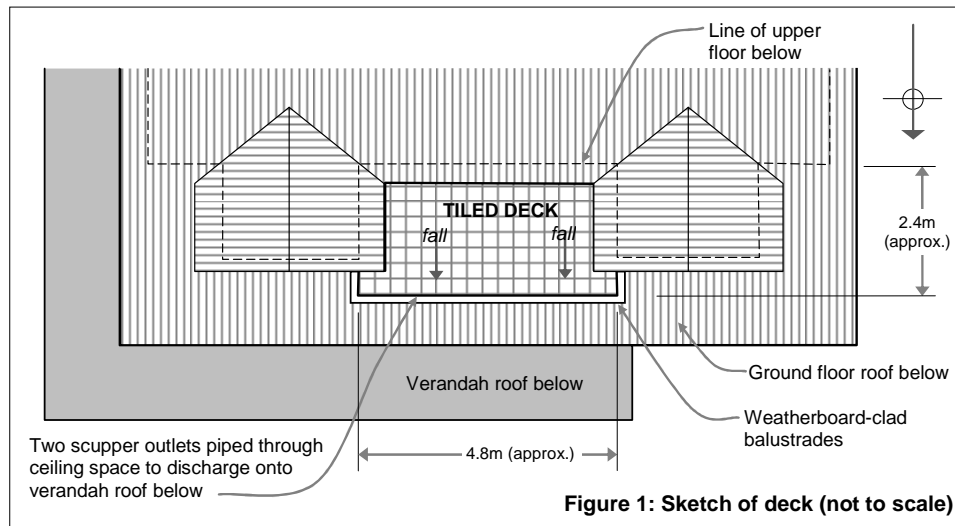
2.2.1 The enclosed deck is to the altered upper floor, as shown in Figure 1, and is located over entry and living spaces below.

2.2.2 The 11m² deck is set within the steeply-pitched roof slope on the north elevation, with a framed balustrade clad on both sides with horizontal timber weatherboards. The deck floor falls to the north, draining into two scupper outlets and an overflow, which are piped through the space beneath the deck, and under the eaves, to discharge onto the verandah. The deck has a tiled floor over a membrane on a plywood substrate.
