Determination 2010/113

Refusal to issue a code compliance certificate for the re-cladding of a house at 54 Levley Lane, Katikati

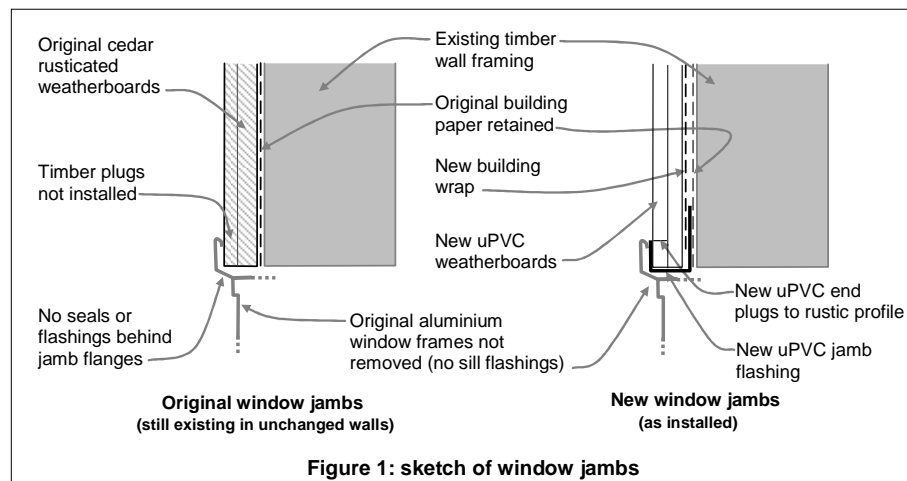
2.5.2 The existing windows within the new weatherboards are therefore face-fixed, with new metal head flashings, uPVC jamb flashings and moulded end plugs to fit the rusticated profile of the boards. The sketch in Figure 1 shows the jamb junctions before and after re-cladding:

- In comparison with the original window junctions, the new junctions provide similar protection to the heads, additional protection to the jambs (see Figure 1) and the same protection at the sills.
