Determination 2011/017

Refusal to issue a code compliance certificate for 3-year-old addition and alterations to a house at 18 Hodgkins Road, Pukehangi, Rotorua

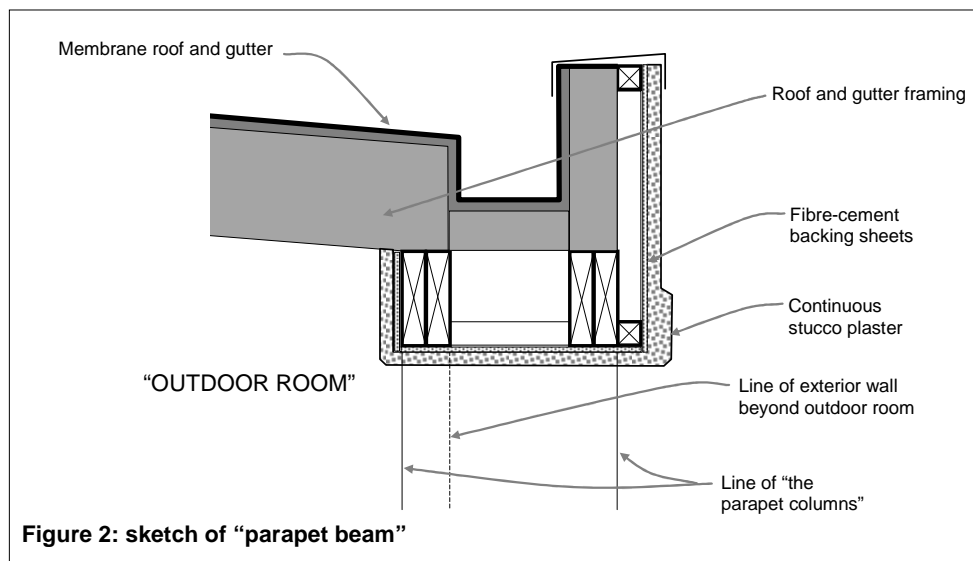
2.7.4 Based on the drawings and the builder’s description to the authority, the framed beams below the west addition parapet (“the parapet beams”) appear to be constructed approximately as shown in the following sketch:

2.7.5 As shown in Figure 2, the stucco extends from the outer face over the underside of the parapet beams between the parapet columns, with no drained cavity provided. The framed columns and parapet beam continue along the west elevation, around the recessed walls to the lounge and the master bedroom.

- the outdoor room bench seats, noting ‘no junction flashing details available’
 - framed parapet beams, noting ‘no ventilated cavity closer or cavity installed’

- the framed parapet beams lack any drainage to allow any moisture penetrating the cladding to escape to the outside (see Figure 2)
- the timber sample analysis taken from the bottom of the pergola column indicates that further investigation is required to establish the cause(s) for the moisture penetration and the fungal growth in the treated timber.
