## Determination 2011/032

### Refusal to issue a code compliance certificate for an 8-year-old house at 10 Ocean Parade, Pukerua Bay, Porirua

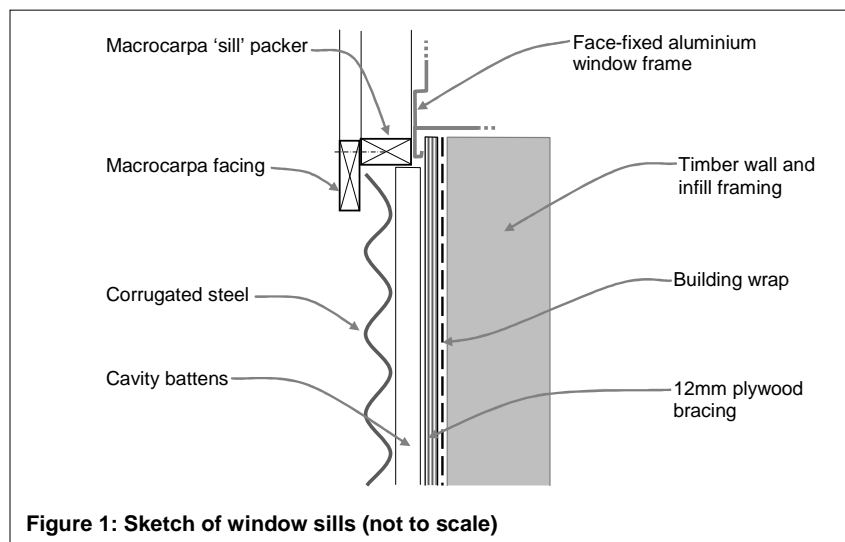
- 2.4.2 On the north and south elevations, the plywood continues as sheet bracing over the side walls of the house. The outer cladding is horizontal corrugated steel and the drawings call for this to be fixed through 50mm x 25mm treated battens and the plywood into the framing. There are no window details in the drawings, however, based on the expert's description and the photographs, the installation appears to be similar to the sketch in Figure 1:

- 6.4.1 Face-fixed windows and doors in the plywood cladding appeared satisfactory, with metal head flashings and timber facings above the flashings and over the jamb flanges. The expert observed water trapped in a deck door channel, but was able to drain this by opening the blocked sill drains.
- 6.4.2 The expert observed that windows installed in the corrugated metal cladding appeared to be face-fixed over the plywood bracing, with a timber 'sill' plate extending out to the face of the cladding and timber facings then fixed into the plate. No sill flashings were installed. This resulted in the sill plate being sandwiched between the window sill flange and the facing (see paragraph 2.4.2 and Figure 1).
