Determination 2011/097

Regarding the refusal to issue code compliance certificates for a 9-year-old addition and an 8-year-old lift installation to a house at 1038 Papamoa Beach Road, Tauranga

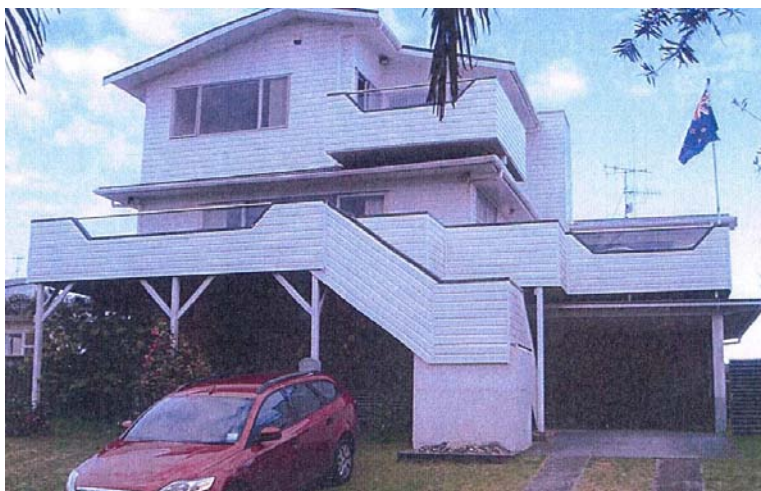
- 2.1.1 The original dwelling was a 1960s two-storey house sited on an exposed residential section that has been classified as a high-wind sea spray zone for the purposes of NZS 3604⁴.
- 2.1.2 The building is constructed with timber framing and clad with PVC weatherboard, with aluminium joinery throughout.
- 2.1.3 The modified dwelling has several roof sections, including part of the original hip-style roof at second floor level (now functioning as eaves), an original gable-style roof over that part of the original dwelling which does not have a third level above it, and the roofs of the addition and the lift installation. All of the dwelling's roofs, apart from the roof of the lift installation, have been clad with corrugated steel roofing material.
- 2.1.4 The resulting house is complex in plan and form. It is assessed as having a high weathertightness risk (see paragraph 6.2.2).

- 2.2.1 The addition consists of a new third floor level along the east wing of the building with an enclosed outdoor deck to the northwest corner.
- 2.2.2 The enclosed deck has been constructed from timber framing overlaid with plywood, with a waterproofing membrane. The membrane extends 150mm up the walls of the deck.
- 2.2.3 The addition has a simple, truss-based, 15° gable-style roof clad with corrugated steel roofing material. The roof of the addition has a 600mm perimeter soffit overhang on all four elevations, and externally-fitted PVC gutters.

- 2.3.1 The lift installation consists of the construction of a new timber-framed lift shaft to house an internal proprietary lift carriage located on the west elevation.
- 2.3.2 The lift installation has a near-flat roof without eaves or guttering, and has been clad with a fibreglass mat and waterproof membrane roofing material.
- 2.4 The expert was unable to confirm whether or not the timber framing used in the addition and lift installation was treated. Given the age of the original house and the earlier additions, the majority of the existing wall framing is likely to use native timber or boracic-treated framing. Given the date of construction of the addition in 2002 and the lift in 2003, I consider the wall framing of the additions to be untreated.
