## Determination 2011/109

### Refusal to issue code compliance certificates for alterations under two building consents to a house at 668 Weedons Road, Christchurch

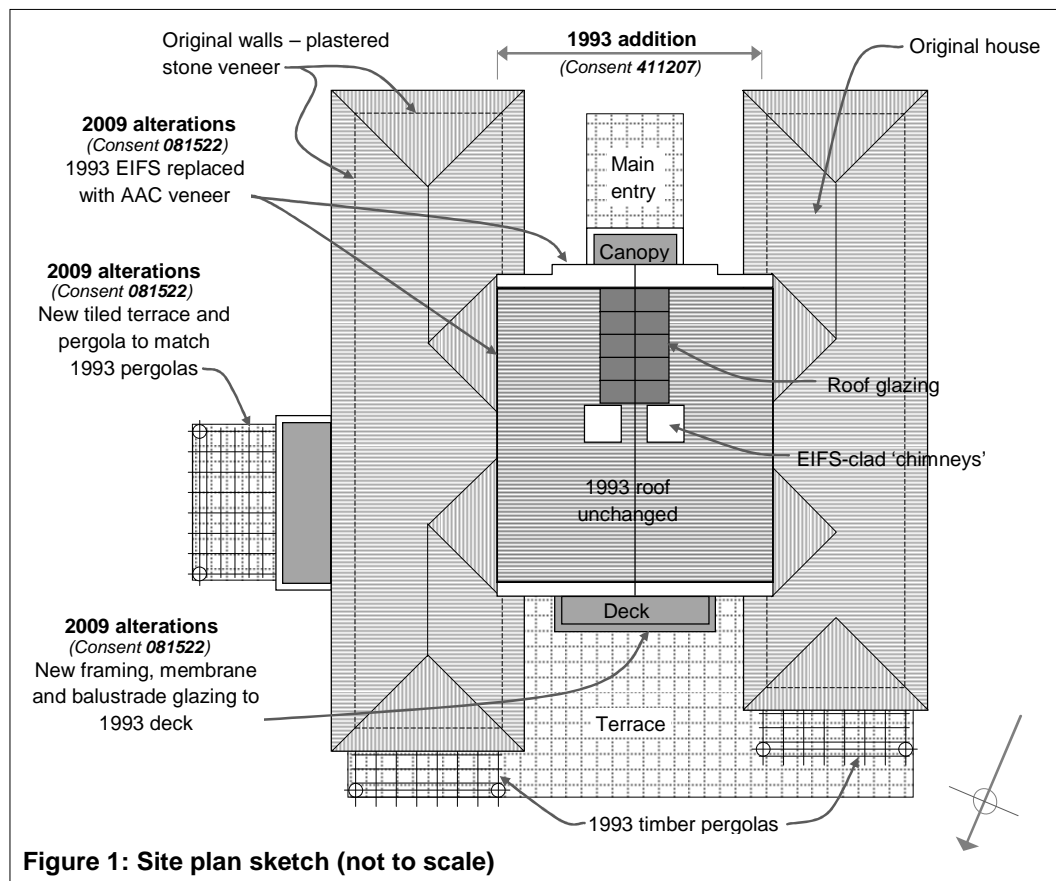
2.1 The building work consists of alterations to a detached house situated on a large level rural site in a high wind zone for the purposes of NZS 3604<sup>4</sup> that is moderated by tall trees that surround the site. The original house appears to have been built as a single-storey building with stone veneer cladding, aluminium windows, and metal roofing. The alterations are shown in Figure 1:

2.4.1 As shown in Figure 1, and as based on the drawings of the existing house included in the 2009 consent drawings, the 1993 alterations appear to have included:

2.5.1 As shown in Figure 1, the 2009 remedial work included:

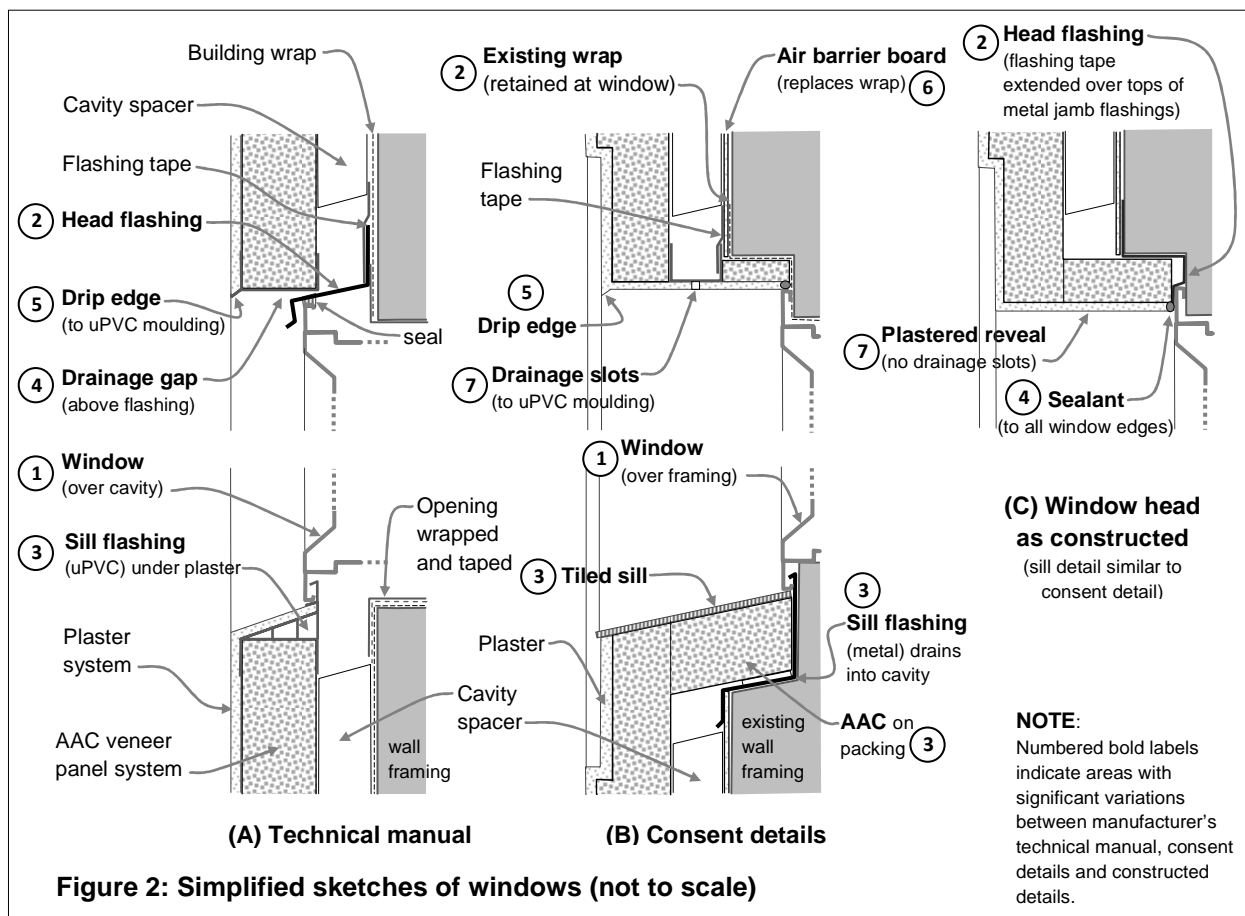
Figure 2: Simplified sketches of windows (not to scale)

2.5.6 The technical manual provides details for recessed windows (A), which show:

- window units installed in line with the cavity (1 above) being recessed into the cladding by approximately 50mm
- drained metal head flashings bridging the cavity (2)

- plastered uPVC mouldings that form the base of a sloping sill, with an upstand behind the sill flange and a turndown over the AAC backing panel (3)
- drainage gaps above the head flashing and beneath the sill flanges (4)
- uPVC base mouldings above the head, incorporating drip edges (5).

2.5.7 The consent drawings show ‘standard’ windows (B) with:

- window units installed towards the interior side of the wall framing, with windows faced-fixed onto 50mm wide timber trimming the opening (1)
- windows being recessed into the cladding by approximately 250mm
- no head flashings and a uPVC cavity closer draining the cavity above (7)
- concealed sloping metal sill flashings, with upstands under window flanges, turndowns over the RAB and tiled AAC forming a sloping sill (3)
- metal jamb flashings from behind jamb flanges, extended to overlap the RAB.

2.5.8 Construction photographs supplied by the applicants (and confirmed by the authority’s inspection records) show a window installed with:

- metal-faced flashing tape wrapped over the timber lintel, extended over the trim and overlapped onto the window head flange (2)
- metal jamb and sill flashings installed and overlapping the RAB (3)
- window flanges sealed against plaster (4).

- 6.2.1 The expert noted that the recessed windows were not installed in accordance with the manufacturer's details, with no visible head and sill flashings and the windows sealed against the reveals with sealant. Construction photographs showed the installation of flashings within the cavity (refer paragraph 2.5.8).
- 6.2.2 Although consent drawings showed slots in the head reveal to allow drainage from the cavity, the expert noted that these were not provided. The drip edge formed in the head reveal shown in the drawings was also not provided, although the expert considered that, given the depth of the reveal, the windows were somewhat protected and that water was unlikely to reach the window head junction.

- 7.3.1 It is clear from the expert's report that there are some areas (primarily the junctions with the external joinery) where the AAC veneer cladding system has not been installed in accordance with the manufacturer's instructions. Though this of itself does not mean that the cladding system is not compliant, I note that as the expert was not able to carry out invasive moisture testing there is insufficient evidence to establish performance. Taking into account the expert's report and the lack of invasive investigation, I therefore conclude that further investigation and/or remedial work is necessary in respect of:

- The installed sill flashing turns down over the RAB into the AAC cavity, with a kick-out to direct moisture away from the RAB (see Figure 2).

- 7.5.3 Reasonable grounds to consider the house has been brought into compliance with building Code Clauses E2 and B2 will require:
- satisfactory investigation and rectification of items outlined in paragraph 7.3.1
  - a satisfactory systematic survey of high risk locations to confirm the condition of the existing timber framing as described in paragraph 8.1.2.
- 7.5.4 Effective maintenance of claddings is important to ensure ongoing compliance with Clauses B2 and E2 of the Building Code and is the responsibility of the building owner. The Department has previously described these maintenance requirements, including examples where the external wall framing of the building may not be treated to a level that will resist the onset of decay if it gets wet (for example, Determination 2007/60).
