## Determination 2012/039

# Regarding the compliance of proposed remedial work to chalets at Waiheke Resort, 4 Bay Road, Waiheke Island, Auckland (to be read in conjunction with Determination 2010/065)

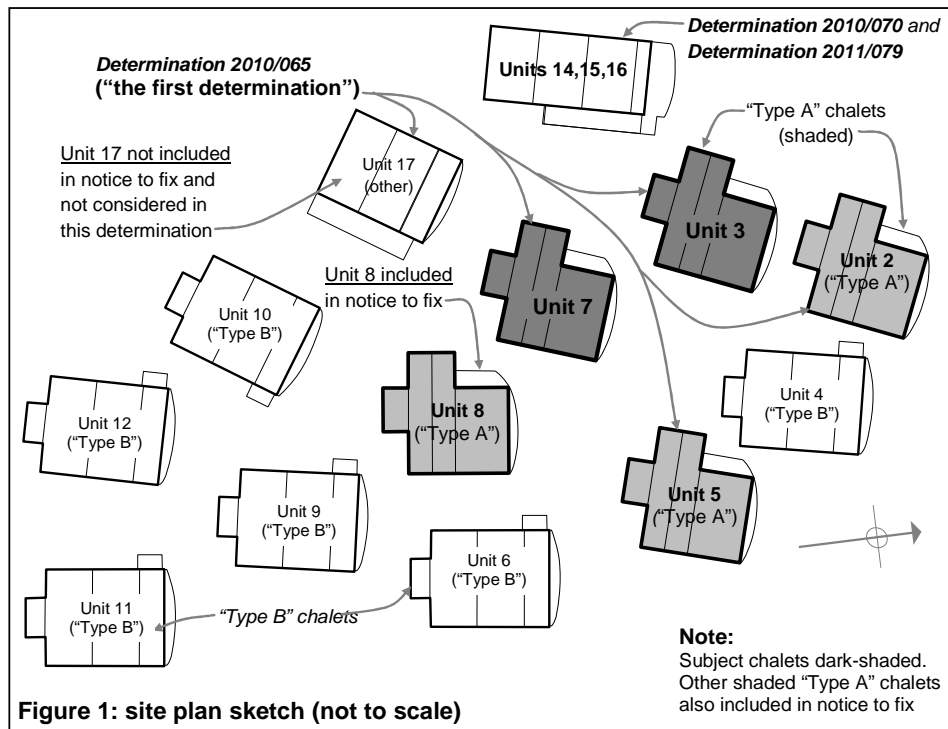
1.3.1 I have previously described certain building matters in Determination 2010/065 issued on 19 July 2010 (“the first determination”), which considered five buildings, including four Type A chalets (see Figure 1).

2.1 The building work consists of repairs to free-standing chalets within a large unit-titled development. The Type A chalets were originally constructed as cabins in the early 1980's and are part of a larger group of chalets as shown in Figure 1.
