## Determination 2012/046

### Refusal to issue a code compliance certificate for an 18-year-old house at 361 Oira Road, Drury

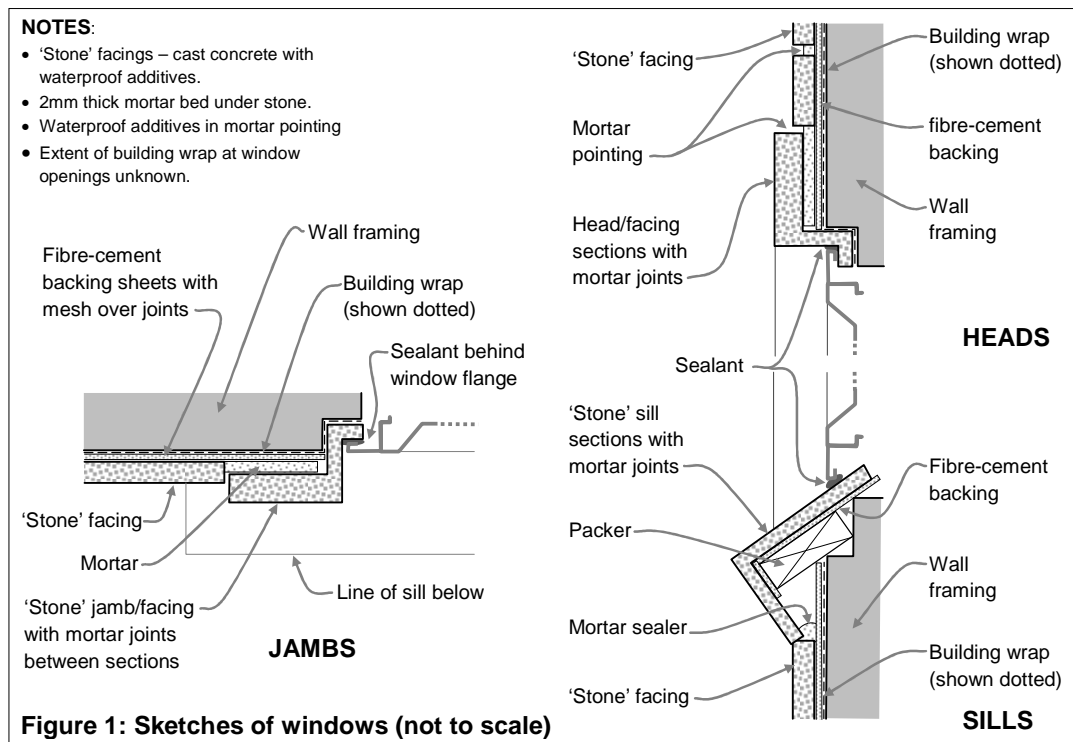
2.5 The aluminium joinery units are set into specially cast sections of the stonework. The following Figure 1 is an interpretation of the window installation based on the expert's descriptions, photographs, and technical literature:

- The junction between the sill and jamb sections at the exterior joinery units provide a possible avenue for water to enter by capillary attraction should a crack open up. Also, there was no obvious “escape route” for any moisture that entered these junctions.

- The head section terminated behind the joinery units and this elevated the sealant to a “critical” status, although the depth of the head recess provided additional protection. In addition, the flat surface of the head cladding could allow water entry that did not have an easy escape route, and this was occurring in at least one location.
