Determination 2012/054

Regarding the refusal to issue an amendment to a building consent for a 3-year-old conservatory addition to a house at 14 Byron Street, Rolleston

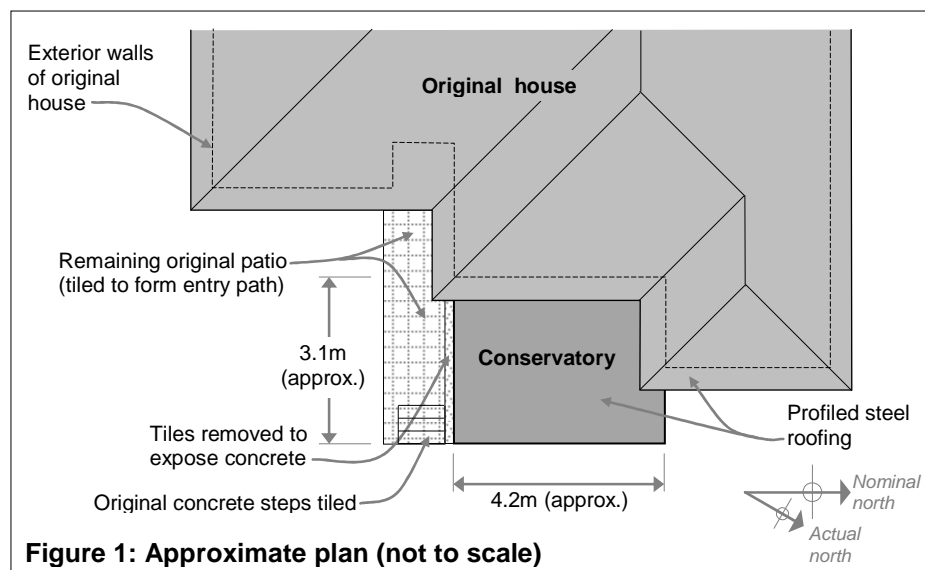
- 2.1 The building work consists of a conservatory added to a 1970’s single-storey house on a flat site in a high wind zone for the purposes of NZS 3604⁵. The expert takes the rear of the house as north-facing, and this determination follows that convention.
- 2.2 The conservatory has been constructed above part of an original raised concrete patio to the east of the house as shown in Figure 1:

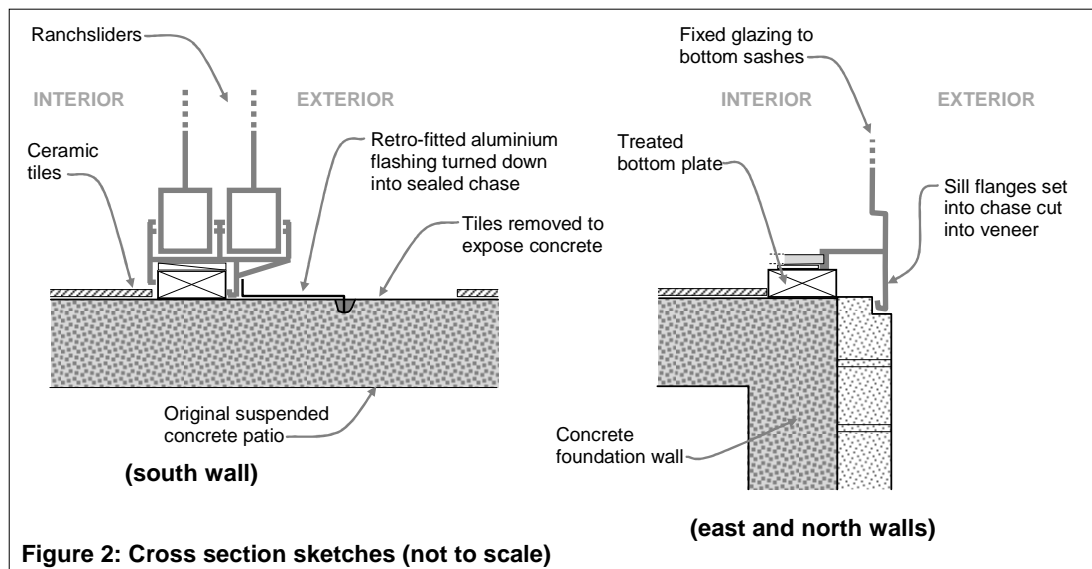
2.4.3 It appears that the original consent drawing showed the conservatory erected over a 65mm topping slab that was not installed (see paragraph 3.2.1). Construction photographs show bottom plates fixed directly over the original concrete with no sill flashing and tiles butted against conservatory walls. The row of exterior tiles against the ranchsliders has since been removed to allow a metal flashing to be installed.

2.4.4 As-built details at bottom plates appear to be similar to the sketches in Figure 2:

3.3.1 In January 2011 a new detail for a 'proposed flashing' was prepared; showing a flashing extending from the ranchslider sill flange to a 20mm chase cut into the patio concrete, with a note stating 'detail is to all external sides of conservatory'. The row of tiles against the ranchslider sills was subsequently removed and a flashing was retrofitted at the junction (see Figure 2).

- 5.3.2 At corner posts, jamb flanges overlap the folded corner flashings, with a sealant fillet at the junction. The expert pressed against the flashing, noting that sealant was not bonded to the metal. At the bottom of the north and east walls, sill flanges are set into a rebate cut into the block veneer, with a cover of about 20mm (see Figure 2).

6.2.2 The authority has refused to issue an amendment to the consent, and maintains that the as-built details as shown in Figure 2 have the 'potential to trap moisture in aluminium frame and bottom plate' and the amended drawing does not accurately reflect actual construction.
