Determination 2015/031

The refusal to issue code compliance certificates for a 12-year-old shop/dwelling and an 8-year-old toilet block, and alterations carried out without a building consent at 2515 Oxford Road, Oxford

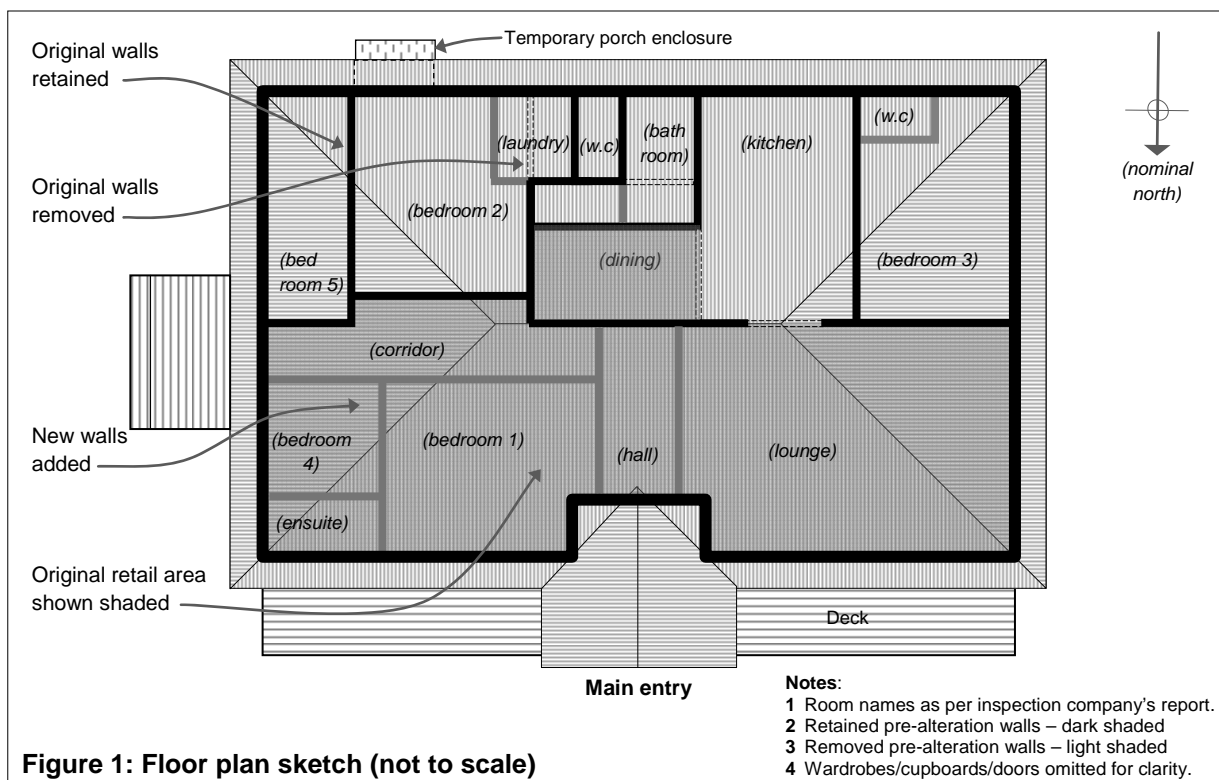
2.2.2 Interior alterations were carried out from 2010 to 2013, which changed the as-built shop/dwelling into a five bedroom dwelling as shown in Figure 1:
