Determination 2015/045

Regarding the refusal to issue a code compliance certificate for a 12-year-old addition with monolithic and brick veneer claddings at 57 Blockhouse Bay Road, Avondale, Auckland

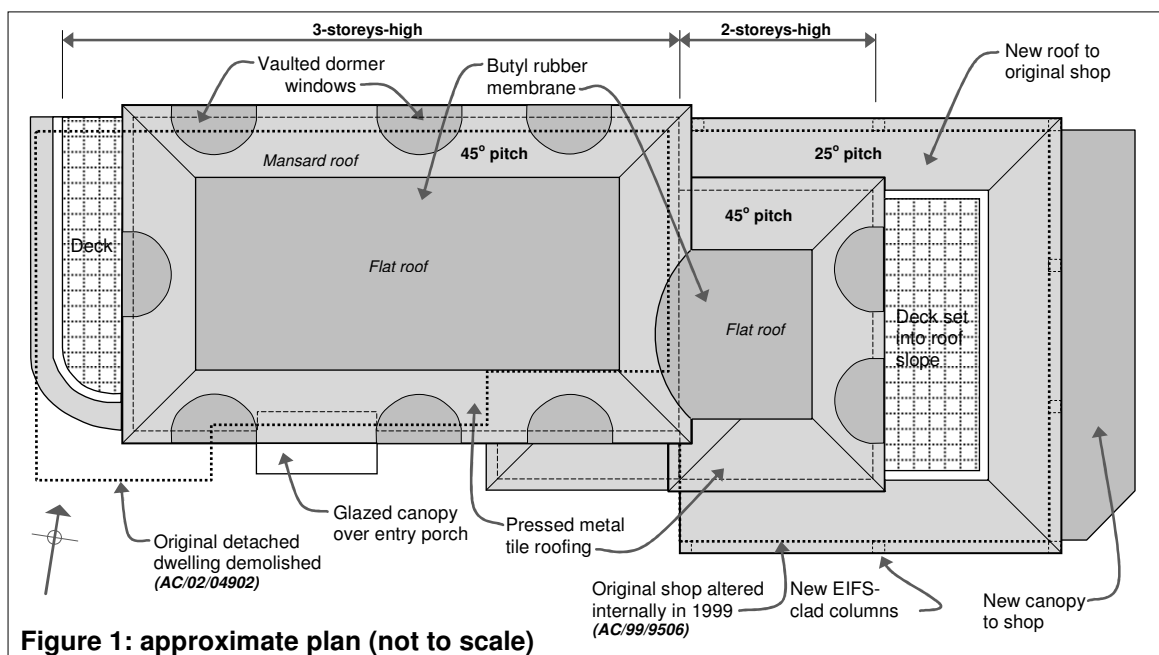
- 2.2.1 The subject building work consists of a large house addition to the existing shop, with the house extending over part of the re-roofed shop as shown in Figure 1.
