Determination 2015/049

Regarding the refusal to issue a code compliance certificate for alterations to an existing house at 43 Waikaraka Drive, Te Puna

Summary

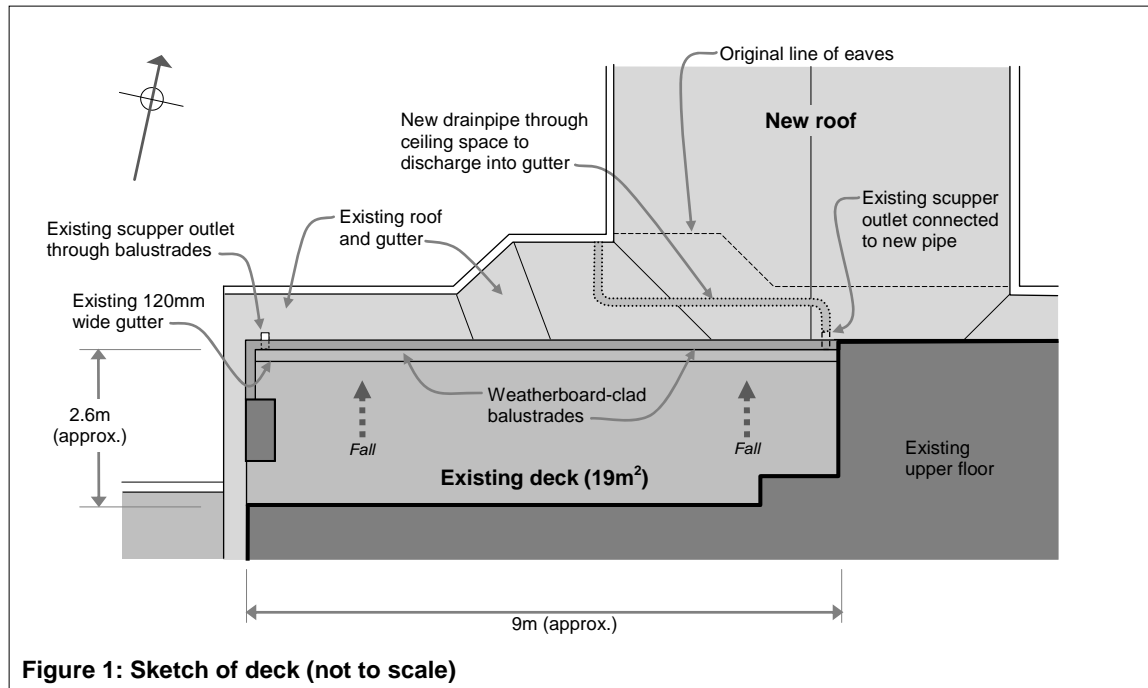
- 2.3.1 The 2014 alterations included a single-storey timber-framed addition to the east to form a semi-outdoor dining area ("the dining addition"). The roof to the new dining area intersects with the original lower roof, blocking one of the original outlets to the existing deck as shown in Figure 1 (over page).

- 2.4.1 The existing membrane deck floor falls towards a full-length 120mm wide membrane-lined gutter at the front edge, which drains to 90mm x 65mm scupper outlets at both ends. The west outlet remains unchanged, while the east outlet is re-routed through the lower roof space to discharge into the gutter.

- 2.4.2 The existing east scupper outlet was apparently re-used so as not to disrupt the deck membrane and a detail dated 15 May 2013 titled 'Information Request Amendment' was provided by the designer. The detail provided a schematic sketch of the proposed junction between the existing and new pipes, with a note stating 'sealed joint with [butyl rubber] wrap'.

- 2.4.3 The existing 90mm x 65mm scupper pipe was modified to allow it to slide into the new 100mm x 50mm uPVC downpipe, with the joint waterproofed with butyl rubber membrane wrapped around the junction and overlapping each pipe by about 100mm. After the pipe was installed, the authority raised questions about the durability of the junction and the roofer sought and received advice from the membrane supplier.

5.1.2 Taking account of the expert’s report together with the factors outlined above, I am satisfied that the deck drain as installed and jointed is currently watertight and is likely to be so in the future. The ongoing performance of the junction is reliant on the durability of glued joints: it is suggested that mechanical clamps, or similar, be installed around the butyl rubber wrap to secure it to the pipework.
