## Determination 2016/001

# The refusal to issue code compliance certificates for a 15-year-old extension to a house with weatherboard and brick veneer claddings at 1007 Moonshine Road, Porirua

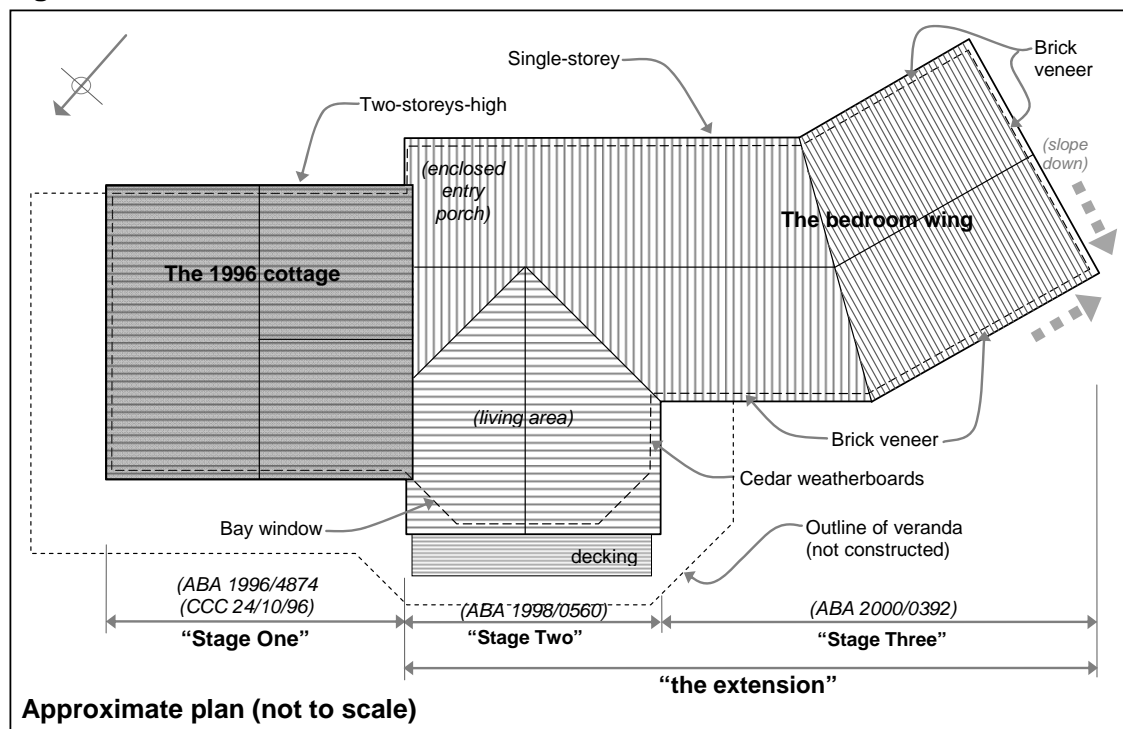
**Figure 1:**

2.2 The completed house is shown in Figure 1 and comprises:

- Stage 1 (the 1996 cottage): a simple rectangular two-storey building with an asymmetrical gable roof and a mezzanine level within the steep roof slope (not considered in this determination).
- Stages Two and Three: a single-storey extension to the southwest, providing three additional bedrooms, a bathroom and living areas.
