Determination 2016/004

Regarding the weathertightness of some 19-year-old stucco plaster walls to a house at 467 Mill Road North, Invercargill (to be read in conjunction with Determination 2015/040)

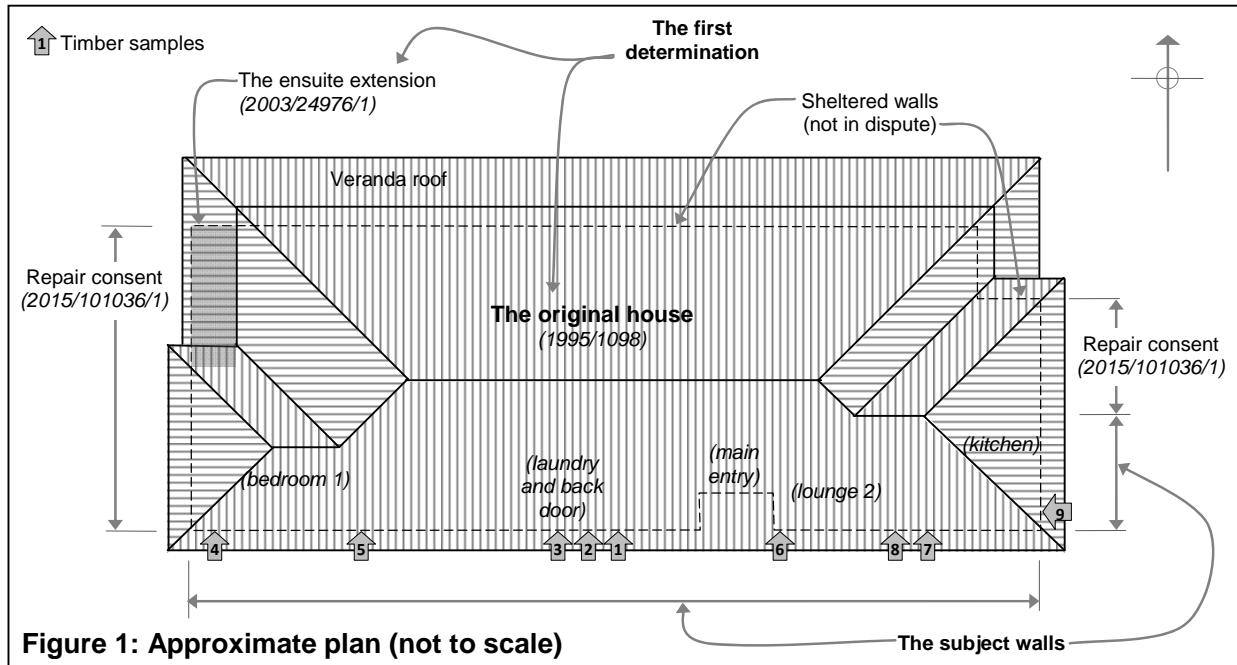
- 2.1 The building is a single-storey detached house, with conventional light timber framing, a concrete slab and foundations, aluminium windows, monolithic wall cladding, and a profiled metal hipped roof. A lean-to veranda extends along the long northern face of the building and around the northeast corner as shown in Figure 1 (see over page).

- 5.4.3 To further investigate the condition of framing in the laundry area, the expert removed skirtings and made cut-outs through the lining (see Figure 1). The expert forwarded timber samples for analysis and recorded invasive moisture readings of:

- 5.4.5 To further investigate the condition of the bottom plate, the expert removed trim and made cut-outs through the lining (see Figure 1) and observed that the timber 'in every location was of visually sound timber, free from any obvious moisture, staining, mould or degradation.'
