Determination 2016/038

Regarding the code-compliance of weatherboards to a partly constructed house at 28 Roberta Drive, Spreydon, Christchurch

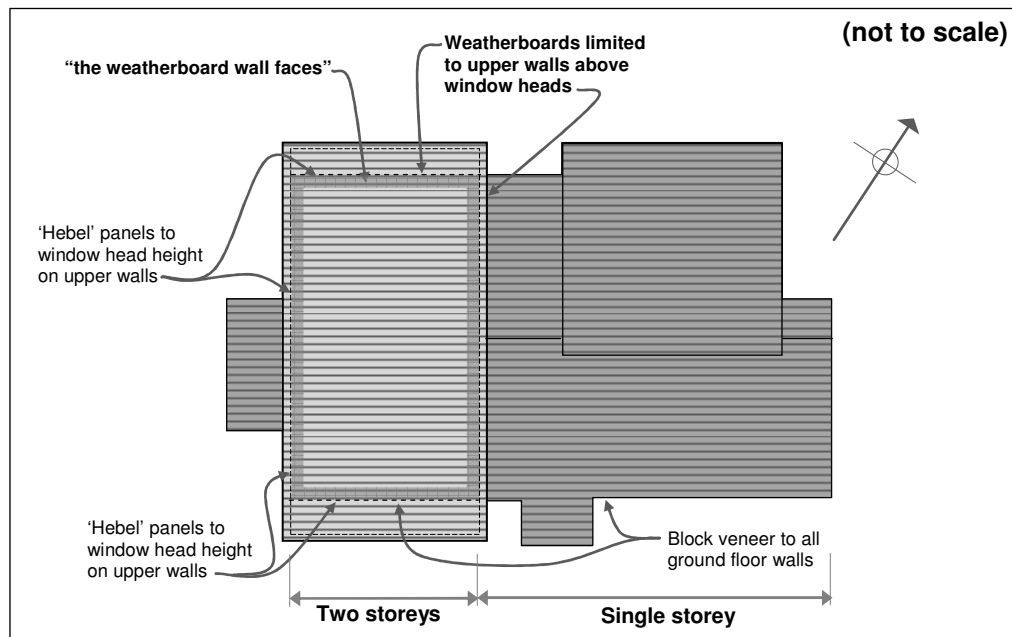
Figure 1: Wall claddings

Wall claddings are a mix of weatherboards, masonry veneer and plaster-finished AAC⁷ cladding.

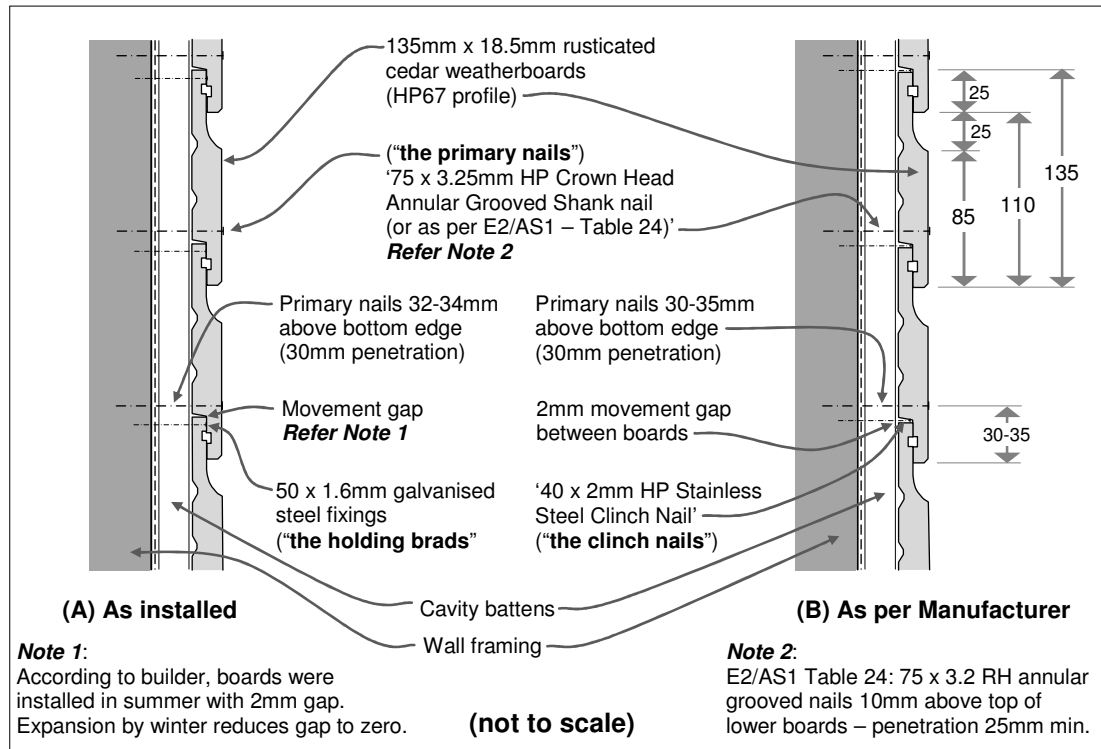
Figure 2: Weatherboard fixings

- Sketch 2(A): during installation, boards were held in place using the holding brads to allow set out prior to being fixed with the primary nails. The holding brads are 50 x 1.6mm galvanised steel nails fixed through the top of the boards into every second cavity batten.

- Note 1 to Figure 2(A): the weatherboards appear to have been installed in about December 2015 and the builder has stated that a 2mm movement gap was included, with expansion of the boards up to the time of the expert's inspection (June 2016) taking up that gap (see paragraph 3.3).

- Sketch 2(B): the manufacturer specifies 40 x 2mm stainless steel clinch nails, which allow board set out prior to being fixed with the primary nails. The clinch nails are positioned in the 2mm movement gap between boards and are shaped to hold the top of the board in place without penetrating its surface.

- Note 2 to Figure 2(B): the Acceptable Solution E2/AS1 calls for primary nails to be RH grooved nails that miss the lower board and penetrate through the battens and into framing by a minimum of 25mm, with the nail positioned 10mm above the top of the lower board.
