Determination 2016/043

Regarding the compliance of weatherboards as installed to a house at 14 Te Whangai Head Road, Pataua North, Whangarei

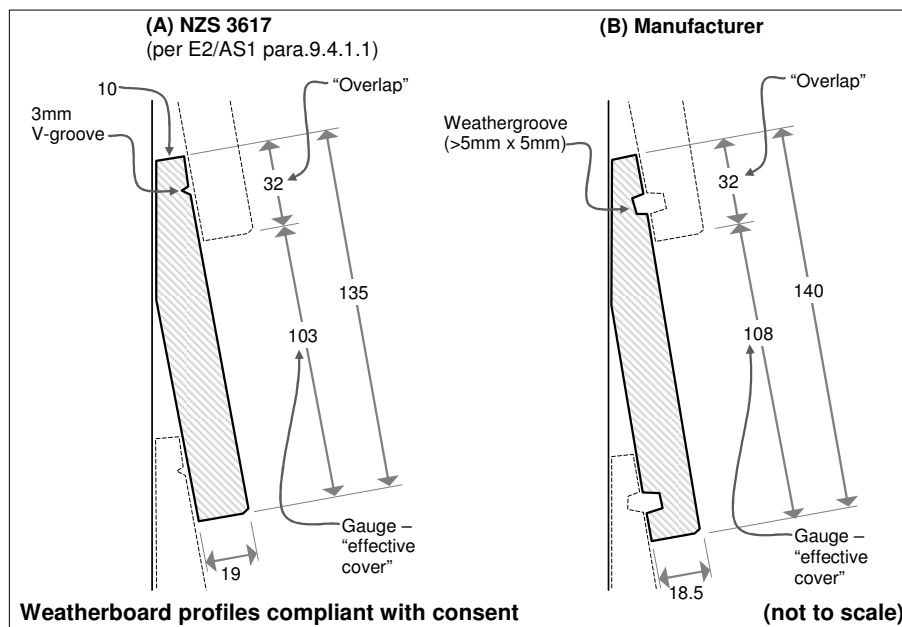
Figure 1: Weatherboard profiles

- 2.3.4 Figure 1(B) shows the profile of the installed weatherboards. This is compared to the board profile shown in Figure 1(A), which is that described in Acceptable Solution E2/AS1:

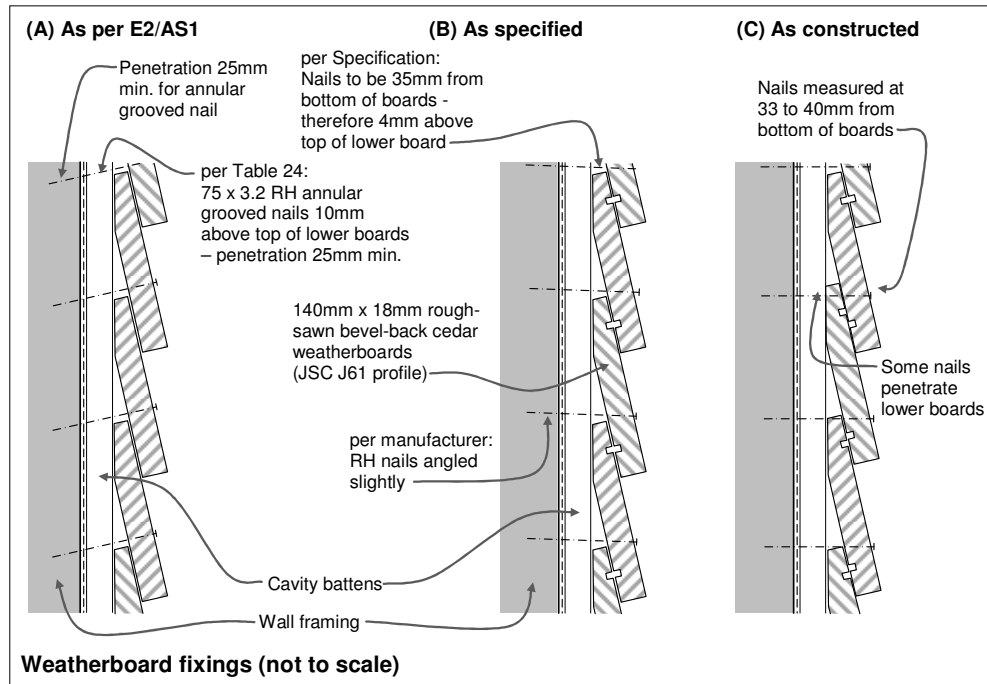
Figure 2: Weatherboard fixings

- 2.4.2 The expert’s investigations show that the installed weatherboards are as indicated in the sketch in Figure 2(C). This can be compared to Figure 2(A), which complies with the Acceptable Solution E2/AS1, or with Figure 2(B) which aligns with the manufacturer’s instructions for the specified weatherboards.

- Sketch 2(A): the Acceptable Solution E2/AS1 calls for nails that miss the lower board and penetrate through the battens and into framing by a minimum of 25mm, with the nail 10mm above the top of the lower board. The board profile in E2/AS1 is described ‘as given in NZS 3617⁶ or BRANZ Bulletin 411⁷’.
- Sketch 2(B): the manufacturer specifies nails angled slightly upwards. The specified 35mm above the bottom of the board would result in 4mm clearance from the top of the lower board.
- Sketch 2(C): in the as-built installation, the visible face of boards (“the effective cover”) varies from about 94mm to 107mm, with nails measured at 33mm to 40mm from the bottom of boards. The nailing combined with overlap variations mean that many nails penetrate through the top of lower boards.
