Determination 2017/003

Regarding the refusal to issue a code compliance certificate for a 12- to 15-year-old house with monolithic cladding at 4 Komokoriki Hill Road, Warkworth

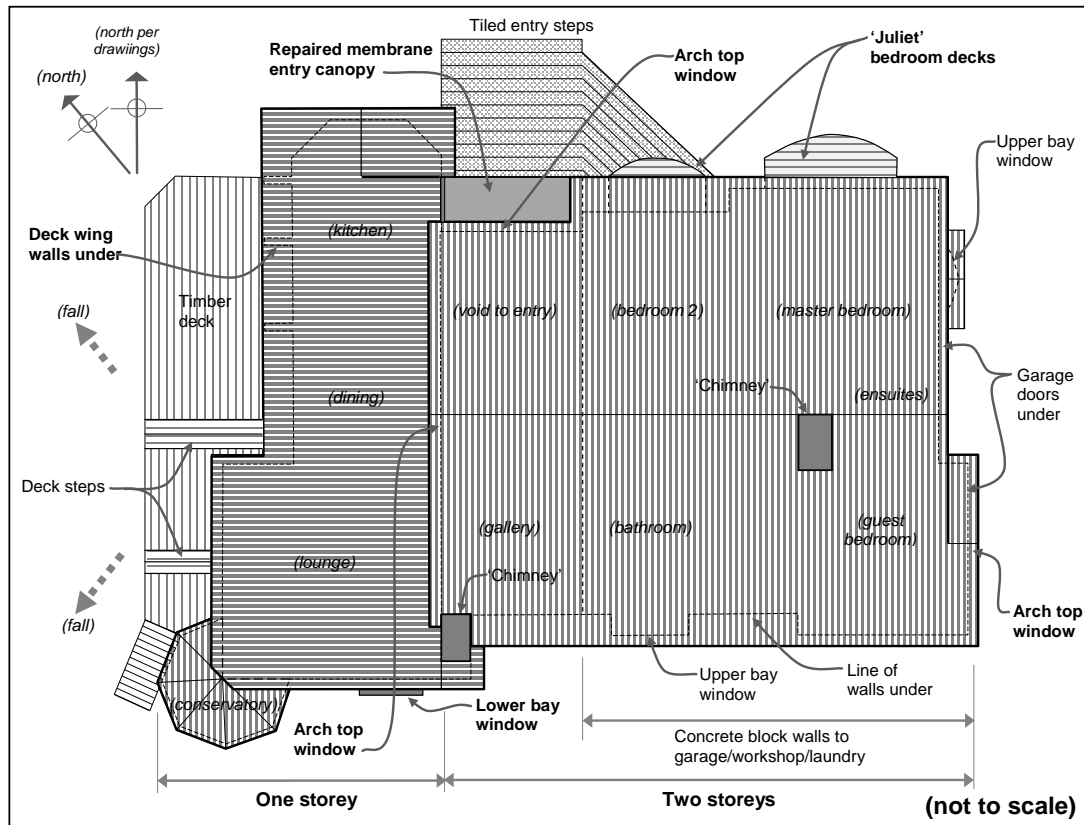
Figure 1: Approximate site plan

- 2.3 The northwest gable end wall includes an arched window above the lean-to roof to the single storey living areas. As shown in Figure 1, roofs form gables above three projections and a hipped roof conservatory extends from the west corner, with apron flashings at roof/wall junctions. Curved membrane roofing forms an entry canopy, with internal gutters to the roof/wall junctions at the ends.

- 2.4.1 On the upper northeast wall, two cantilevered 'Juliet' decks extend from the master bedroom and bedroom 2. The decks have floors of spaced timber decking, with open metal balustrades. Deck soffits and the outer curved floor perimeter are clad with the same spaced timber decking boards.
- 2.4.2 On the ground floor, an attached timber framed deck with open metal balustrades extends along the northwest elevation. The deck floor steps down towards the southwest, with a flight of steps down to ground level beside the conservatory. Three wing walls extend from the northwest wall beneath the 800mm deep eaves soffit ("the deck wing walls") as shown in Figure 1.
