Determination 2017/011

Regarding the refusal to issue an amendment to a building consent for repairs and repainting of the AAC cladding system of a 4-year-old house at 4126/6 Hampden/Palmerston Road, Moeraki

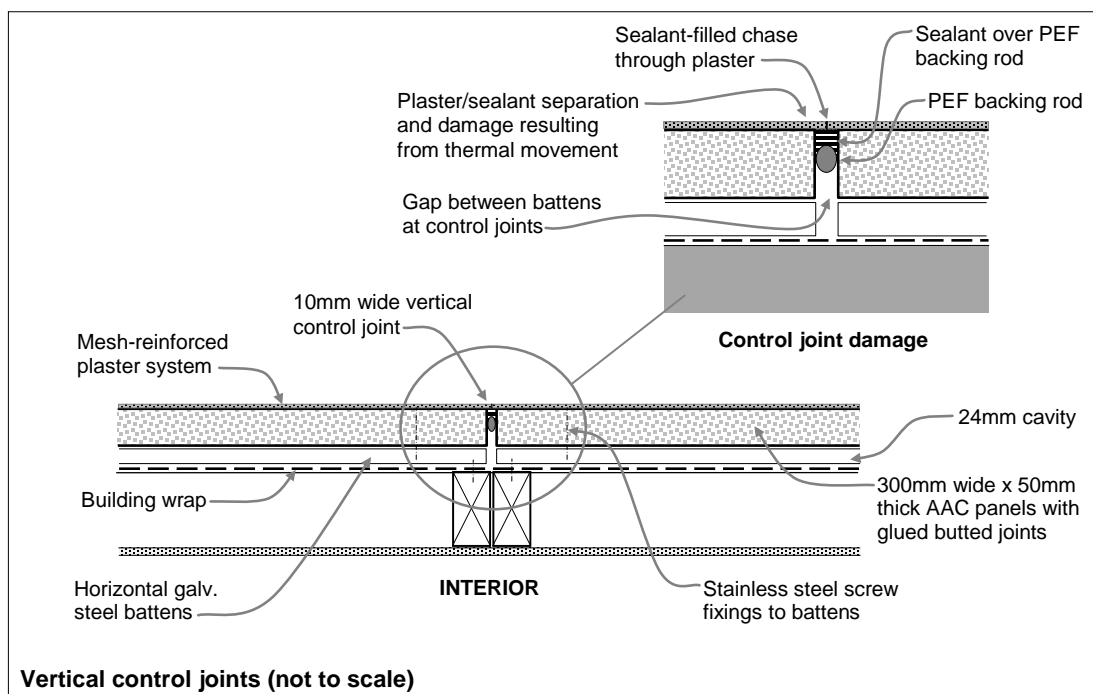
Figure 1: Typical vertical control joint

- 5.2.2 The expert inspected the 26 vertical control joint locations (see Figure 1), 14 internal corner junctions and wall sections with adhered joints, observing:

- 20 of the vertical control joints were uniform and without defects
 - 6 joints showed minor 'disruption' to the sealant joint ("the disrupted joints"), but no evidence of moisture migrating down to the base of the joints

- thermal movement of the joint had disturbed edges of render above the joint
 - underlying joint widths were 10mm, which is in accordance with instructions

...minor targeted repair to 6 control joints only and a paint colour change undertaken by a suitably qualified LBP trades person.
