Determination 2017/085

Regarding the authority’s decision to issue a code compliance certificate for alterations to a house at 36A Simla Crescent, Khandallah, Wellington

Summary

This determination considers the authority’s decision to issue a code compliance certificate for alterations to an existing house and whether the building work complied with the building consent and the Building Code at the time of that decision.

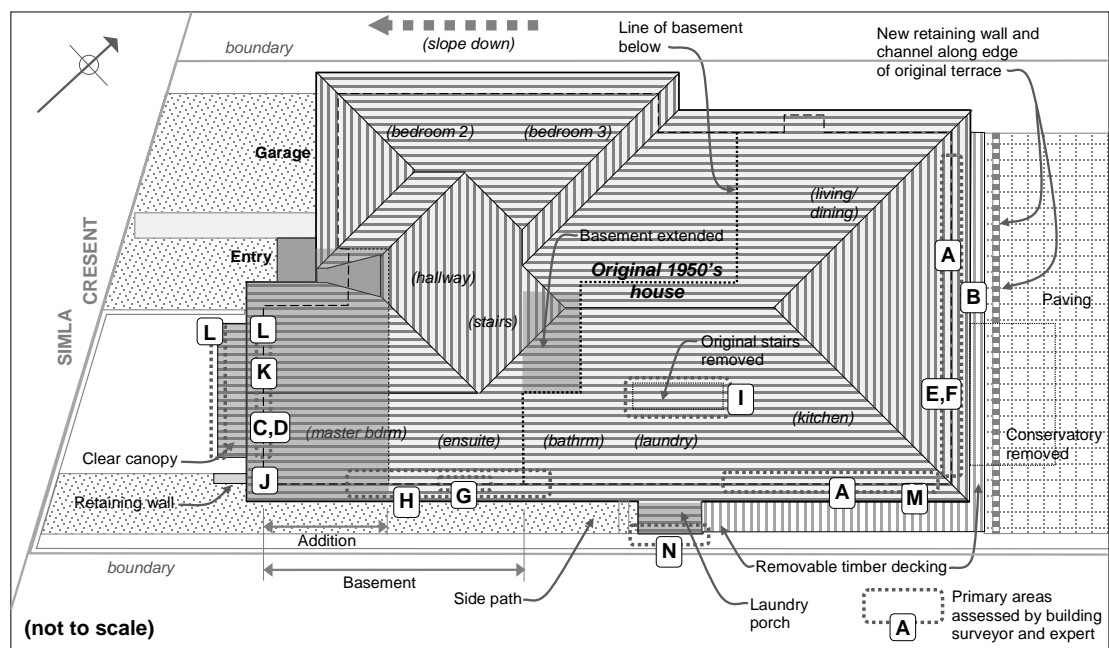
Figure 1: Approximate site plan

2.2.1 As shown in the sketch in Figure 1, alterations included demolition of the original concrete entry stairs, a small 2-storey addition to the southwest, a porch addition to the southeast, extensive interior alterations, and associated landscaping work.
