Determination 2018/009

Regarding the refusal to issue a code compliance certificate in respect of remedial work to the decks to Units 220, 221, 224, 225, 228, 229, 232, and 233 at Terrace Downs Villas, Lake Coleridge Road, Darfield

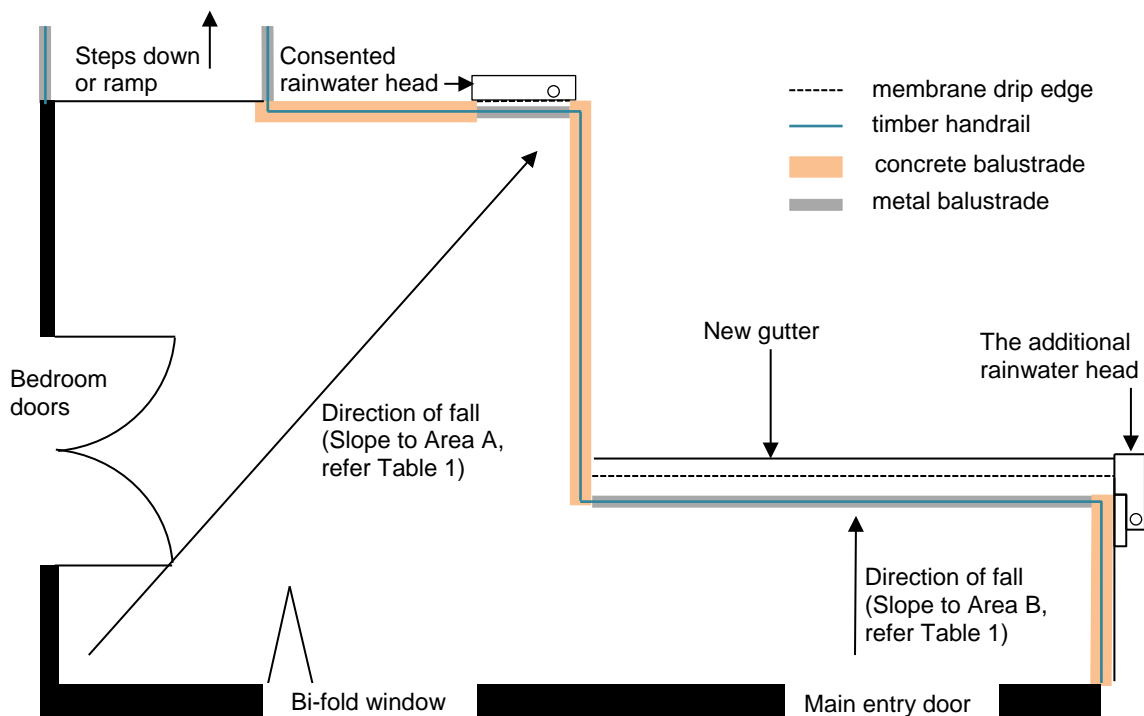
Figure 1: As-built plan of a typical deck (plan for units 220, 224, 226, & 232 mirrored, not to scale)

5.4.1 The expert measured the decks' cross falls to areas A and B noted in Figure 1 as follows:

In response to the authority's refusal letter dated 16 August 2017	
Cross falls	<ul style="list-style-type: none"> Deck falls are at right angles to the direction of travel between the deck entrance and entry to the units. The consented 30mm fall has been exceeded on all balconies, resulting in a fall of 0.4° or greater (but less than 1:40 fall specified in E2/AS1). Most decks exceeded the 1:50 (1.14°) slope stated D1/AS1. A "safe fall" is required to comply with Clause D1. Unit 220 has the steepest cross fall (2.3°) but did not feel unsafe to walk along. The BRANZ Appraisal for the membrane allowed its use on slopes of up to approximately 9°, exceeding what has been built.
Water ponding and inadequate falls	<ul style="list-style-type: none"> After wetting the decks, water ponding was visible for up to 2 hours on Units 220, 221, 224, 225 and 232. Falls on all eight decks exceeded 30mm. Ponding is caused by "slight undulations in the screed on a very shallow pitch". It was "unreasonable" to expect a flat finish on a screeded surface. The membrane is relatively coarse and provides a high surface tension that would slow the dispersal of water on the shallow slope. The manufacturer has inspected the decks and confirmed it would honour the warranty at the falls achieved. The seams were well-sealed by heat welding. Generally membrane decks fail at junctions; there appeared to be no risk of the decks leaking due to the slight ponding evident.

6.2.3 The expert considered the ponding is caused by a combination of slightly uneven screed and the embossed surface of the membrane itself. He considered achieving a completely even screed surface on a low slope was not possible in practice. The embossed surface of the membrane also contributes to a slower dispersal of the water with the low slope.

6.2.4 The falls to the as-built decks are in most instances in excess of the falls described in the building consent. I also consider the falls able to be achieved in this case are restricted by the physical layout of the existing building which must impact on the practical options available to the designer and builder. The expert observed the seams were well sealed through heat welding. He also noted generally membrane decks fail at the junctions; there was no apparent risk of the decks leaking as the ponding occurred in the centre of the decks away from any junctions. Given the building's construction, the membrane is also unlikely to be affected by any future movement of the substrate (e.g. sagging or settlement) as might be the case with a timber-framed building or deck.

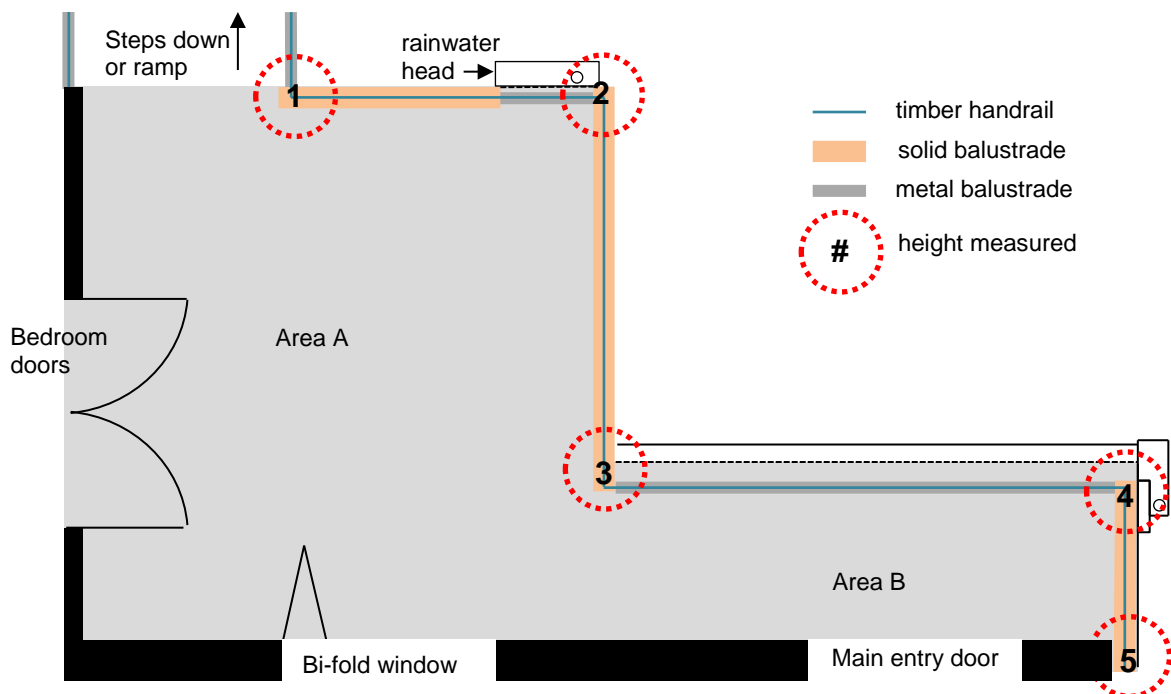
Figure 2: Balustrade height at locations shown (plan for units 220, 224, 226, and 232 mirrored, not to scale)

5.5.1 The expert measured the height of all the balustrades in response to the authority's assertion that one unit's balustrade was not appropriately high to comply with Clause F4. He measured the balustrade heights at the locations shown in Figure 2 with results shown in Table 2.

6.5.3 The expert measured the barrier heights to the decks and, in places, found a shortfall of between 10-50mm below the 1000mm minimum barrier height stated in Acceptable Solution to Clause F4, F4/AS1, most notably at the higher points in the deck screed. A 40-50mm shortfall was measured in respect of a very short section of barrier next to the entry door to four of the eight units.

- 6.5.13 The performance of the balustrade in terms of Clause F4 must be assessed as an existing building element against the requirements of section 112. There is no evidence to show the compliance of the reinstated barrier is worse than it was before, but there is evidence to suggest it did not comply before the remedial work commenced. I note that the areas where the balustrades fail to comply with the Building Code do so to only a minor extent.
