Determination 2018/022

Regarding the issue of a notice to fix in respect of the concrete foundations at 24 Dollar Place, Prebbleton

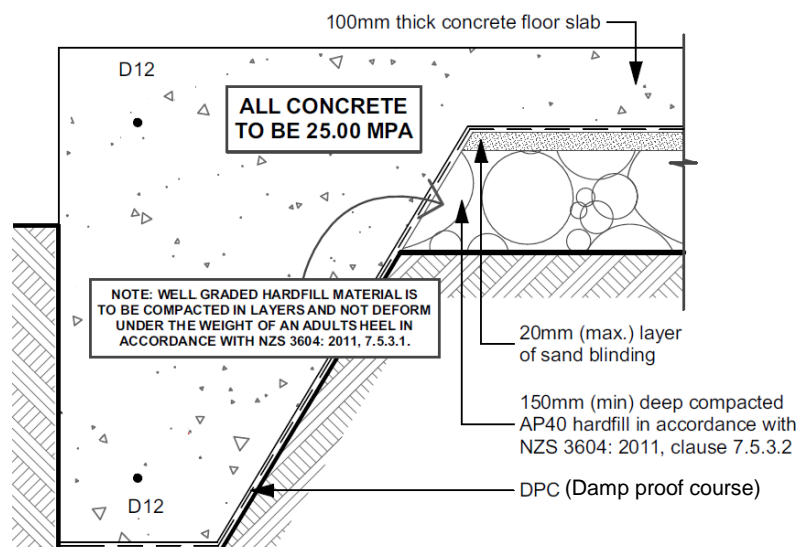
Figure 1: Perimeter foundation detail (not to scale)

- 2.1.1 The authority issued a building consent (BC170628) for a four-bedroom single-storey house on 12 May 2017. The proposed building is timber-framed on a 100mm thick concrete slab with a perimeter thickening, and two 375x375mm areas of thickened floor slab to receive load from the roof trusses.
