Determination 2018/039

The code compliance of a walk-in shower to an ensuite in a 5-year-old house at 565 Maronan Road, Ashburton

Summary

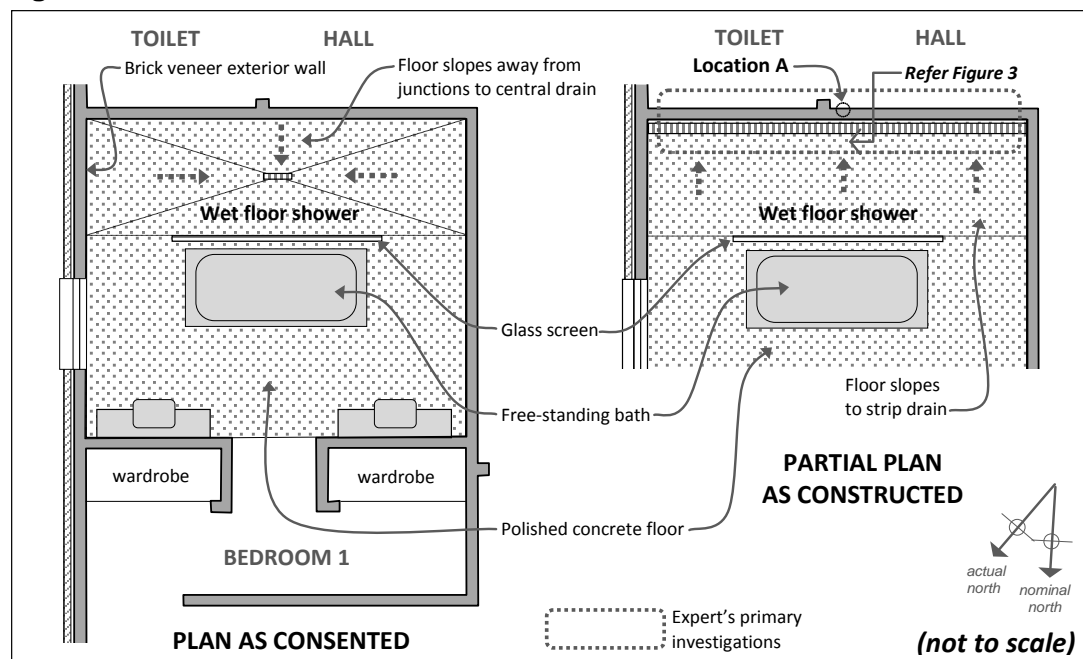
Figure 1: The ensuite bathroom

- 2.4.1 The ensuite bathroom is shown in Figure 1, with the partial as-built plan highlighting the south wall as the focus of the authority's concerns and the expert's investigations.

- 5.3.2 The expert investigated the south wall of the ensuite by removing skirtings and 7 small cut-outs of lining from the adjacent hall and toilet (see Figure 1), observing:

- no evidence of mould on the back of shower plasterboard.
- 5.3.3 The expert took surface readings on the back of shower plasterboard just above the bottom plate and obtained consistent results from three different moisture meters. Readings were ‘well within an acceptable range’, except for one area towards the toilet door which was ‘slightly elevated at 17%’ (see Figure 1, Location A).

- 5.3.4 The expert drilled 80mm into the bottom plate and took invasive readings close to the shower plasterboard and noted a similar pattern to the above; with readings ‘well within an acceptable range’ except for the same Location A, which had a moisture level of 18% (when corrected to account for CCA treatment). The expert also noted the moisture readings dropped to below 16% some 100mm away from Location A.

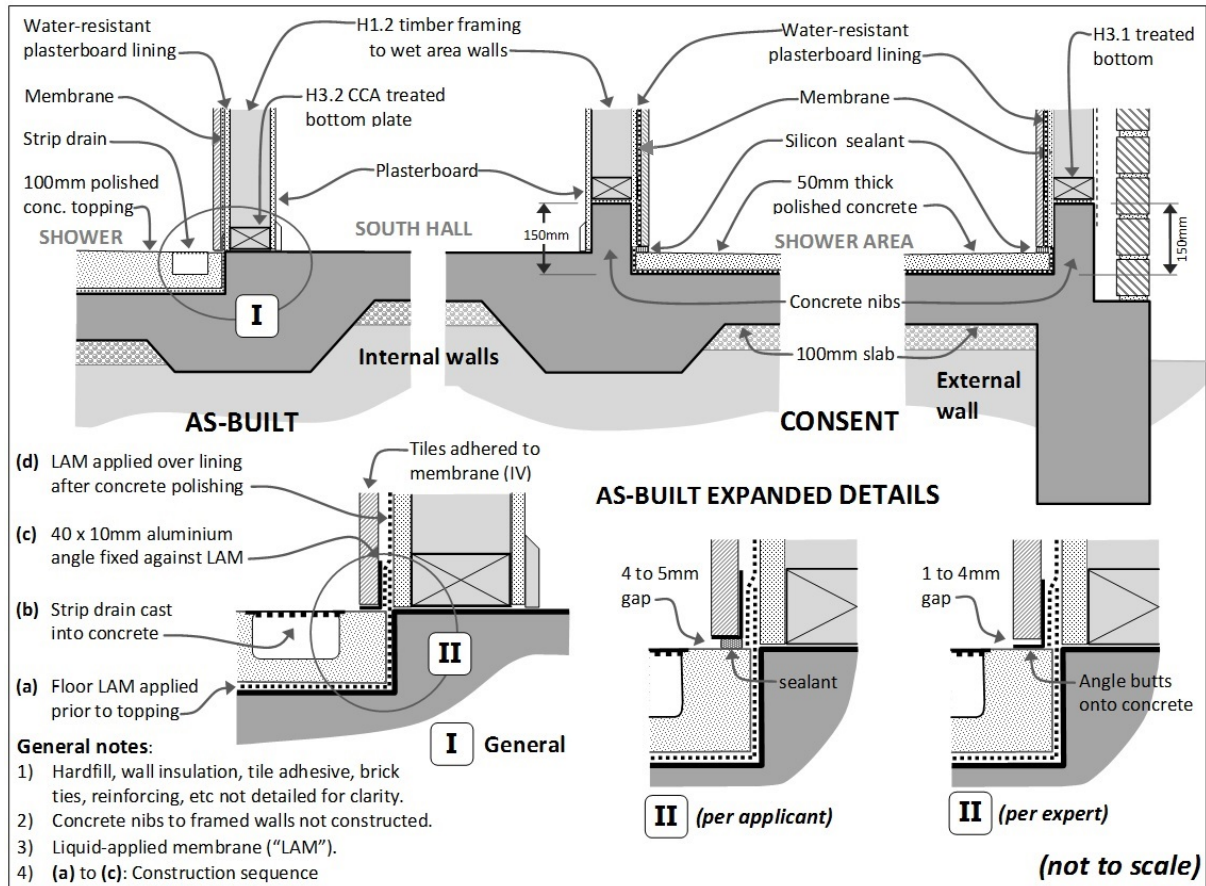
Figure 2: Simplified sketches of shower junctions

5.2 The south wall/floor junction (see Figure 2)

- 6.2.3 In regard to the south wall/floor junction, as shown in Figure 2, I note the following:
- It appears the shower has only been in use for a limited period of time and only limited account can be taken of its present performance in use.

- Although the drain is adjacent to the south wall/floor junction, it is positioned within the floor topping slab and is separated from the junction. However, the location of the drain means water is directed towards the south wall.

- There is no reinforcement of (or detailed information about) the membrane at the junction of the vertical face of the concrete foundation slab and the plasterboard above. These are very dissimilar materials subject to the normal construction tolerances, and the timber frame to which the plasterboard is fixed will be subject to movement from variations in moisture content. This junction is critical to the performance of the shower membrane.

- The 30mm overlap of the floor and wall membranes is small.

- The membrane upstand may have suffered damage when the shower floor concrete was polished but whether this has occurred is not known. No information has been provided that records how the membrane was protected during the polishing of the concrete floor.

- The aluminium angle at the wall/floor junction is fixed onto the shower floor concrete.
- Water is able to access the tiling adhesive at the rear of the tiles at the gap between the tiles and the aluminium angle at the base of the wall, and will also be drawn into any gap between the angle and the floor.

- 6.3.1 The first barrier to moisture ingress (the tiling) is compromised by an unsealed gap between the wall tiles and the planted aluminium angle, and capillary action can draw water through the tile adhesive above the aluminium angle as well as under the aluminium angle at floor level.

- 6.3.2 The second barrier to moisture ingress, (the membrane), may have been compromised by damage to the membrane upstand when the concrete surface was polished. The ongoing durability of the membrane is likely to be affected by the performance of the membrane along the junction of the face of the concrete foundation slab and the plasterboard above.

- 6.3.3 The expert's report establishes the current performance of the south wall/floor junction is not adequate because there is evidence of moisture penetration into the underlying timber in one location. I am therefore satisfied the ensuite bathroom does not comply with Clause E3 and Clause B2 of the Building Code.

- 5.4.1 The expert considered BRANZ guidance on similar junctions and noted several wall/floor junctions that include sealant at the joints.
- 5.4.2 Taking account of the minimal amount of moisture ingress at the shower wall/floor junction, the expert considered a bead of mould-inhibitive sealant applied to the gap would likely prevent moisture penetration, although this would require regular maintenance to remain durable.
