## Determination 2019/014

### The refusal to issue a code compliance certificate due to concerns about weatherboard fixings to a house at 34 Reotahi Road, Whangarei Heads

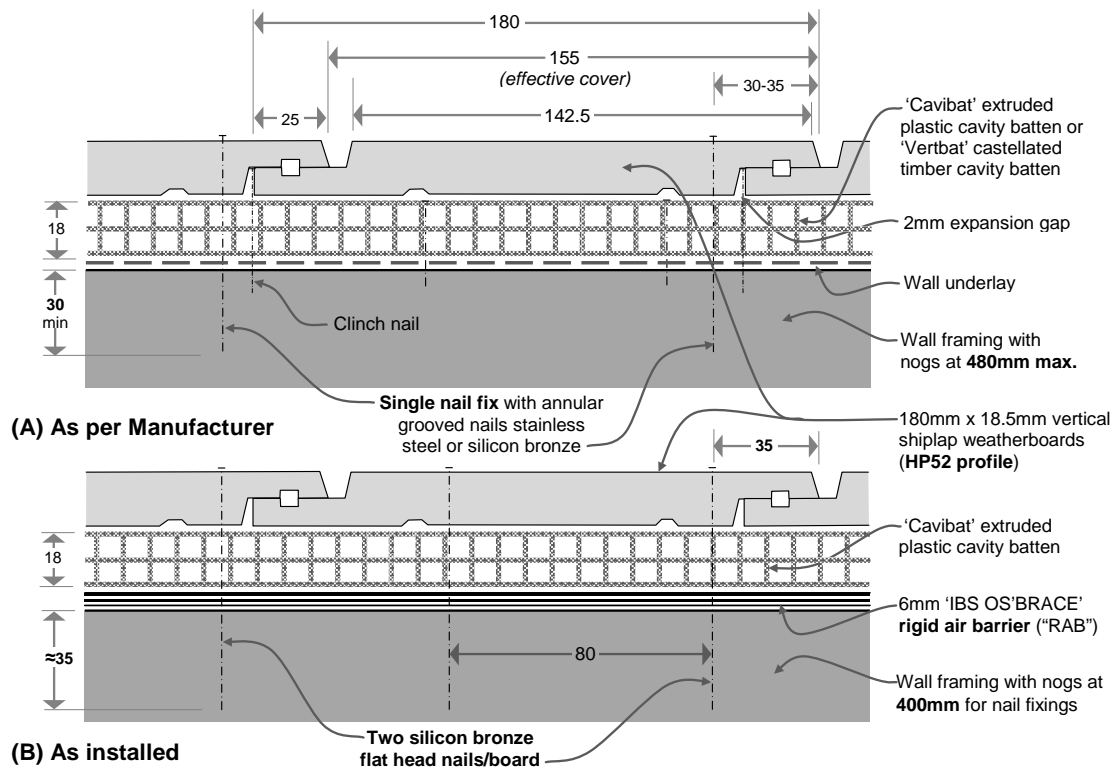
**Figure 1: Weatherboard installation (not to scale)**

2.4.1 The expert's investigations show that installed weatherboards are as indicated in the sketch in Figure 1(B). This can be compared to Figure 1(A), which aligns with the manufacturer's instructions.

2.4.2 Although the type/size of fixings and the alignment of weathergrooves appears consistent in Figure 1, significant differences are as follows:

- Sketch 1(A): the specification calls for a single nail per board at 480mm maximum centres vertically, fixed through cavity battens and building wrap, with the nails penetrating 30mm minimum into the framing
- Sketch 1(B): the installed cladding is nailed with two nails per board at 400mm centres vertically, through extruded plastic cavity battens and 6mm thick rigid air barrier into the framing, with the nails penetrating 35mm into the framing.
