## Determination 2019/020

# The refusal to issue a code compliance certificate for a 16-year-old house with monolithic cladding at 7 Second Avenue, Devonport, Auckland

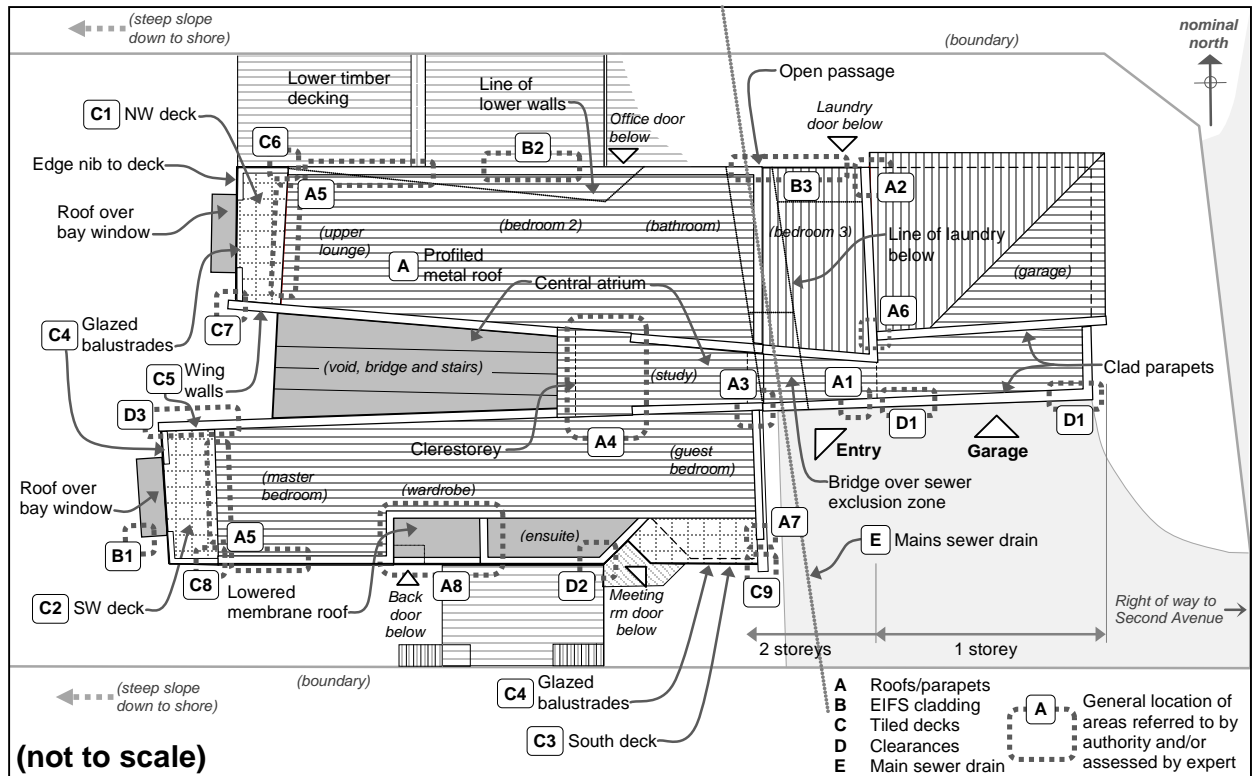
**Figure 1: Approximate site plan**

2.5 As shown in Figure 1, the roof is generally clad with profiled metal with two small areas of membrane over west bay windows. Mono-pitched roofs fall to the west above the north and south wings, while the east-sloping atrium roof glazing extends up to a clerestory window. At the north-east end of the upper floor, the roof falls to the north above bedroom 3. Roof overhangs are limited to the 450mm eaves to the north and east of the hip roof over the single-storey garage.

2.6.2 Most external walls extend up to form metal-capped sloping and flat parapets. EIFS parapets also extend above the roof to separate areas as shown in Figure 1. Parapets to the north and south atrium glazed roof extend to the west as wing walls (Area C5) with EIFS-clad openings adjacent to the west decks (C1 and C2). Glazed inserts in the wing wall openings raise the barrier heights of the latter. An east parapet is stepped down (Area A7) and slopes as a wing wall to the south deck (C3).
