# Determination 2022/005

## **Regarding the compliance of building work at 1D Fifeshire Crescent, Stepneyville, Nelson, with Building Code clauses B1 Structure and E1 Surface Water, that provide protection of other property at 18 Poynters Crescent, Stepneyville, Nelson**

### **Summary**

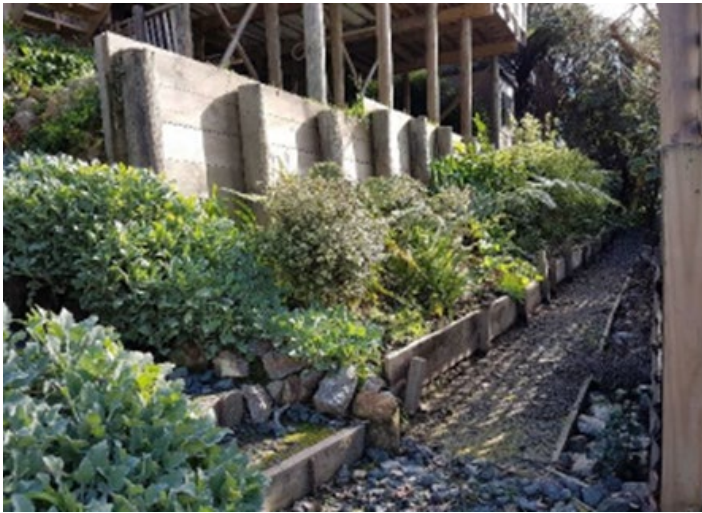
- 2.12. In the area between the base of the retaining wall on the owner's property and the northeast boundary to 12 Poynters Crescent, is a vegetated garden border, a narrow stone footpath, and a channel full of loosely laid stone directly next to the horizontal corrugated sheeting (refer to figure 2(a)).

(a) The retaining wall shown below the new deck

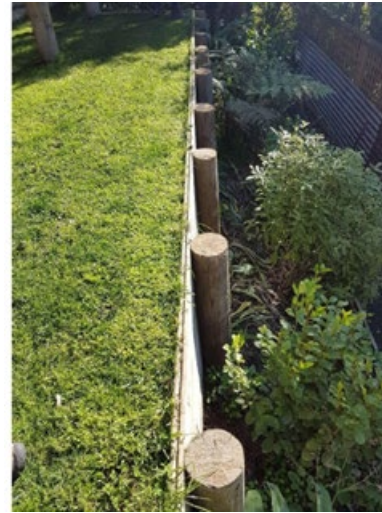
(b) Top of the retaining wall

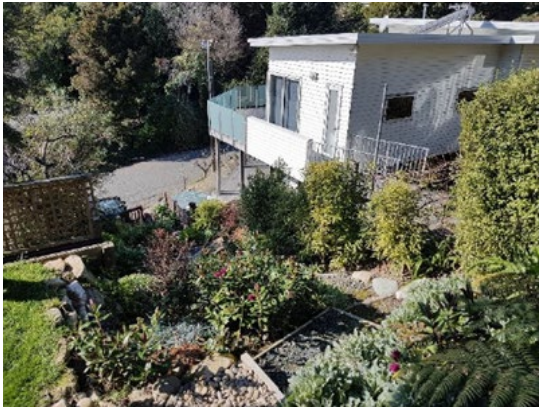
- 2.13. To the far southeast end of the retaining wall is another vegetated border and stone filled steps. This is the top flight of all the steps that wind down the access leg to Poynters Crescent below. The steps are formed using timber risers secured in place by metal pegs and angled slightly so the treads slope (in part) away from applicants' property. There is more vegetation and loosely laid stones on either side of these steps (refer to figure 2(c) and (d)).

(c) End of retaining wall

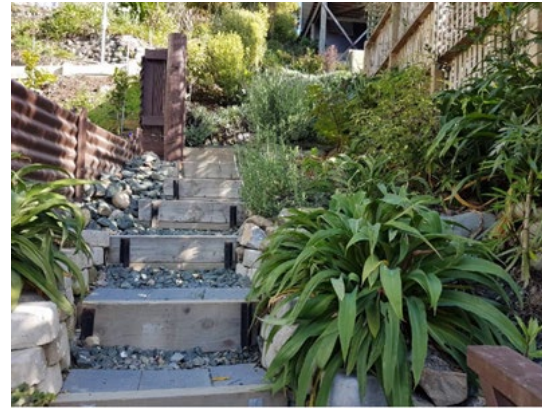
(d) Access leg and steps

18 Poynters Crescent is to the left of horizontal corrugated sheet, and the boundary to 12 Poynters Crescent is indicated by the wooden fence to the right. Structure D is to the left of the steps.

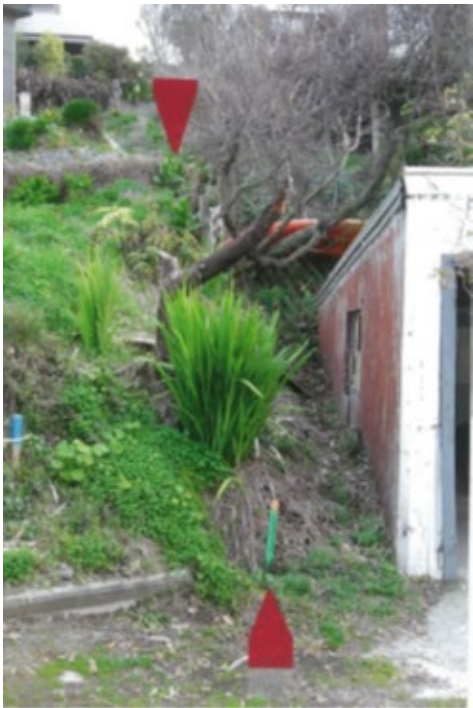
**Figure 3: View prior to building work**

- 2.15. I note that the owners and the authority consider that the uncertified fill generated from when the applicant's dwelling was built had previously crossed the boundary and was stacked against the garage, and it was this fill that was part of the material that was removed during the sitework. However, the applicant has provided affidavits, photographs and other evidence to support his assertion that this was not the case. Figure 3 gives an indication of what existed prior to the excavation of the ground and part demolition of the garage.

Approximate line of the boundary is indicated by the red arrows. The property of 1D Fifeshire and existing garage (prior to demolition) is to the right of the boundary, and the property of 18 Poynters Crescent is to the left of the boundary. Photograph taken in approximately 2010 and provided by the applicant.

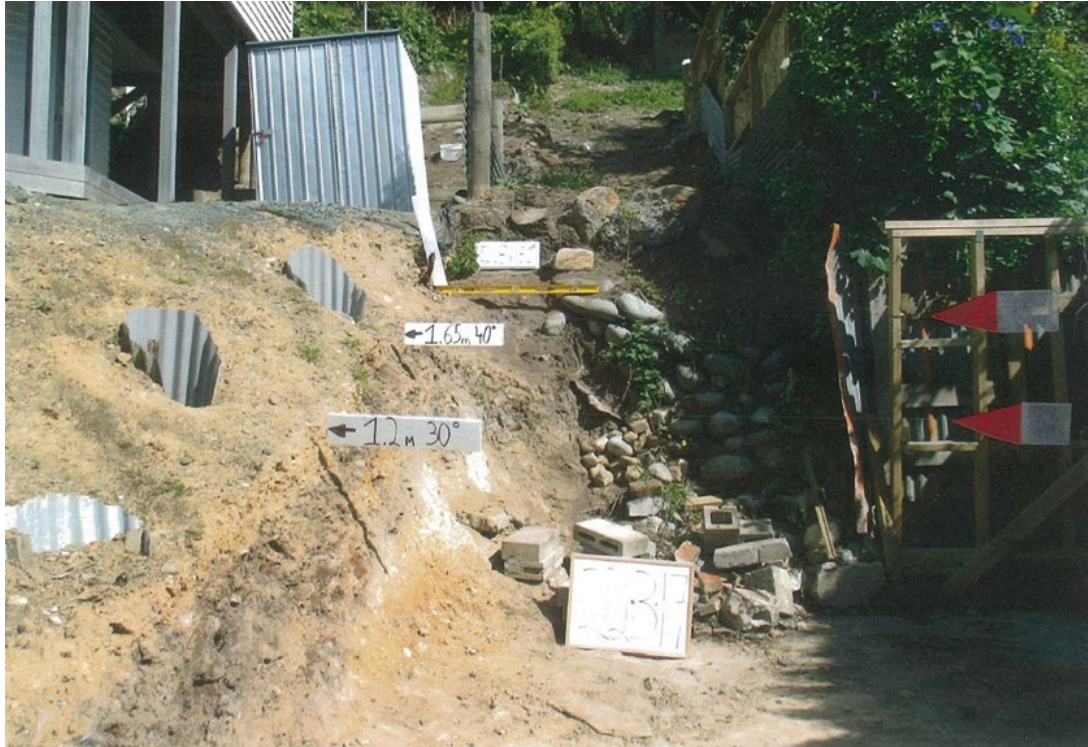
- 2.16. The photograph in figure 4 shows cut slopes along the boundary in March 2017, before the structures were erected and the additional sitework carried out to create the car-pad. The height markings of 1.2m and 1.65m are relative to the garage floor. I note that figure 4 also indicates that the previous garage has been partly demolished.

**Figure 4: Earthworks on 22 March 2017 viewed from Poynters Crescent, with the applicant's property on the left (image provided by the applicant)**

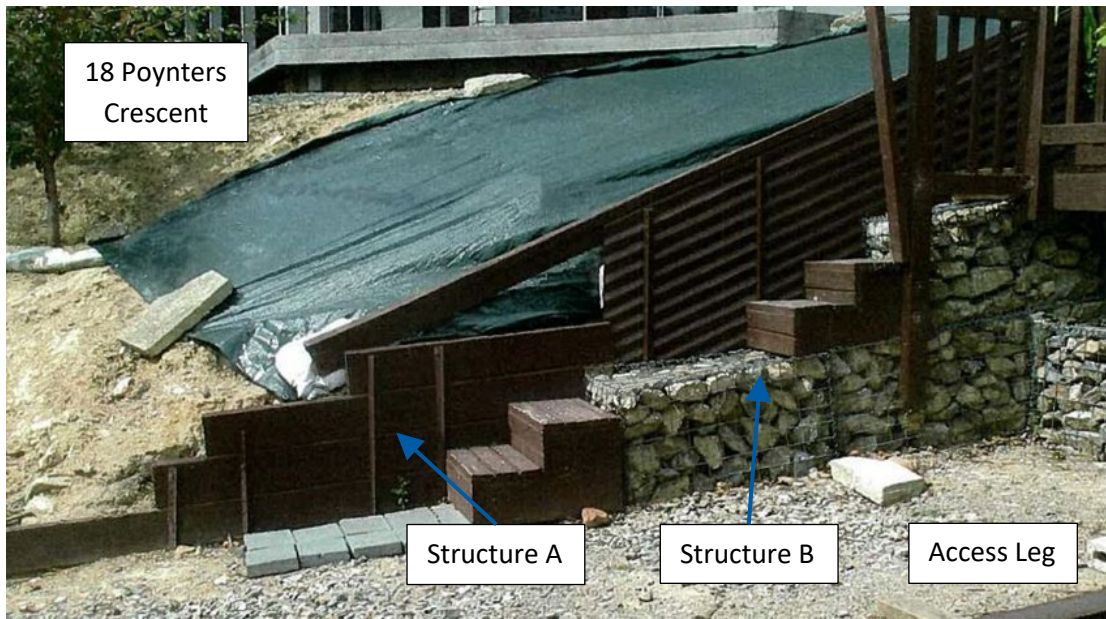
(a) The timber boarding, gabion baskets, and corrugated iron fencing behind the gabions (structures A and B), viewed from car-pad (9 February 2020)

- 7.5.5. No evidence has been provided to show that the iron fencing elements (that form part of structure B) are likely to comply with clause B1 as a retaining structure. The materials used and manner of construction are not consistent with typical retaining wall construction practices, have a very small bearing surface area, and will provide inadequate resistance to probable soil pressure loads.

- 7.5.6. The experts found that, "there are no grounds to conclude that the assembly [structure B] meets the structural functional and performance requirements of the Building Code".

- 7.5.8. Metal stakes are typically intended for fencing purposes. The stakes and iron have been painted with "an unknown paint product" but it is not clear if the buried parts of the metal stakes are painted. Corrosion-induced deterioration in this area would go undetected. The fence does not have "any substantiated durability provision" and "the complete structural assembly for" structure B does not comply with clause B2.

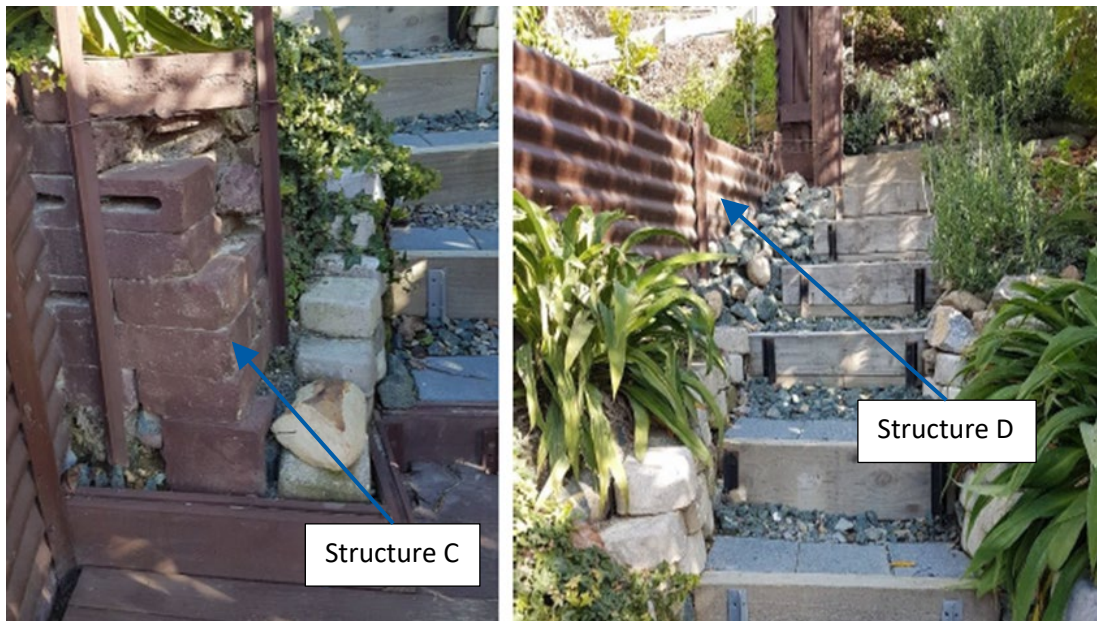
**Figure 5: The structures along the boundary (image (a) provided by the applicant; images (b) and (c) from the Ministry’s experts’ report)**

(b) Dry-stacked masonry (structure C) (c) Corrugated iron fencing (structure D)

<b>Structure D - Corrugated iron fencing</b>		
<p>Not constructed in line with standard industry practice.</p>	<p>Not compliant with clause B1 or clause B2.</p> <p>Metal stakes used in this structure only have a small area providing soil-bearing resistance against overturning force, low flexural strength, and no corrosion protection although located in a high corrosion zone. Corrugated iron sheet also vulnerable to corrosion over time.</p>	<p>Localised rotation and creep of (owners') backfill, which may gradually overturn onto the applicant's property – the structure and backfill would eventually be deposited onto the adjacent flat ground on the owners' property.</p> <p>Impact of such rotation considered local to the structure, would not have an impact on the applicant's dwelling, and not expected to have a significant impact on the stability of the land.</p>

- 7.6.4. The critical element in structure C is the metal stakes, which although painted with “an unknown paint product”, are unlikely to have their buried portions painted. Corrosion-induced deterioration in this area would go undetected.

- 7.6.5. Overall, due to the inadequate durability of the metal stakes, the experts’ concluded that structure C did not comply with clause B2.
- 7.7. The experts also included a sketch that indicated the horizontal and vertical dimensions of structure B, along with lines that approximated the “current ground level” on the applicant’s side of the structure, and “projected ground” level if the landslip was reinstated.

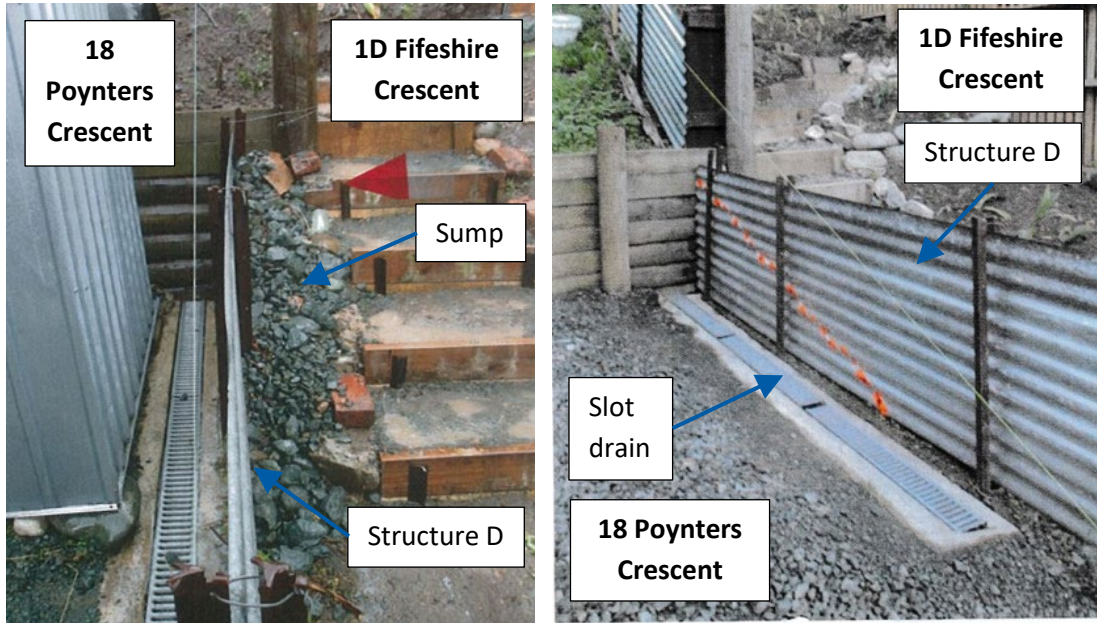
2.18. There is a narrow drain (“the slot drain”)<sup>11</sup> next to the upper end of the structure D, on the applicant’s side of the fence/retaining wall (refer to figure 6 and figure 7). The slot drain is about 3m long, 90mm wide and 75mm deep, and has a longitudinal grade of 0.7 degrees. It is orientated in the direction of the slope and is located in a flat area created by the applicant. It drains surface water away from this area to the Poynters Crescent stormwater infrastructure, and was installed by the applicant in approximately 2011. The slot drain is lower (in part) relative to the natural ground level on the access leg.

(a) Looking along structure D and the boundary at the top of the access leg, with the applicant's property and slot drain on the left (5 January 2018). The stone-filled sump is located between the steps and structure D

(b) Looking across the applicant's property to the boundary, with orange tape marking the level of aggregate against the structure D (25 March 2018)

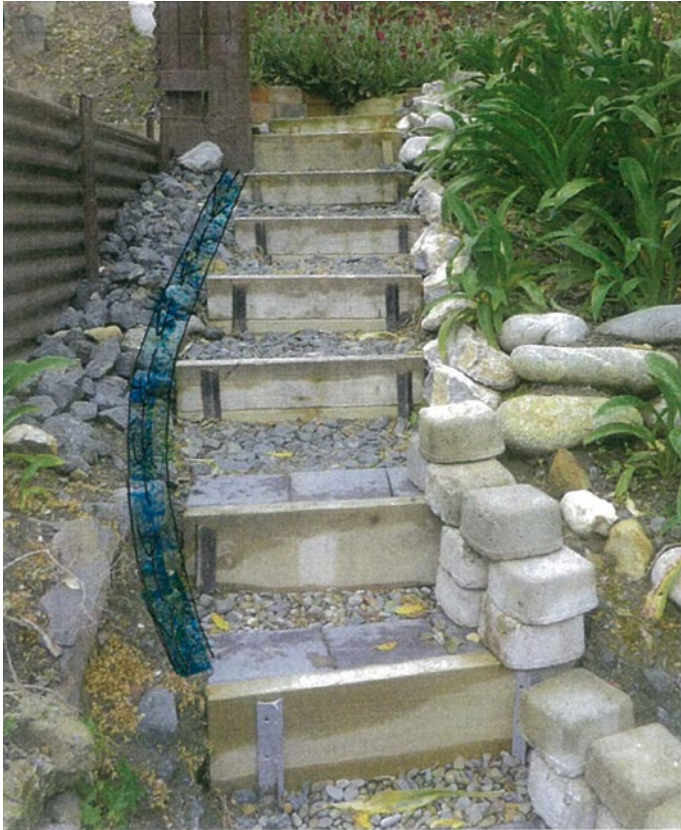
**Figure 4: Image provided by the authority. Approximate location of drainage coil marked in 'blue'**
