Determination 2022/007

Regarding the proposed or purported refusal by an authority to issue two code compliance certificates and grant two certificates of acceptance for building work in respect of alterations to an existing building, timber deck, and several retaining walls

438 Portobello Road, Macandrew Bay, Dunedin

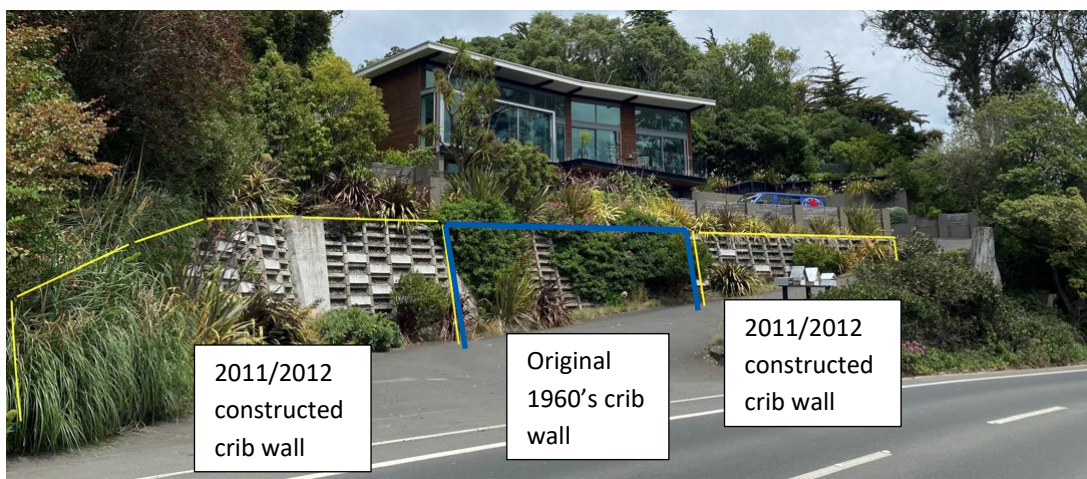
Figure 3: Construction timeline for crib retaining wall

(Note: Photograph was provided by the owners on 11 January 2022. The area marked with a blue line indicates the section of the wall that was first constructed sometime between the 1950s and 1960s. The areas marked with yellow lines indicate the sections of the wall constructed without a building consent in 2011 to 2012).

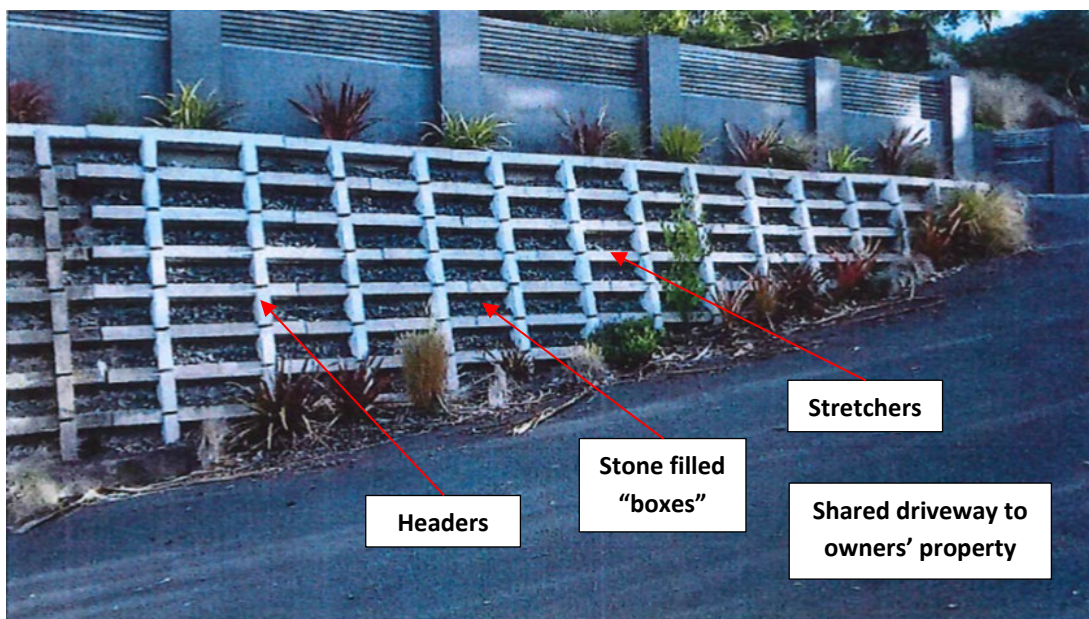
Figure 4: West end (top section) of the crib retaining wall

- 2.9. The method of construction relies on concrete stretchers placed parallel to the front face of the wall. The headers are concrete members which are perpendicular to the face of the wall, the ends of which are visible. The headers have recesses in them to seat the stretchers. The stretchers and headers form a series of interlinked 915mm-wide crib “boxes” which are filled with stone (angular basalt hardfill)¹⁸. See figure 4.

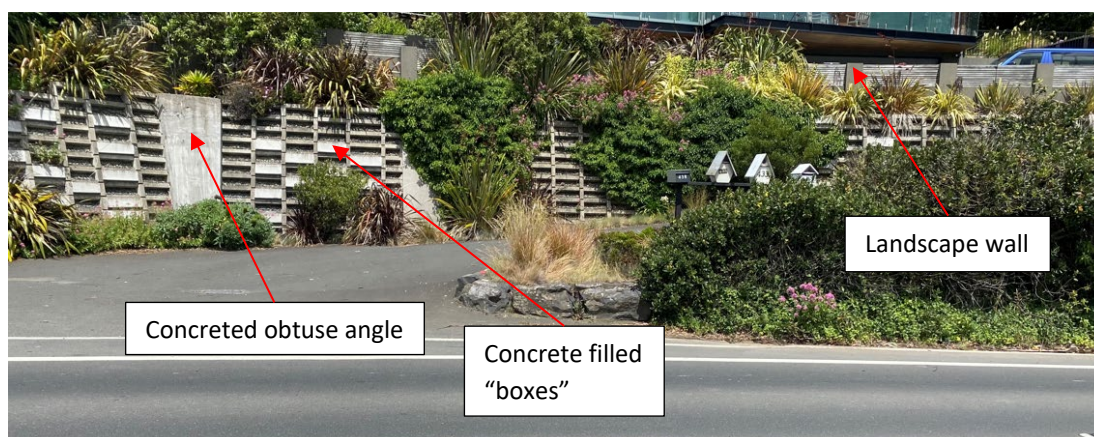
Figure 5: Remediated crib retaining wall

- 2.17. The third building consent included the placement of reinforced concrete in some of the boxes formed by the crib wall headers and stretchers, as well as replacing the crib construction at the obtuse angle in the wall with reinforced concrete. See figure 5.

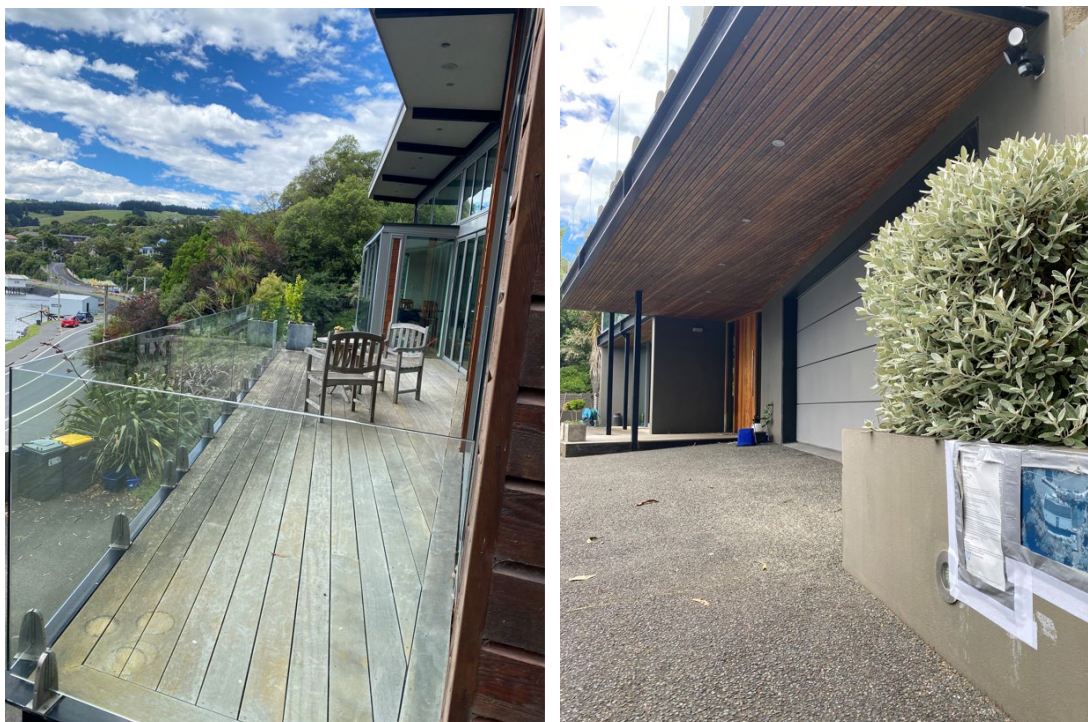
- 2.27. The first-floor level timber deck is located along part of the north elevation of the dwelling. Figure 7 indicates the approximate setting out of the deck in relation to the rest of the dwelling. See also figure 9.
- 2.28. The deck was originally constructed under the first building consent ABA-2008-1319.
- 2.29. The deck is constructed using 190 x 45mm deck joists spaced at 450mm centres, with 100 x 25mm thick decking on top. The building consent plans for ABA-2008-1319 indicate that the underside of the deck was exposed (i.e. not covered or concealed by any additional timber battens or slats).

- 2.33. The remedial building work involved refixing the battens to the joists, and initially this was done using 120mm x 5mm zinc-coated screws at approximately 500mm centres. However, after concerns were raised by the authority about the durability of these screws (due to the location of the building being in a high exposure zone, close to Otago harbour), additional 150mm long stainless-steel straps were fixed using stainless steel nails into the sides of all of the deck joists and battens. In total, 92 straps were installed. The original screws are still in place but are now redundant, as the straps carry the full load of the soffit (refer to the owners’ structural engineer’s fourth report dated 7 September 2021 in Appendix A, table 2).

²⁵ The hardwood timber slats refer to the external building element that can be observed on the underside of the deck. See figure 9(b).

- 2.34. On 11 January 2022, in an email to the Ministry, the owners stated:
- [the] Agent for the owners confirms the hardwood timber slats²⁵ have been re-fixed with stainless steel screws.

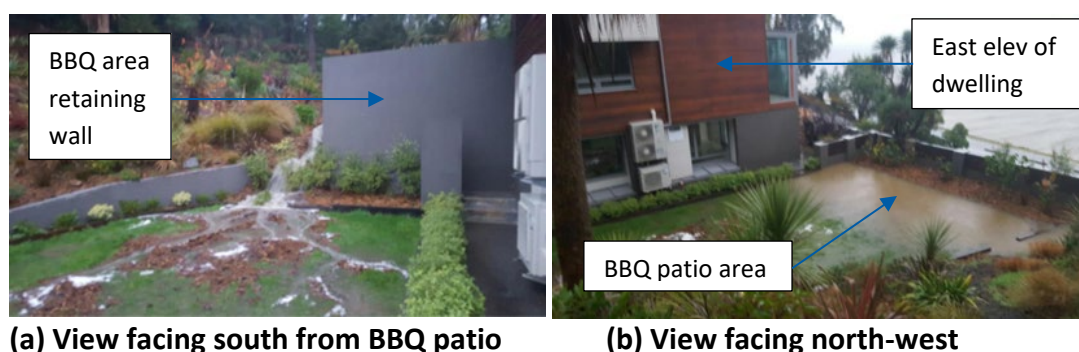
Figure 10: Photographs from 2015 storm event

- 3.8. In June or July 2015²⁶, Dunedin experienced exceptionally heavy rainfalls. The back of the owners’ property flooded. See figure 10 (a) and (b). This caused a small leak through the concrete block foundation wall at the back of the garage. A small amount of gravel was also washed out of the crib retaining wall.
