# Determination 2022/014

**Regarding the authority's decision not to issue a notice to fix for earthworks and a retaining wall**

**101B and 101C Grafton Road, Thames**

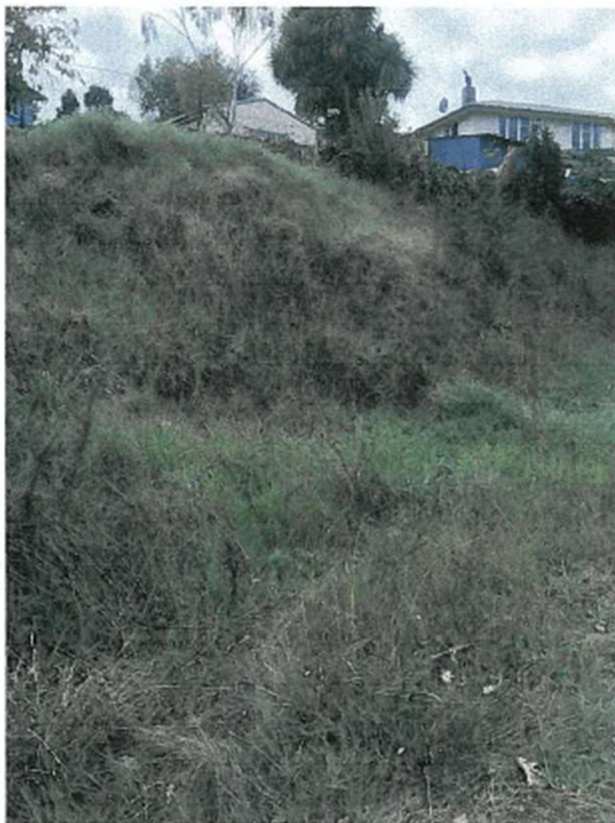
- 3.5. The applicants purchased their property in May 2015. The applicants advise that at the time the concrete guttering along the southern edge of their driveway had already largely collapsed due to soil slumping along the boundary line, and there was a fine crack in the first concrete plate at south-east end of the driveway.

**Figure 2: Photograph of embankment in May 2015**

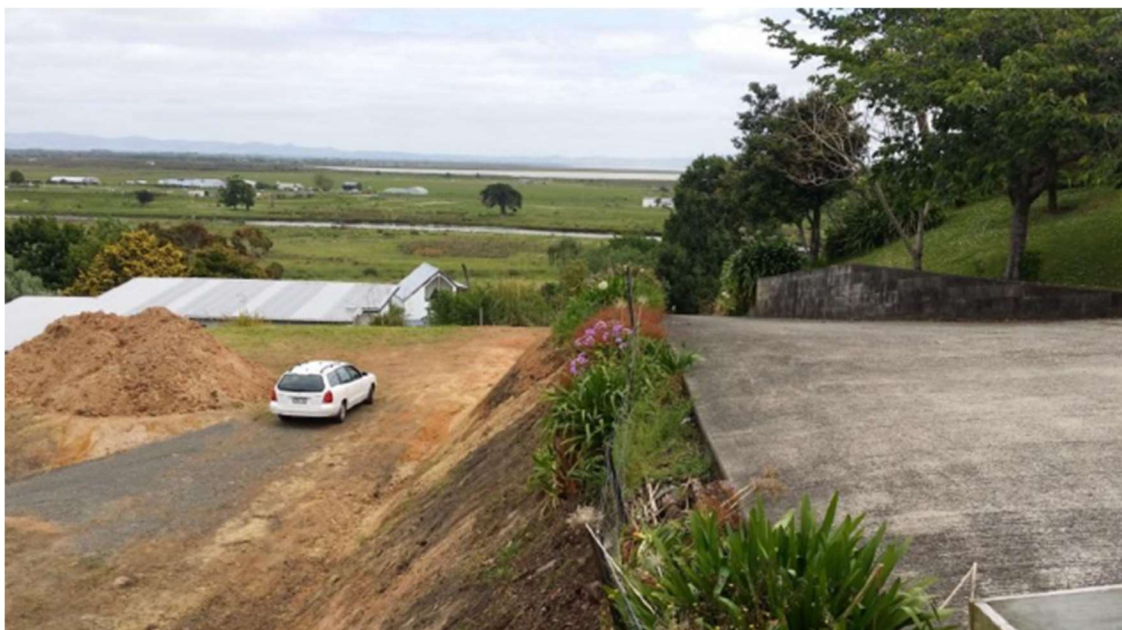
**Figure 3: Photograph of November 2015 earthworks**

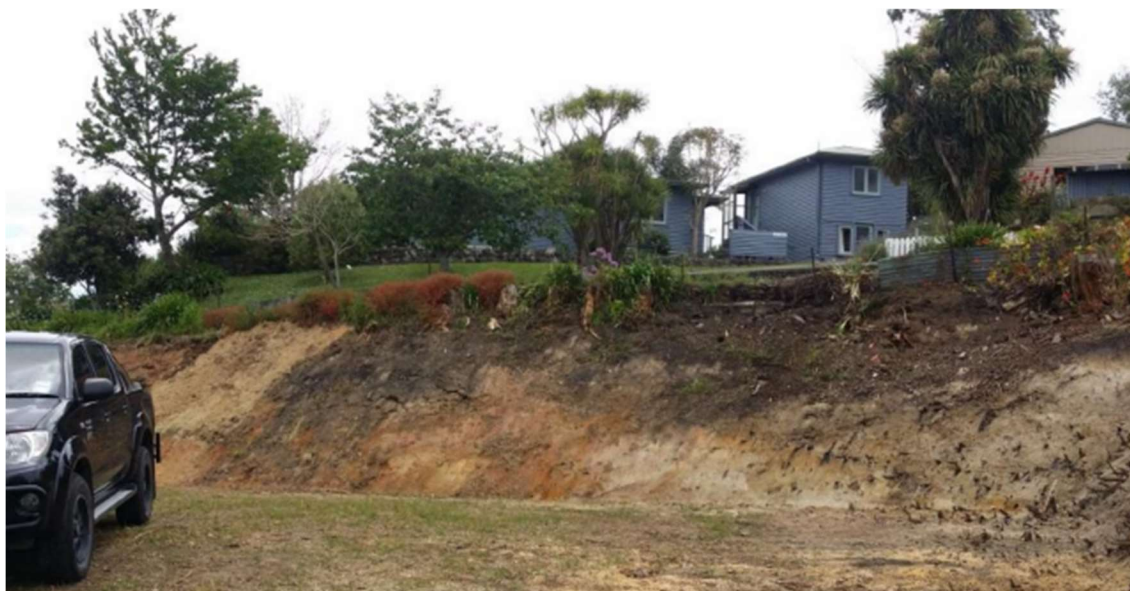
### **Figure 4: Photograph of November 2015 earthworks**

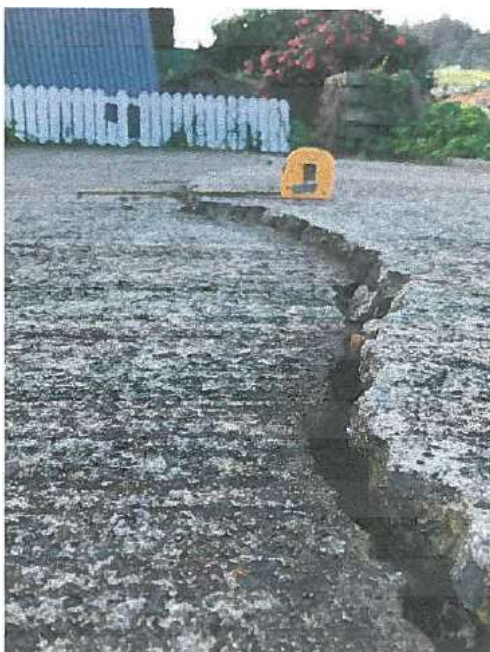
- 5.6. In a submission dated 24 July 2020, the applicants provided photographs that showed further widening of the driveway crack up to 50mm. The photographs also showed one side of the driveway plate was now elevated above the other.

**Figure 5: Photograph of driveway crack**
