# Determination 2022/017

**Regarding the refusal to issue a code compliance certificate for weathertightness remedial work on a townhouse**

**12 Marina View, Paremata, Porirua**

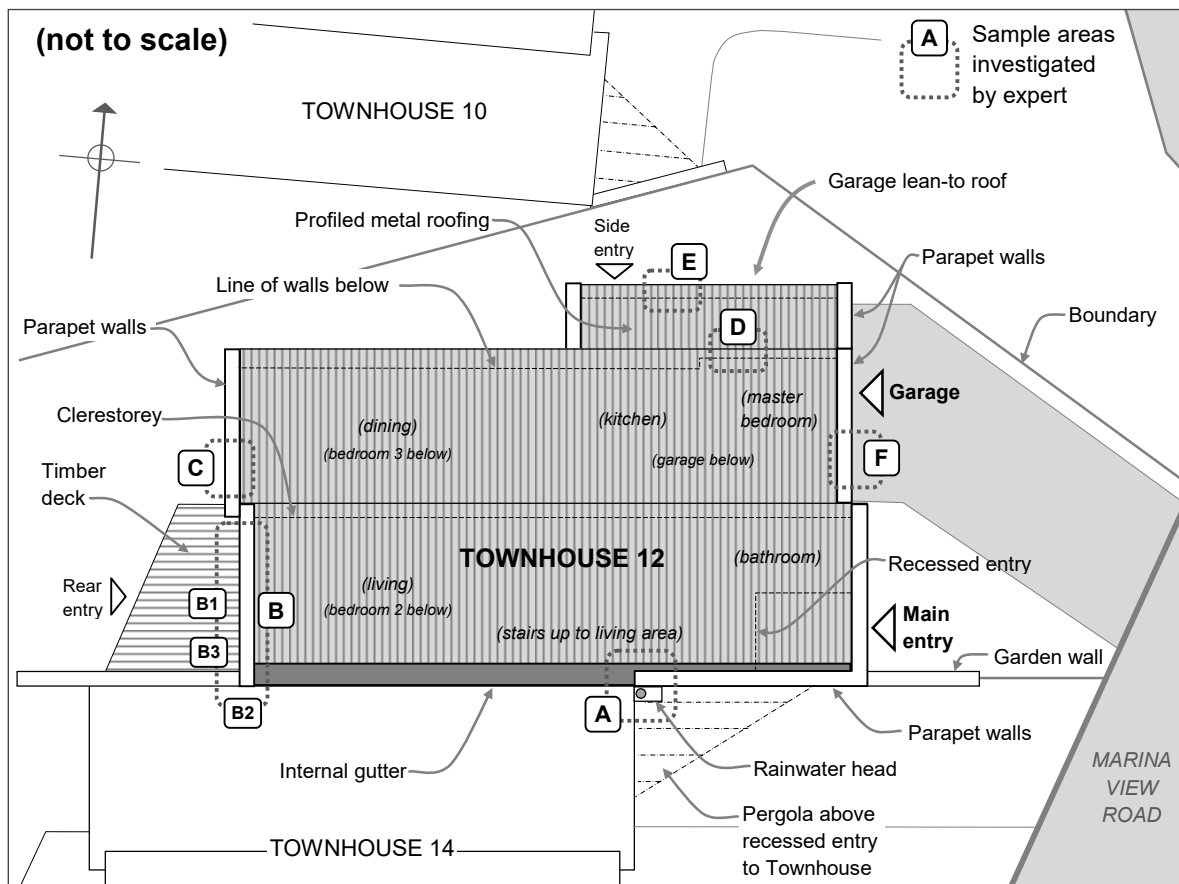
Figure 2: Expanded site plan – Townhouse 12

- 4.9.6. Area F: Framing below master bedroom east window (no sample taken).
- 4.10. The expert observed the following (see Figure 2):
- 4.10.1. At the party wall (Area A):

- (a) standard and fire-resistant plasterboard cut out from unit 12 side
  - (b) water stained framing to the unit 14 side, with evidence of moisture tracking down stud into bottom plate where fixings severely corroded

- (c) Samples 2a and 2b extracted from stud and bottom plate
  - (d) no evidence of moisture damage to back of unit 14 linings despite extensive staining and decay to framing

- (e) historic water marks to back of lining and metal batten on unit 12 side indicates damage is likely to be historic
  - (f) 17 percent moisture reading indicated no recent water penetration.

- (a) 9 percent moisture reading and no sign of damage to upper bottom plate below the internal gutter/parapet wall junction (Area B1 – Sample 1)
- (b) 12 percent moisture reading but obvious decay to outer face of framing below junction despite undamaged building wrap (Area B2 – Sample 8)
- (c) 14 percent to 16 percent moisture readings and no sign of damage to lower bottom plate at door/window junction (Area B3 – Sample 5).

- (a) visible replacement framing, indicating that some decay was identified and framing replaced during remediation work
- (b) original jack stud stamped with 'H1 97'
- (c) unable to see outer face of facing from inside, but no visible indication of moisture-stained wrap or framing (Sample 3)
- (d) 14 percent moisture reading indicates no recent water penetration.

- (a) no moisture staining to wrap or framing
- (b) no visible evidence of moisture ingress or decay damage
- (c) no timber sampling considered necessary
- (d) window is below roof eaves and not in parapet wall
- (e) 13 percent moisture reading indicates no recent water penetration.

- (a) no visible indication of moisture-stained wrap or framing
- (b) Sample 6 extracted from bottom plate
- (c) 15 percent moisture reading indicates no recent water penetration

- (a) no visible evidence of moisture ingress or decay damage
- (b) no timber sampling considered necessary
- (c) 13 percent moisture reading indicates no recent water penetration.
