Determination 2023-012

Regarding the decision to issue a code compliance certificate for alterations to an existing dwelling

58 Moncks Spur Road, Redcliffs, Christchurch

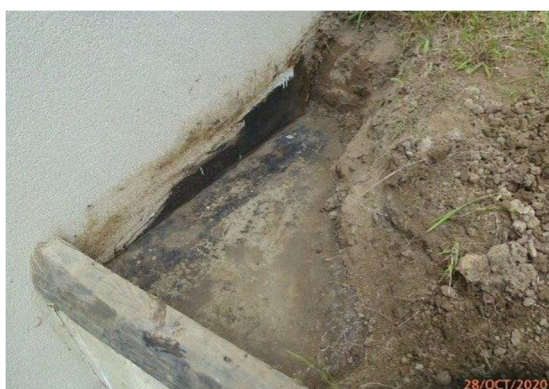
Figure 2: Excavation to west side of ensuite extension³¹

The expert excavated an area of the ground along the west side of the ensuite to a depth of approximately 200mm, exposing "the horizontal surface of what appeared to be the toe [of the] foundation".

The expert confirmed there was no drainage coil found, and no sloping concrete topper at the toe of the foundation as shown in the as-built drawing. The expert stated that, regardless of the "as-built" information provided by the builder, the concrete surface adjacent to the foundation wall has been laid flat and there is no provision for any water to be drained away from the wall.

Note: No drainage coil has been installed, the horizontal concrete surface is level, and the 200mm strip of liquid applied tanking is exposed. No protection provided to the tanking.

- 6.27. It is evident from the expert's observations that the finished ground level (made up of soil and grass) is higher than the exposed liquid applied tanking product, and it has been placed directly against the rendered surface of the foundation wall along part of the west elevation.

- 6.29. Together, these have the potential of allowing external moisture to be absorbed into and through the wall (while noting the wall is constructed of reinforced concrete blockwork).

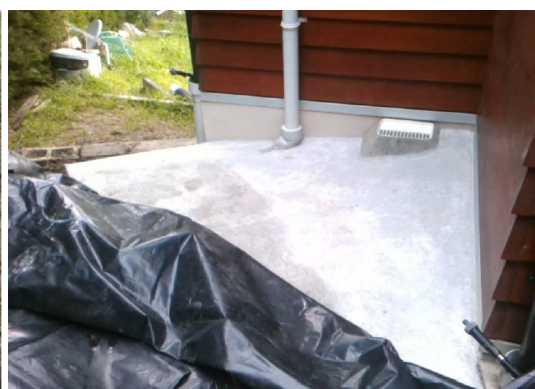
Figure 3: Sloping concrete surface to south side of ensuite extension³²

(It is unclear whether the builder's reference to the "sloping concrete surface" and "pitched concrete topping" are the "concrete topper" shown at the foundation toe in figure 5 and/or the finished concreted ground level (which is sloping) on the south side of the extension as shown in the photograph in figure 3.)

of 10 August 2018 notes a “concrete channel has been installed” and includes a photograph of the south side of the ensuite extension. The photograph shows a concreted sloping surface at ground level on the south side of the ensuite extension (figure 3).³⁰ This suggests that this particular variation (ie the addition of the sloping concrete surface in this location) was accepted by the authority, and I consider this forms part of the building consent for which the code compliance certificate was issued.

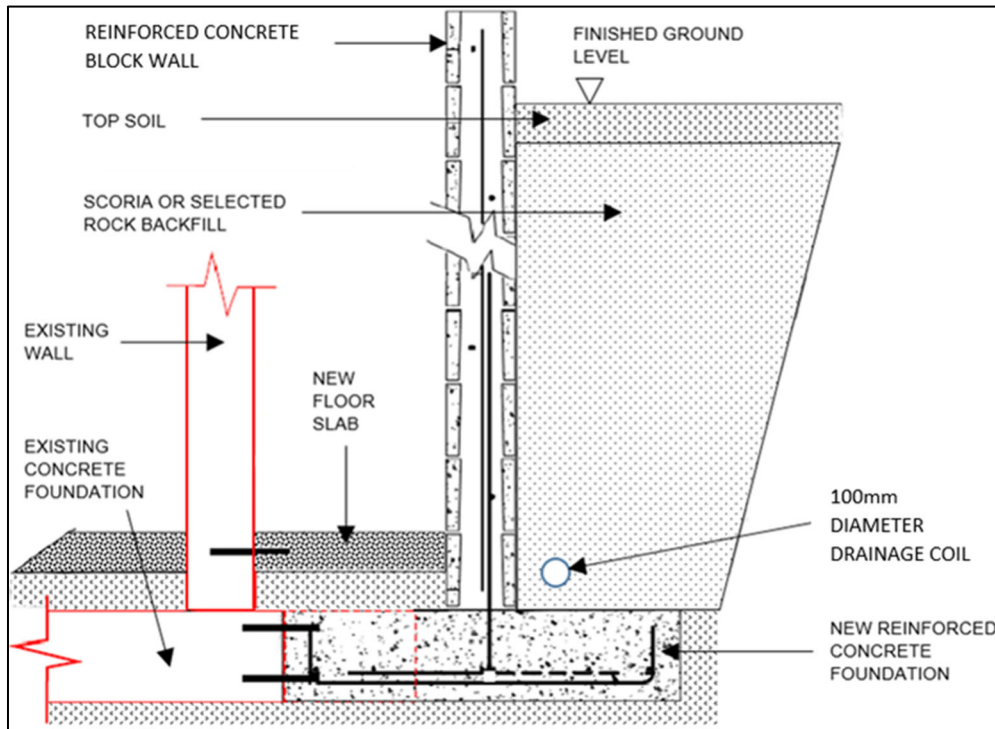
Figure 4: Extract from plan “Block Wall Design” S-01 (not to scale)

- 6.19. The building consent plan sheet²⁹ shows a 100mm diameter drainage coil to the west side of the ensuite extension (see Appendix A, figure 4). It is not clear from the building consent plans whether the drain coil was intended also run across the south side of the ensuite extension foundation wall.

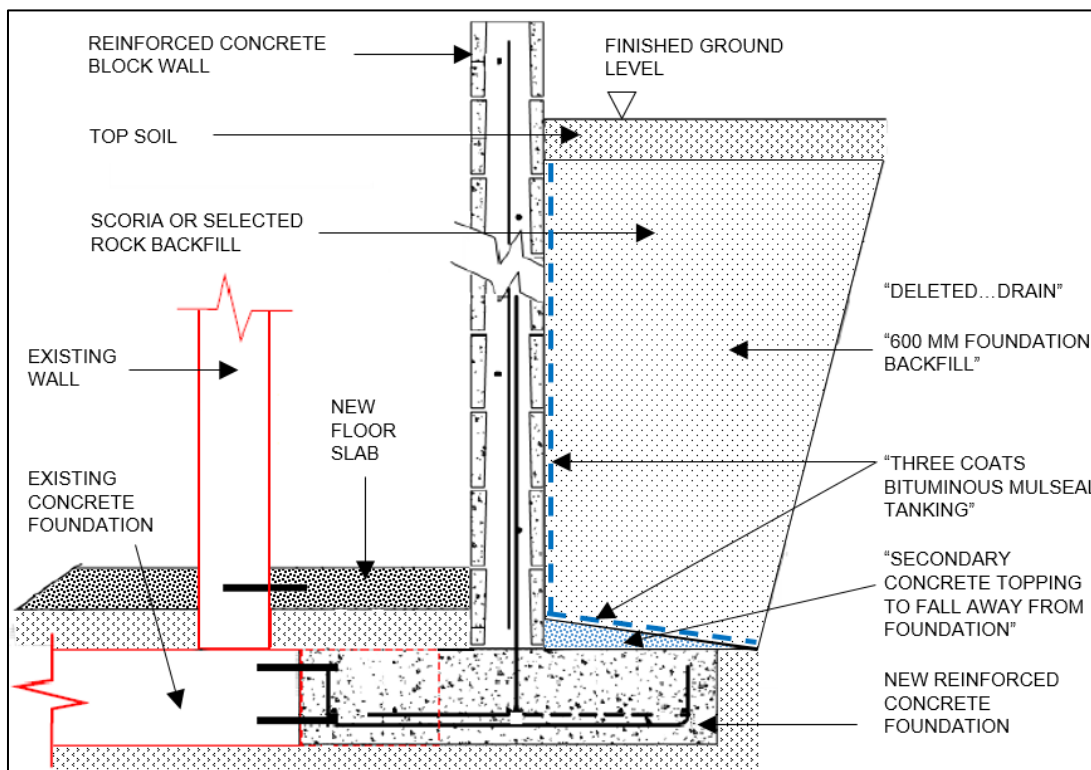
Figure 5: “As built” plan (not to scale)

- 6.21. The builder submits that the revised detail that omitted the drainage coil (Appendix A, figure 5) was discussed with the authority’s inspector on site. The builder provided an “as built” plan to the authority on 16 August 2018. This was after the final inspection by the authority on 10 August 2018 but before the code compliance certificate was issued on 19 September 2018. The as-built plan indicates the drainage coil was not installed and it was replaced by a sloping concrete surface at the toe of the foundation (the “concrete topper”) and the application of a liquid applied tanking membrane to both the west and south sides of the ensuite extension (refer to Appendix A, figure 5).
