# Determination 2023/021

## The refusal to issue a code compliance certificate for a 21-year-old dwelling

**23 Chatsfield Place, Kamo, Whangarei**

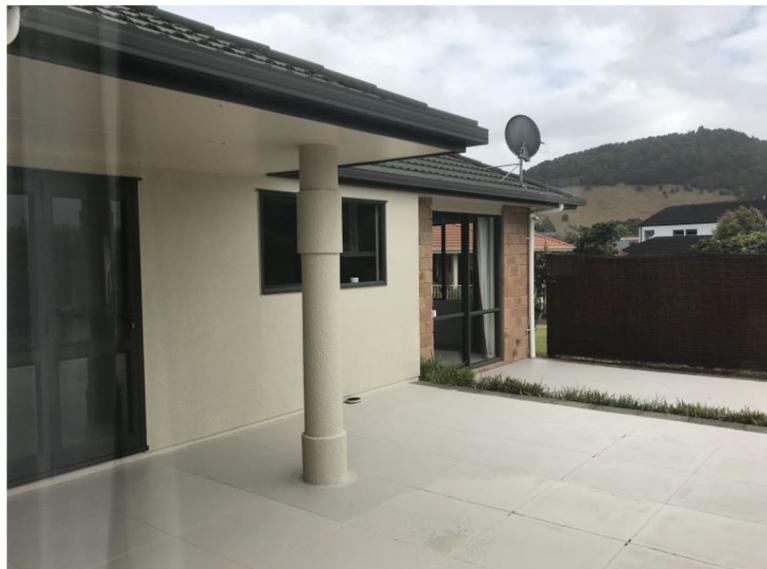
**Figure 2: The post in the rear patio**

4. Timber post enclosed by [EIFS] with [EIFS] in ground contact. [Requires] at least 50mm separation from patio.
  5. Flashing requires to meter box.
  6. All holes in base of meter box to be sealed.

- 5.5.3. Regarding the post at the rear of the property (see Figure 2), the owner submit that the cladding is a PVC pipe fitted around the post and is “sealed top and bottom” with the bottom of the post estimated to be about “30cm below the patio”. The concrete was laid post-construction, and the two mouldings are “polystyrene foam that was glued around the pipe prior to it being painted”.

- 5.5.4. The owner submit that the post is “currently enclosed in a plastic sleeve the bottom of which is buried in approximately 30cm in concrete” and therefore, “adequately protects it from moisture ingress”.

- 6.22. Neither the owner nor building surveyor have provided specific information on the weathertightness of the post where there is direct contact between the post cladding with the patio area. This could have been a source of moisture ingress which could impact the post. Without further evidence on the bottom of the post or any moisture reading information on the post itself, there is insufficient evidence of compliance with clauses E2.3.3 and B2.3.1.

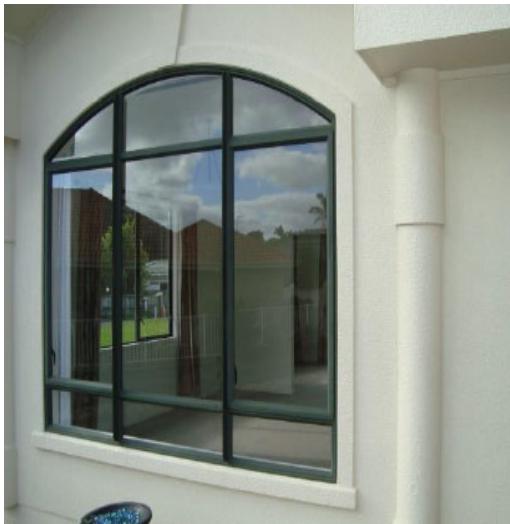
**Figure 3: Curved lounge window**

- 4.14.3. Results of invasive moisture testing at window heads and sills, and bottom plate areas indicated are “within the expected range”, with the exception of the front lounge curved window.

- 4.14.4. “High moisture readings were recorded for the sill level of the front lounge curved window”, and further investigation and invasive testing is required.

- 6.14. So, this leaves the curved windowsill area (see Figure 3) and the post in ground-contact to be addressed.

- 6.15. The building surveyor engaged by the owner found evidence of moisture in the sill area of the front lounge curved window. This is suggestive of the penetration of moisture through the external envelope.
- 6.16. Although the seal to the front lounge curved window has been repaired, I consider there is insufficient information to establish whether the performance of the external envelope complied with clause E2.3.2 due to the presence of elevated moisture levels in the timber in the area inside that part of the wall.

- 6.17. I note that when the owner advised that the seal to the front lounge curved window was repaired, the extent of any damage to the underlying framing was not fully investigated as recommended by the building surveyor.

- 6.18. On the evidence presented to me the failure of the seal to the front lounge curved window (prior to it being repaired), in my opinion led to water entering the building causing undue dampness. This may have caused damage to other building elements such as the timber framing.

- 6.19. Clause B2 Durability requires the cladding to remain sufficiently durable for a minimum period of 15 years. However, the performance of the underlying framing, as a structural element has a minimum specified intended life of 50 years in accordance with clause B2.3 (a). The information provided suggests moisture ingress has occurred and without clear information on any treatment of the framing I do not consider the framing timber will perform for the 50-year period.

- 6.20. Based on the information above, I do not consider that the framing in this area complies with clause B2.3(a).
- 6.21. Although the roof and wall claddings are now 21 years old, the evidence of moisture penetration at the front curved lounge window shows that the external building envelope did not comply with Clause E2.3. 2.
