Determination 2023/023

Regarding the refusal to issue a notice to fix for a concrete slab foundation at 92A Kaitawa Road, Otaki

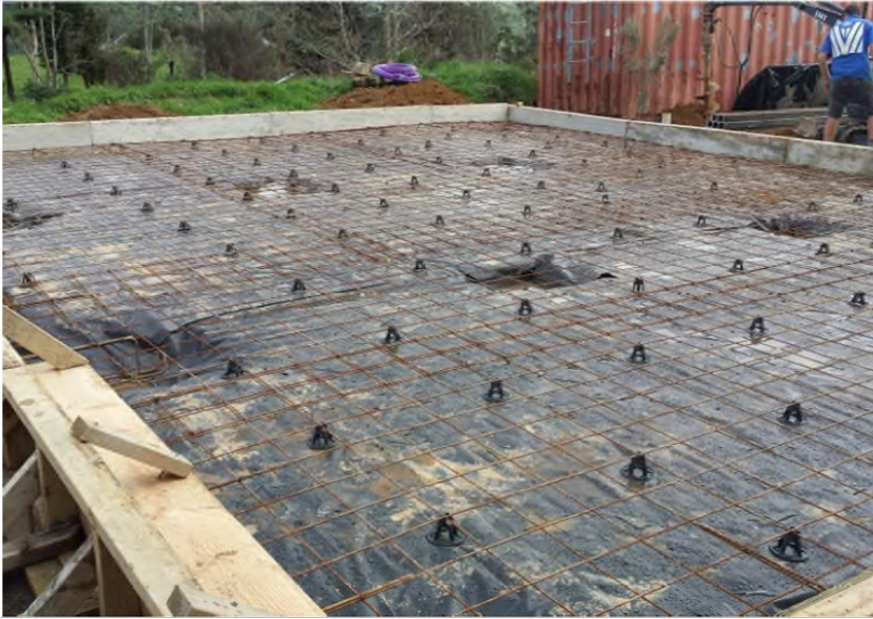
- 2.2. On 7 August 2018, the authority conducted a pre-slab inspection of the foundation. The concrete slab had not yet been poured, so the formwork⁵ and reinforcing steel were visible (see Figure 1). The inspection was noted as 'failed' because the engineer's details and a Producer Statement – Construction Review (PS4) for the completed concrete slab were not available as required. All other aspects of the inspected foundation, including the vapour barrier and reinforcing steel were indicated as passed on the inspection report.

Figure 1: Photograph of formwork, reinforcing steel, and vapour barrier

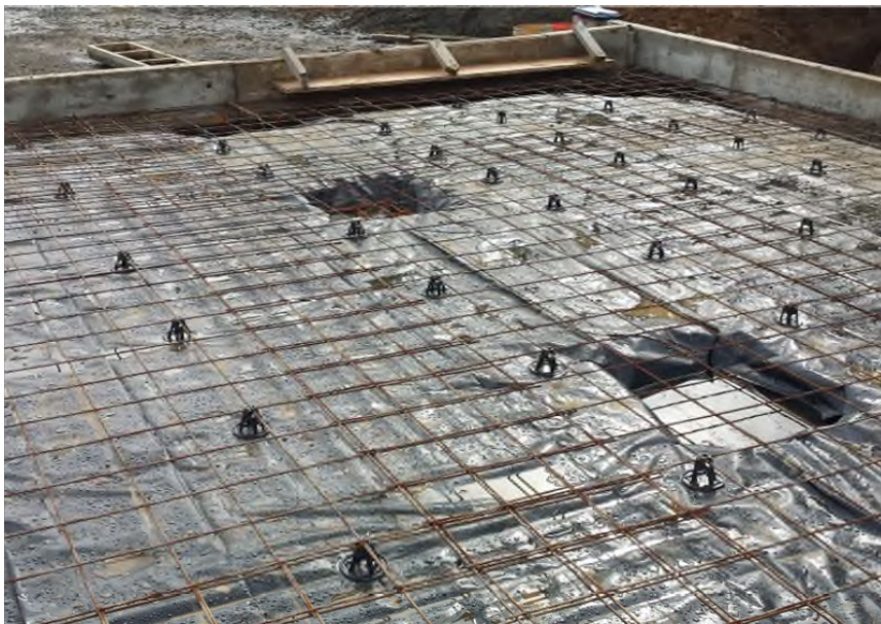
- 2.3. Later that day, a representative of the engineer inspected the foundation. The engineer's site visit record noted that the reinforcing for the slab was in place, that in the north-east corner the foundation was 15 to 25 cm shallower than shown on the plans; and that water had pooled in some of the internal pad foundations (refer to Figure 2). The remainder of the work was noted to be in accordance with the plans.

Figure 2: Photograph of excess water within the internal pads

2.4. Following this site visit, the engineer confirmed in an email dated 10 August 2018 that the footing depth in the north-east corner was 'not ideal, but acceptable', and that water was to be removed from all the footings and pads before the concrete was poured. The engineer noted that the builder should provide photos to show this had been done and that 'on this basis it is acceptable to pour'.

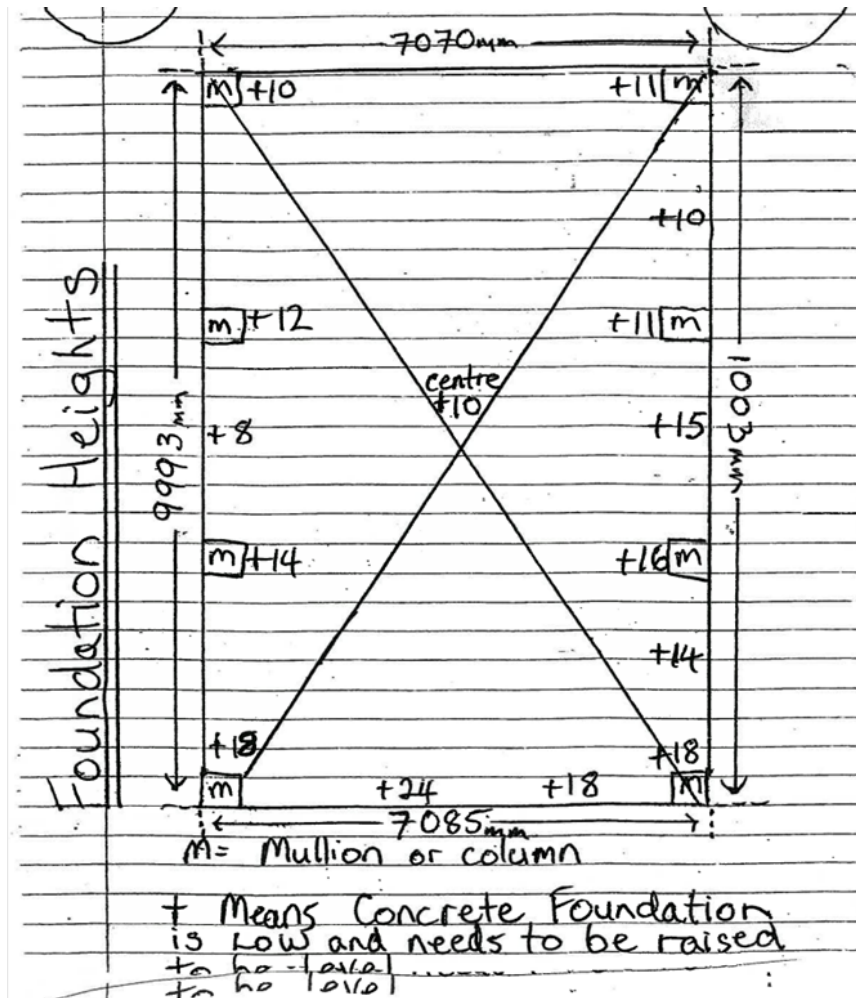
- 2.7. In late 2018, the owner engaged another independent builder to inspect the foundation ('the owner's builder'). The owner's builder reported in a letter dated 12 March 2019, that he had inspected the foundation and found it was 'not very level at all', with 'quite large discrepancies'. He concluded that the foundation did not comply with *NZS 3114:1987*⁶.

- 3.8. The owner also included a drawing, which showed the variations to the concrete slab foundation as pictured below.

Figure 3: Diagram of variations in the concrete slab foundation (not to scale)
