# Determination 2024/001

**Regarding the issue of a dangerous and affected building notice for a residential dwelling**

**307 Lakes Boulevard, Pyes Pa, Tauranga**

## Summary

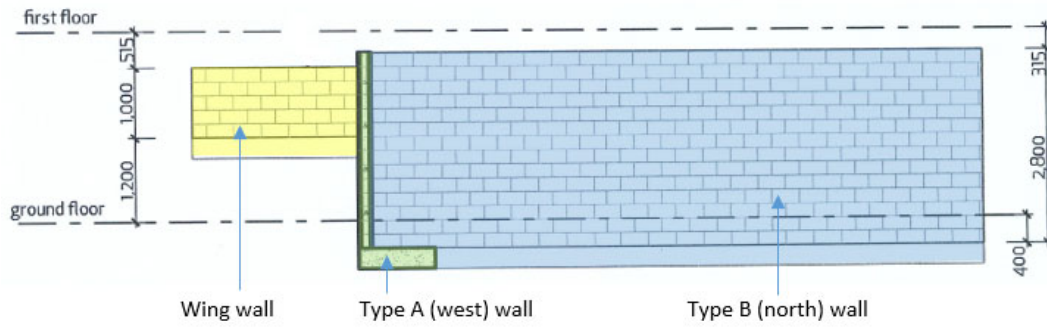
**Figure 4: Wing wall design intent – Section 1-1 (not to scale)**

- 2.15. The wing wall was originally designed to be 1000mm high, constructed as a “20 series<sup>[30]</sup> masonry foundation wall as per NZS 3604 300x300 strip footing with 2/d12 along”.

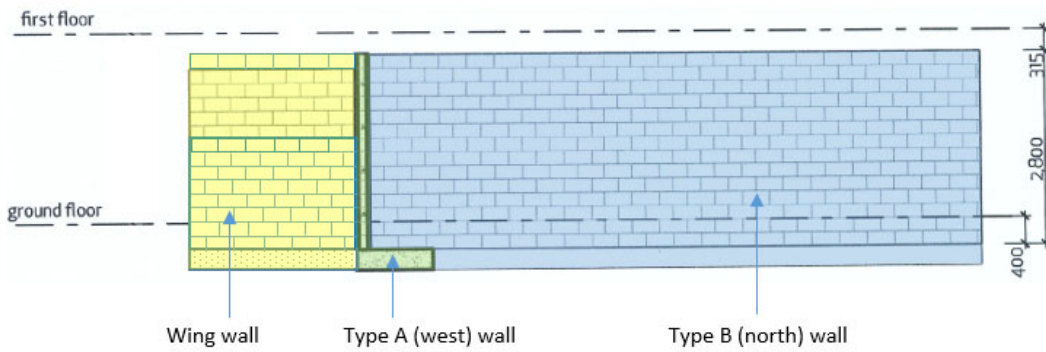
**Figure 5: As-built wing wall – Section 1-1 (not to scale)**

2.22. Scan results of the wing wall undertaken in March 2018 indicate the vertical steel reinforcement was placed at approximately 200mm centre-to-centre spacings.<sup>39</sup> The scan results did not determine the size of the vertical reinforcement, or the presence, diameter, and spacing of any horizontal reinforcing.

With regard to the wing wall, the report noted the footing was 300mm wide x 300m deep, and the wall was 2.8m high and retaining 1.8m of soil. This type of wall is limited to a maximum of 1.4m high under NZS 3604:2011, therefore the wall “does not comply with the consented plans and would not be able to support the retained soil loads”.

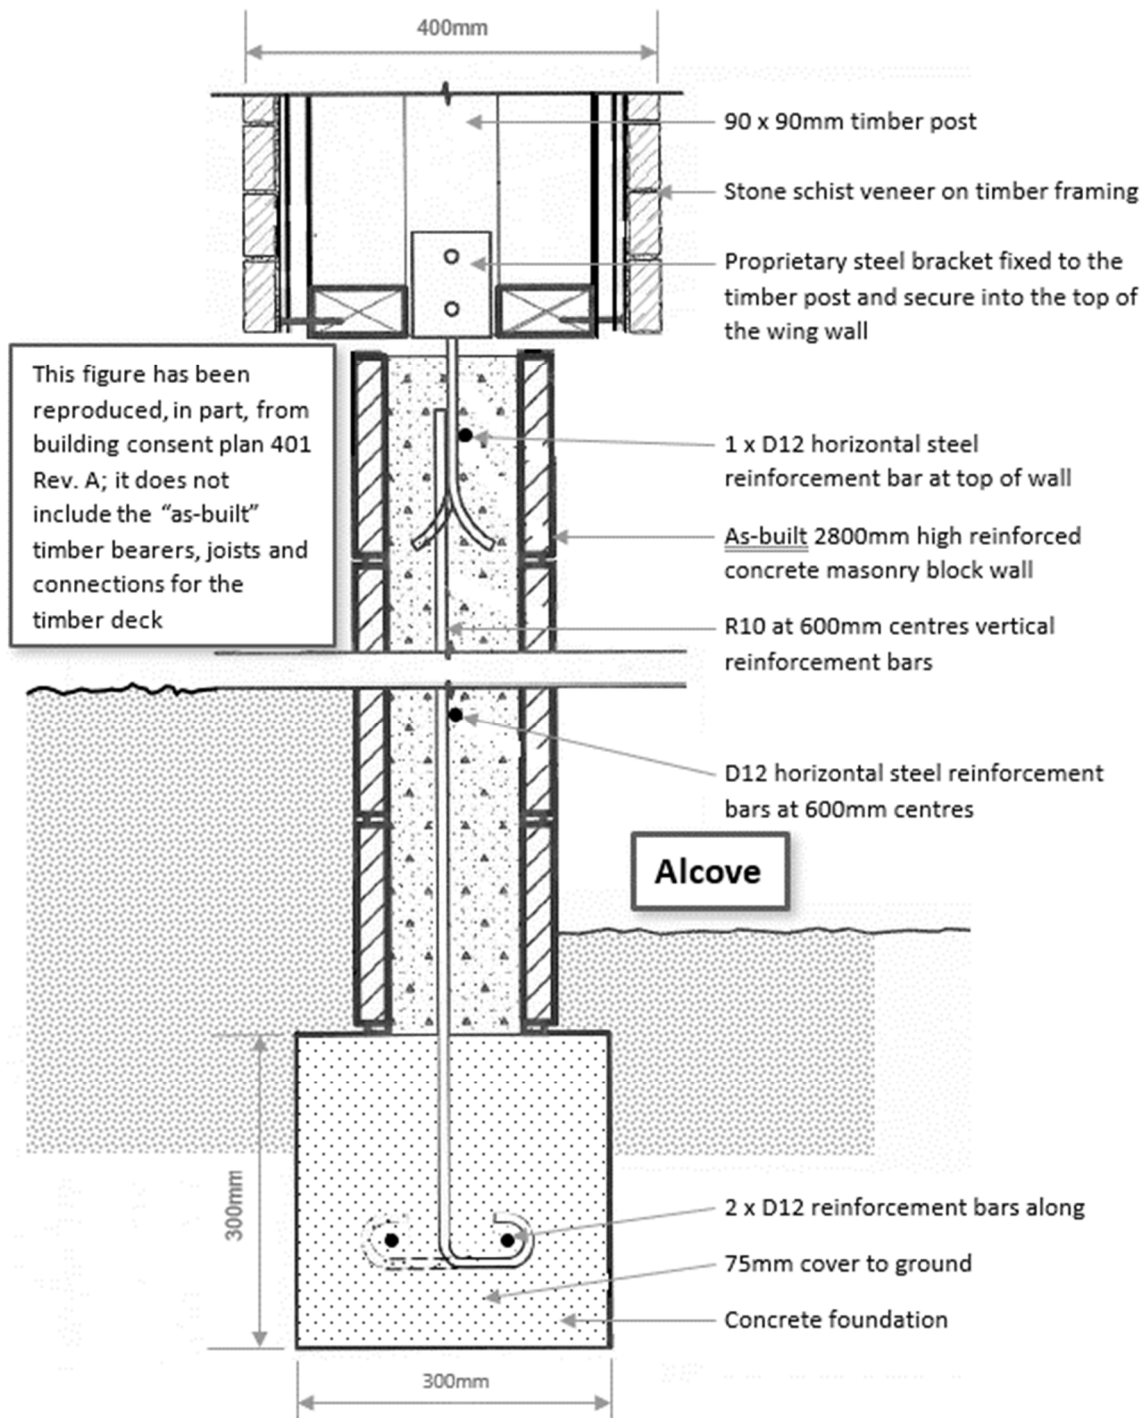
**Figure 7: Wing wall excluding timber deck (not to scale)<sup>41</sup>**

<sup>41</sup> The design specification for the vertical and horizontal steel reinforcement stated in figure 7 has been reproduced from plan sheets 104 revision A and 401 revision A for a wall that was to be 1m high. However, the wing wall as-built was 2.8m high, the vertical reinforcement was spaced at 200mm centres, and the type, size, and spacing of any horizontal reinforcement placed in the as-built foundation and wing wall is not known.

“... due to the basement [wing wall] which has been constructed to a height greater than the permissible levels outlined in NZS 3604 and the wall is retaining soil loads it is not designed to withstand. Therefore, the wall is at risk of failure under everyday static soil pressure loads of which the consequence is likely to cause damage to the property and injury to persons within the vicinity of the wall.”

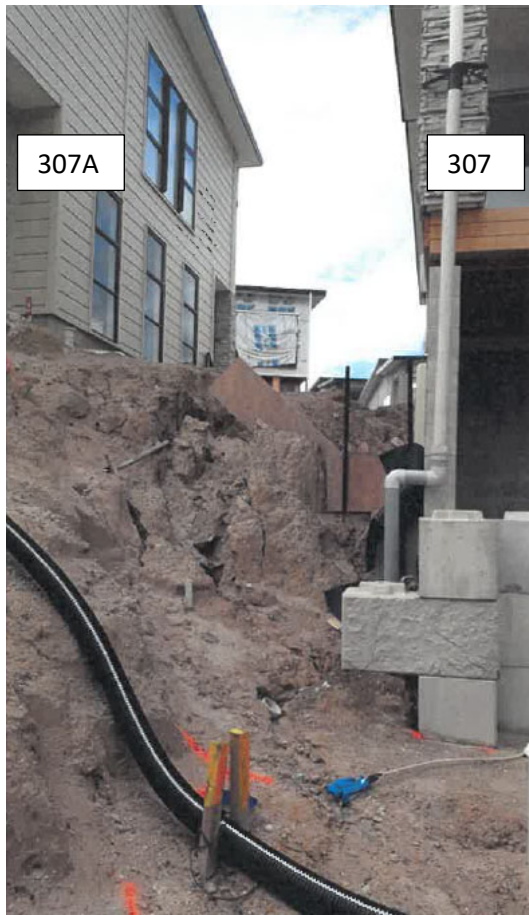
**Figure 8: Scour and erosion between 307 and 307A Lakes Boulevard**

There is a deep scour between 307 and 307A Lakes Boulevard that could destabilise the foundations and structure of 307A.

- 4.16.14. The site’s “pumice soils had a history [of] severe and rapid erosion occurring in heavy rain events”.
- 4.16.15. The extent of subsurface erosion around 307A Lakes Boulevard was unknown at the time of the assessment by engineer 2 in April 2018. However, engineer 2 made a judgement call that 307 Lakes Boulevard was an affected building due to its proximity to 307A Lakes Boulevard and the potential of building materials impacting the dwelling in the event of a sudden scour induced collapse of 307A Lakes Boulevard.

4.16.16. The authority undertook repairs to the scour, laid new drainage, and constructed more silt fences. This inspection and repair process was monitored and repeated several times throughout 2018 (after the issue of the notice).

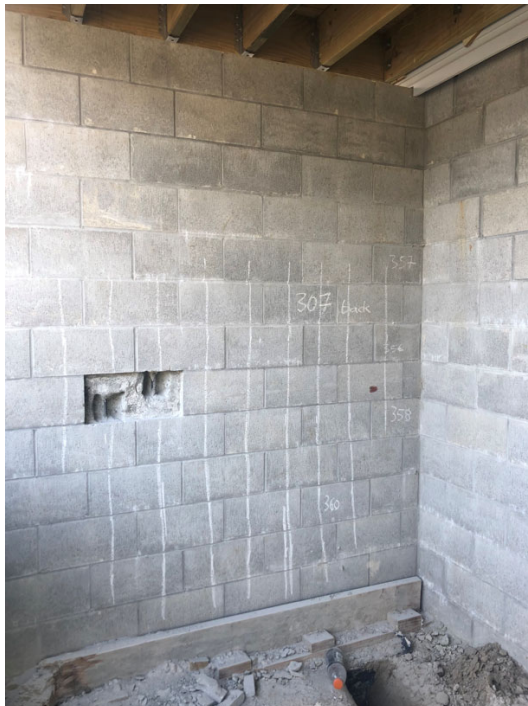
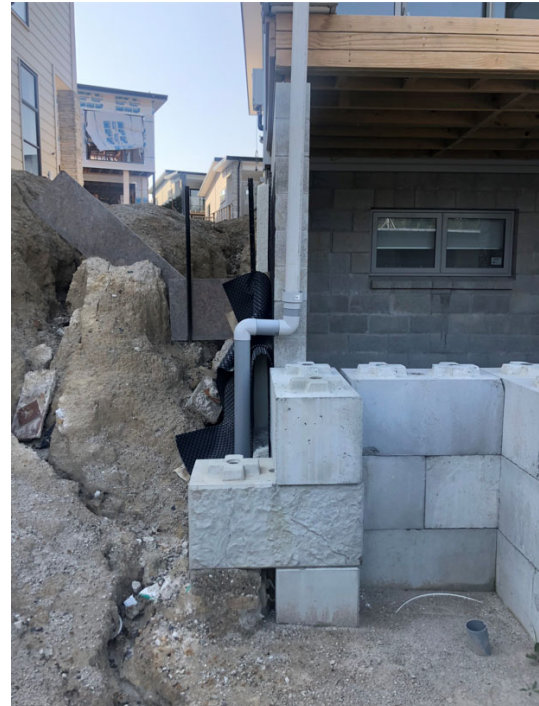
### Figure 9: Wing wall and sloping ground<sup>103</sup>

4.17.5. To allow for the sloping fill behind the wing wall, engineer 2 conservatively checked the wall foundation sliding capacity assuming a fill height of 1.2m. This would equate to the actual fill height near the mid length of the approximately 2.4m long retaining wall.

4.17.6. Calculations showed that the wing wall is overloaded due to height of the wall, the amount of fill material behind it, and the “unfactored sliding factor of safety...is less than the minimum...required”.

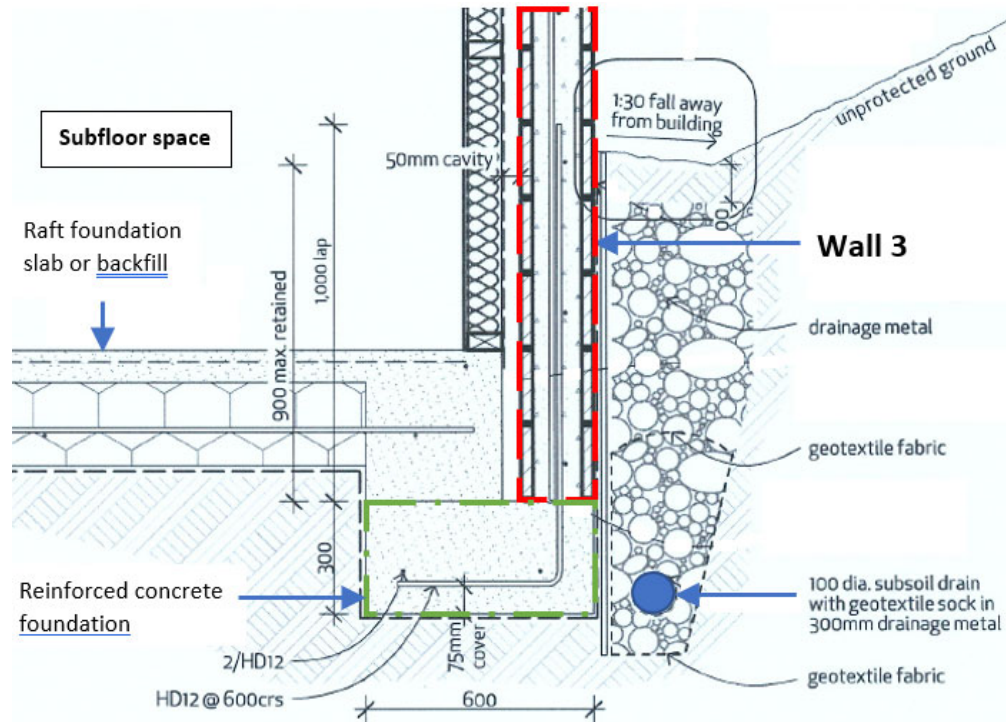
Figure 11: Wall 3 and foundation (not to scale)<sup>120</sup>

- 7.8.2. Wall 3 was 6.2m long and constructed of reinforced concrete blockwork supported on a 600mm wide x 300mm thick reinforced concrete foundation. It has been assumed backfill<sup>118</sup> was placed to a depth of least 200mm in the subfloor space between the raft foundation to the garage and the back of Wall 3 (over the foundation). Refer to figure 11.

- 7.8.5. From all the documentation made available for review (for the purposes of preparing the addendum report), no evidence of damage or distress to Wall 3 was reported by the engineers or other observers reporting on the condition of 307A Lakes Boulevard.

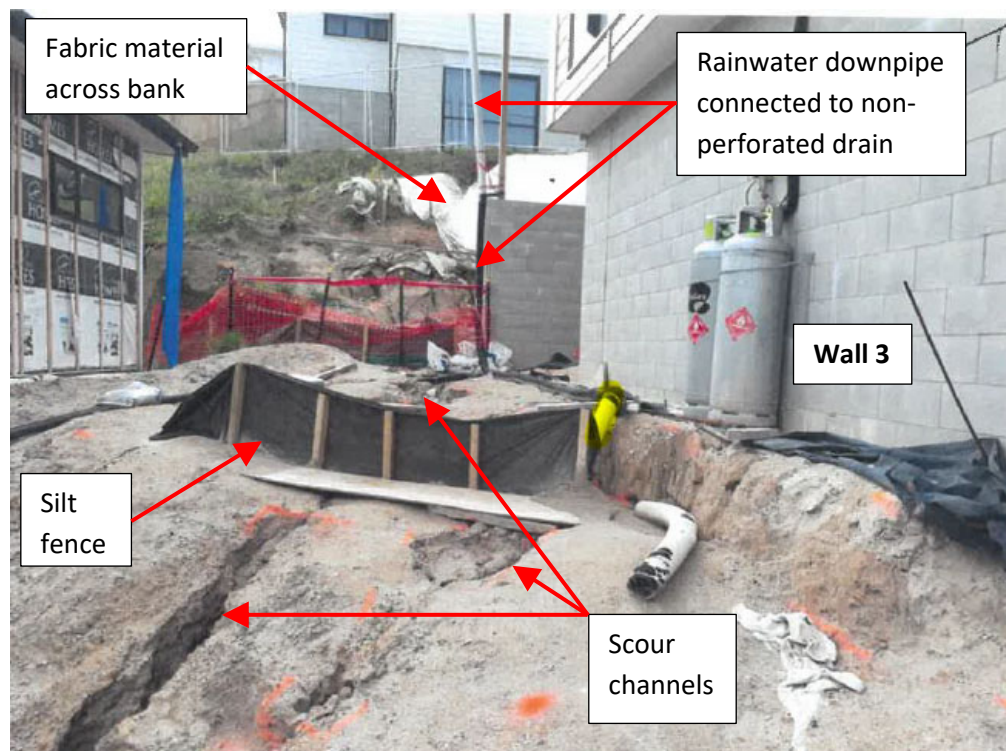
**Figure 12: Area between 307A Lakes Boulevard (on the right) and 305 Lakes Boulevard (on the left)<sup>124</sup>**

7.8.10. The recorded behaviour on the site indicated that both runoff from a large, exposed area of the ground surface and discharges from downpipes carrying roof water generated scour channels.<sup>123</sup> The channels were typically narrow but could extend to greater than 1m below the ground surface. For scour to form there must be a source of water that saturates the soil, and the velocity of water flow is a critical factor (eg as a result of a steep gradient). Saturation reduces the soil's shear strength, making it susceptible to erosion. Refer to figure 12.

7.8.12. The direction of scour (as indicated in figure 12) is oriented away from 307A Lakes Boulevard and is some distance horizontally away from Wall 3, mitigating concerns regarding the structural performance of the dwelling.

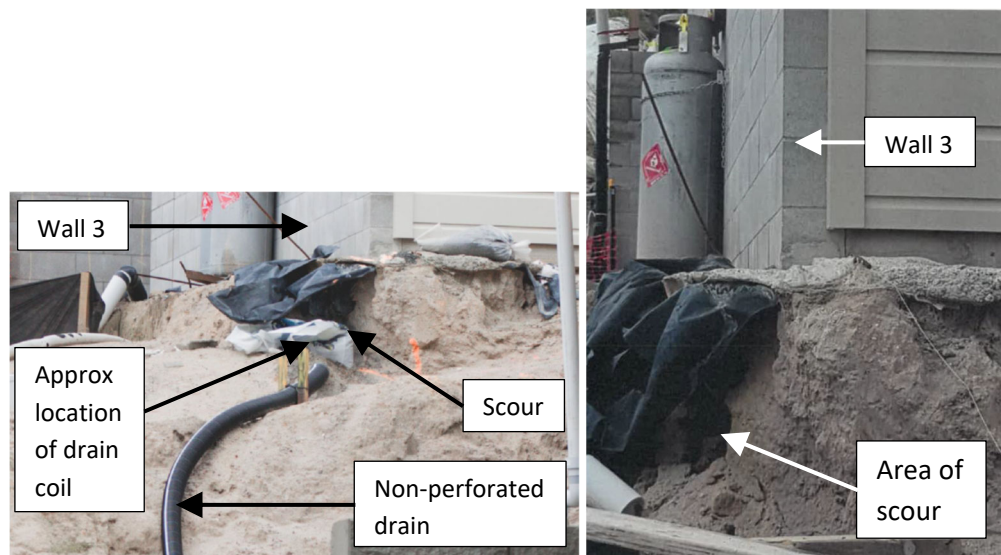
**Figure 13: Southwest corner of 307A Lakes Boulevard<sup>126</sup>**

7.8.13. There was a narrow scour-like feature trending downslope from 307A Lakes Boulevard to 307 Lakes Boulevard, but this was relatively minor and at a distance from Wall 3.
