Determination 2024/031

**Regarding the compliance of building work with Building
Code clause E1.3.1 Surface water**

57 Pomona Road, Ruby Bay

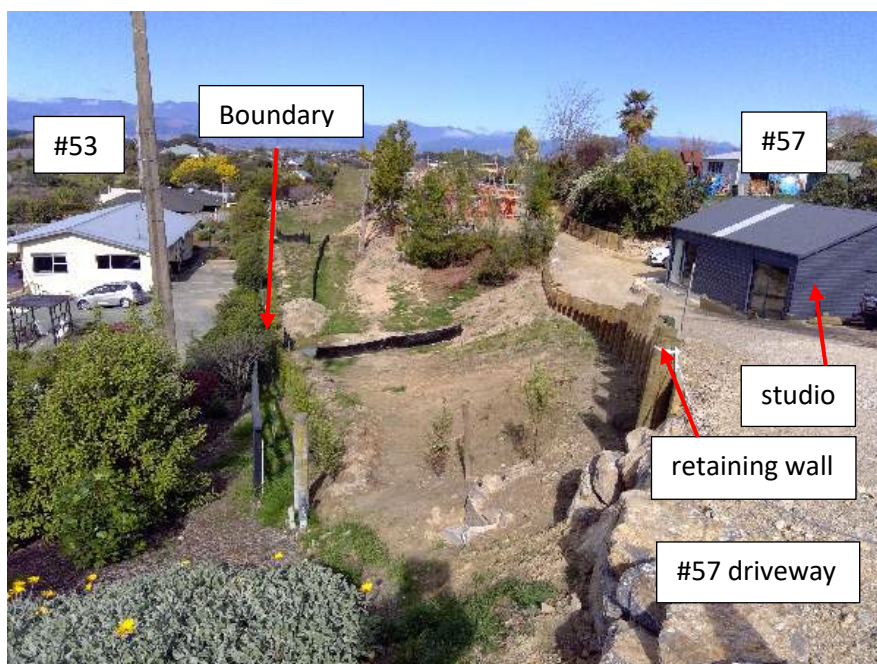
Figure 1: Photograph of retaining wall and driveway (taken 11 August 2020).

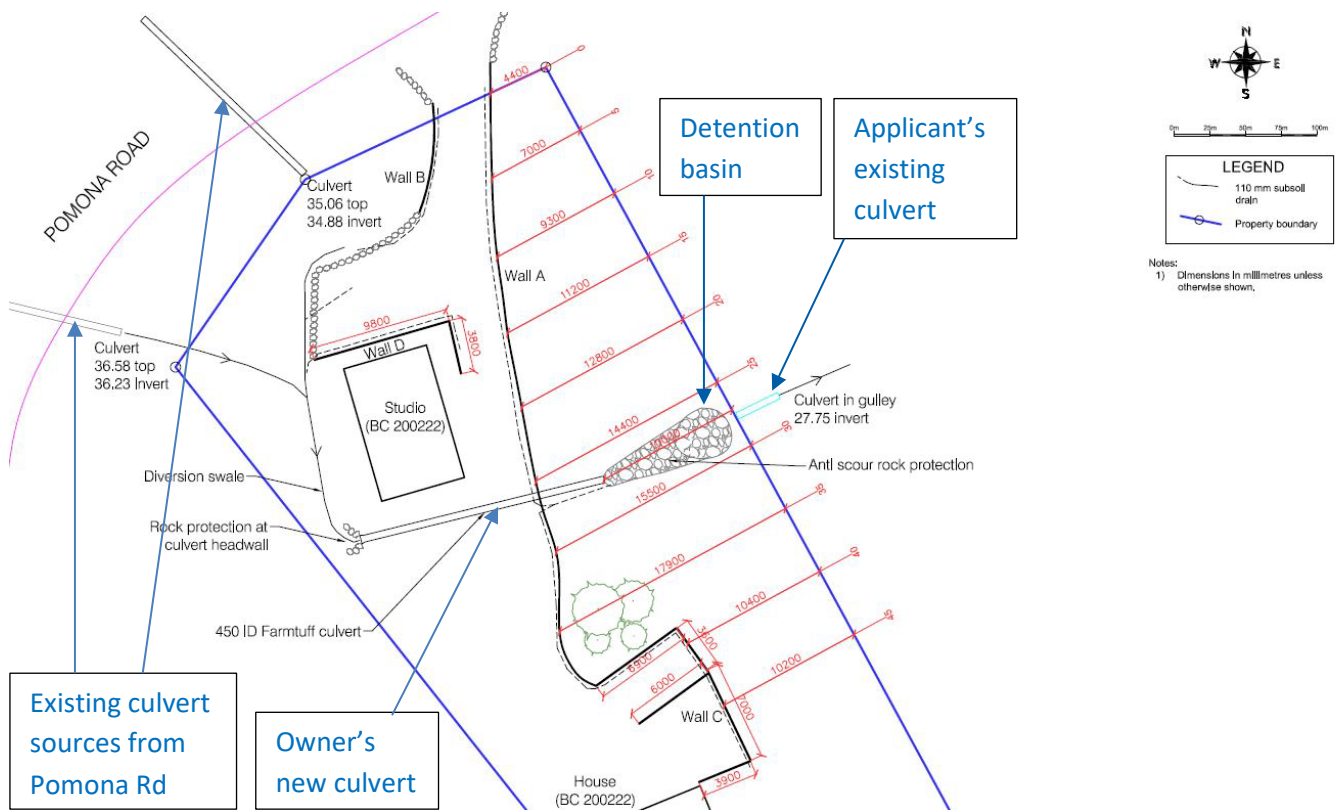
Figure 2: As-built plan (not to scale).

- 2.6. Following the construction of the retaining wall and new drainage arrangements at the neighbouring property, the drainage arrangements are as follows:
- 2.6.1. Storm water from the road above and existing culvert sources is channelled down a 'main drain' on the west side and a 'secondary drain' on the northwest side of the neighbouring property (see Figure 2).
 - 2.6.2. Both drains meet on the west of the studio. Storm water then flows through a diversion swale and is diverted underneath the new parking bays and

driveway via a 450mm⁶ diameter pipe. Outflow is then dispensed eastward via a rock-lined waterway/swale into a detention basin (see Figures 2 and 3).

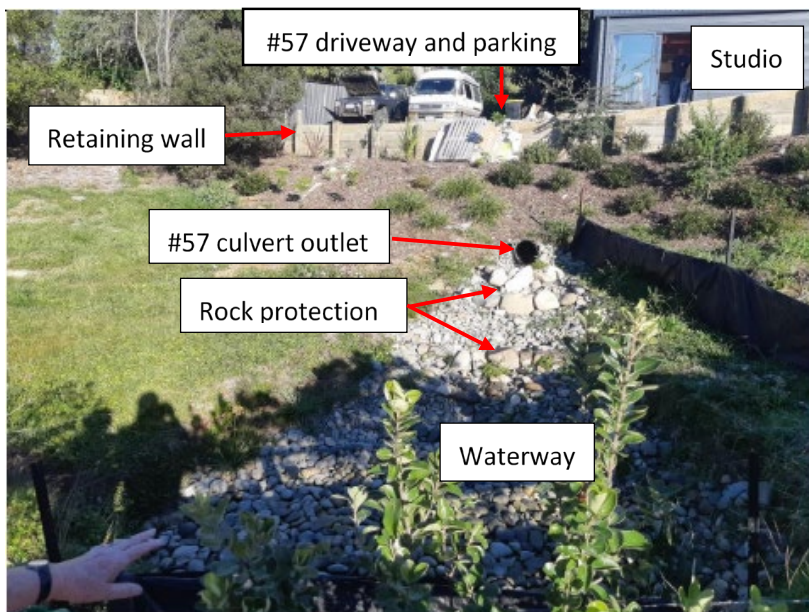
2.6.3. The detention basin is close to the boundary with 53 Pomona Road. The detention basin measures 3m by 3m, is 500mm deep in the centre and is lined with river stone rocks (see Figures 3 and 4).

Figure 3: Photograph of as-built drainage arrangements (taken 13 July 2021).

- 5.3 The experts assessed the 450mm culvert beneath the owner’s new driveway, noting it has been installed in the correct position as per the consent. Although there is no practical secondary flow-path other than over the driveway, substantial ponding upslope would be required before water would overspill the driveway, and it is understood that this has not occurred. The wall and fill are designed to accommodate temporary ponding without significant damage.
- 5.4 Rock protection has been placed at the inlet of the culvert and there are no signs of erosion. Appropriately sized anti-scour rock protection has also been placed below the outlet (see Figure 3).

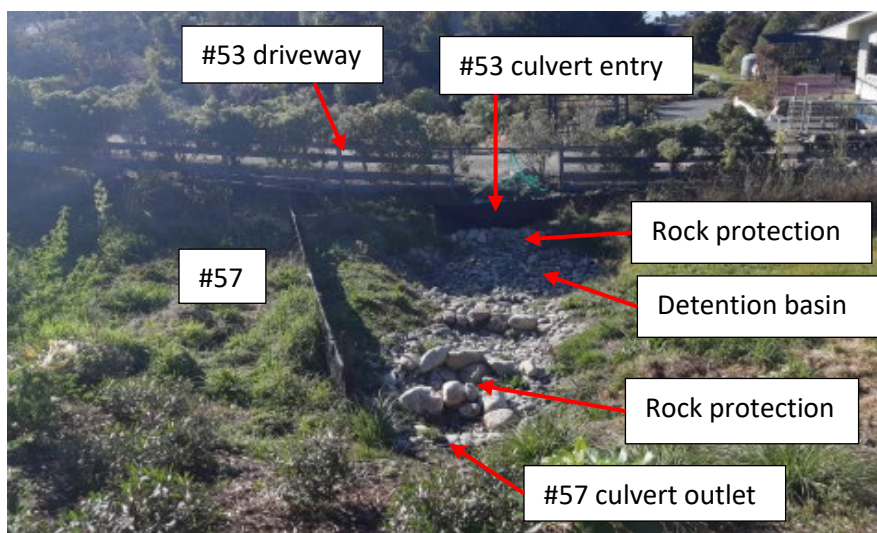
2.6.4. A small pipe drains the detention basin into a 300mm diameter culvert pipe which directs water underneath the applicant’s driveway (see Figure 4). Water is then discharged to the southeast of the applicant’s property.

Figure 4: Photograph of as-built drainage arrangements (taken 13 July 2021).

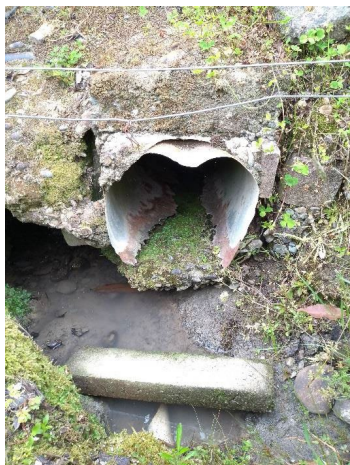
- 4.2.2. The culvert running under the applicant's driveway was in poor condition prior to the owners buying the property and commencing the building work. At that time, there was already an eroded hole to the left of the applicant's culvert. The owners provided a photo of the culvert taken after a storm, which shows water flowing through the eroded hole and damage to the steel pipe at the entrance of the culvert (see Figure 5). The owners state that the condition of the culvert at that time was the same as when they bought the property.

Figure 5: Photograph of the number 53 culvert entrance (taken 21 November 2020).

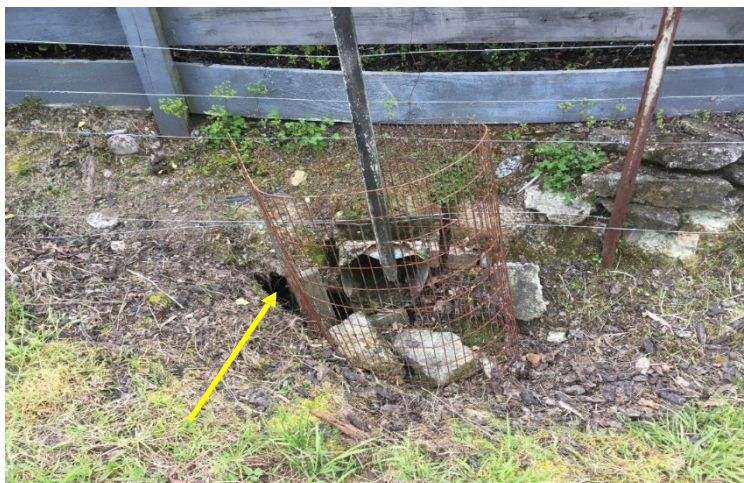
the steel sheet had rusted away, the main culvert had partially collapsed and water was entering through a broken joint about halfway along the barrel. Stormwater has eroded the embankment next to the steel sheet extension and a hole has developed here, allowing water to flow down the outside of the culvert before entering the barrel at the broken joint and exiting the culvert at the downslope end.

Figure 6: Photograph of pre-existing boundary-line drainage arrangements, with arrow pointing at eroded hole (taken 24 October 2019).

- 4.9. The engineer submits that “the culvert and piping situated on the applicant’s property has been damaged for some time and that this damage has occurred gradually and imperceptibly over a period of years due to settlement of the fill forming [their] driveway at this point”. The engineer states that “none of this damage has occurred as either a direct or indirect result of the works undertaken on the neighbouring property”.

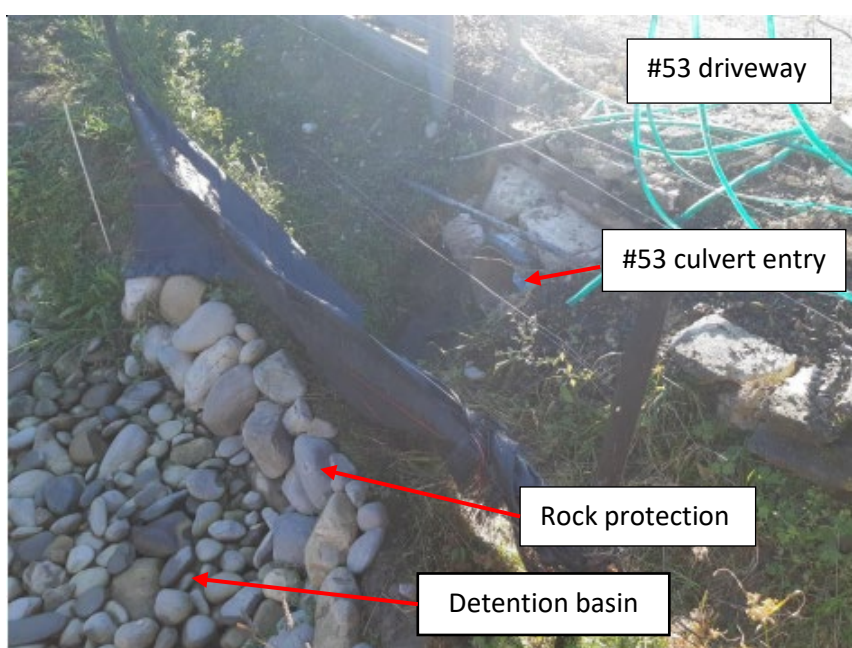
Figure 7: Rock protection at downstream rise of detention basin (taken 13 July 2021).

- 5.7 The detention basin's function is "energy dissipation by abrupt rise". Medium sized rock protection has been placed against the downstream rise of the basin (see Figure 7). The report notes that this is compliant with E1; however, the size and placement of the rock will need to be monitored as small rocks may become displaced over time by the force of the water.
- 5.8 Evidence of minor scour to the applicant's culvert entry was noted, which is likely a result of an inadequate headwall arrangement providing a transition of flow into the culvert.

- 5.16 The experts found that the culvert beneath the owner's driveway has sufficient capacity to discharge flows from the 57 Pomona Road catchment in a 1 in 10-year rainfall event. They concluded that the stormwater mitigation works undertaken at 57 Pomona Road are compliant with clause E1.3.1.
- 5.17 To ensure continuing compliance, ongoing maintenance of the energy dissipation feature at the boundary of the properties will be required. The medium sized rock protection could become dislodged and reduce the feature's effectiveness over time.

- 6.22. I note the comments made by the engineer and expert that the rock protection should be regularly maintained to ensure the rocks continue to provide protection to dissipate the flow of water. I consider the work to check and replace any rocks is normal maintenance expected in accordance with Clause B2 Durability.
