Determination 2024/040

The compliance with clause B2 Durability of macrocarpa timber cladding containing knots

1415 Devon Road, Brixton, Waitara

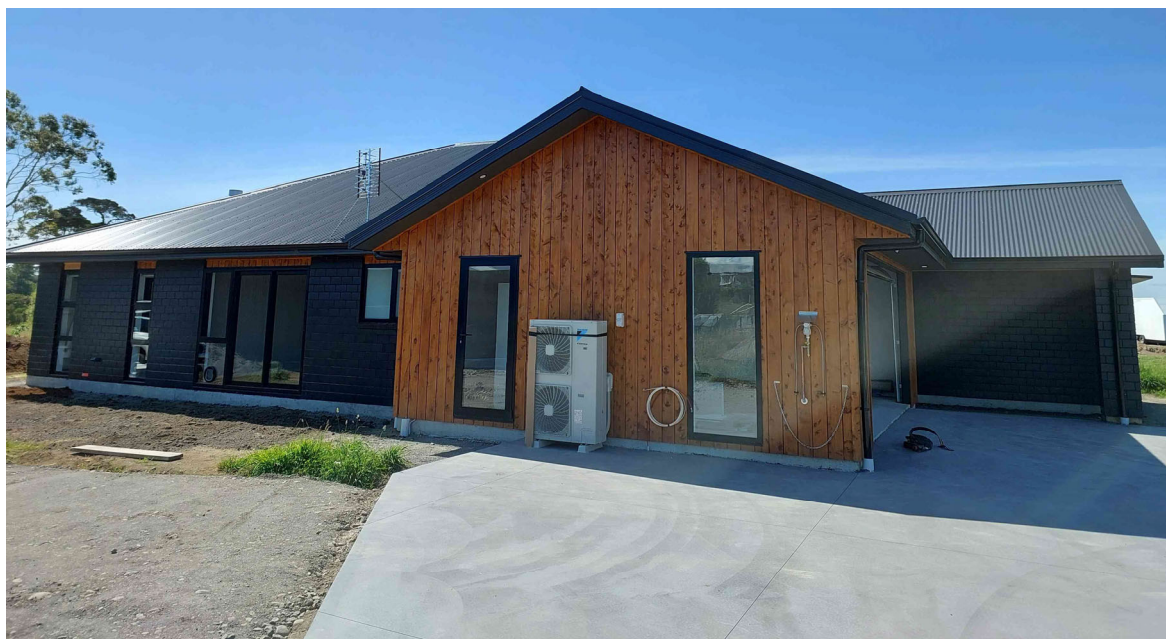
Figure 1: The macrocarpa cladding

- 4.11. In photographs provided by the owners and taken by the authority during inspections, it is apparent over all elevations on the dwelling that there is a high frequency of knots in boards across all elevations (figure 1). The sizes and shapes of

the knots vary. However, photographs of individual knots show some with bark pockets around the edges or knots with holes or a combination of both, as well as cracks and splits that appear to be full thickness.

- 4.14. The requirements of section 111.2.3 are for all holes and bark products to be excluded and that knots shall not exceed 50mm in size. It is evident there are holes and bark pockets, and therefore the cladding as installed does not comply with B2.3.1(b) by way of NZS3602.

- 4.16. Given the frequency and consistency of knots generally across all elevations, I am of the view there will be multiple knots containing bark pockets and/or holes across these elevations. While there are some sheltered areas on the dwelling, such as the covered entry and eaves of at least 400mm, the dwelling is in a very high wind zone⁹ with the boards also installed on gable ends. In this location as well as lower areas on elevations with eaves, the cladding will not be sheltered from wind-blown rain.

- 4.17. It is unknown whether the bark pockets and holes are the full thickness of the boards. However, even partial penetration into the boards will mean moisture can get in and sit in these areas in the boards and soak into the grain of the timber. Although the cladding boards have been treated with a timber oil after installation, this oil does not in-fill any holes and I am of the view it will not significantly reduce the effects of moisture ingress in the holes and bark pockets in the knots.

- 4.18. Moisture soaking into the timber grain will lead to premature deterioration of the boards, which will not meet the intended life of no less than 15 years required by B2.3.1(b).
