## Determination 2007/73

### Refusal by a territorial authority to accept a window installation detail at Parehua Country Estate, Martinborough

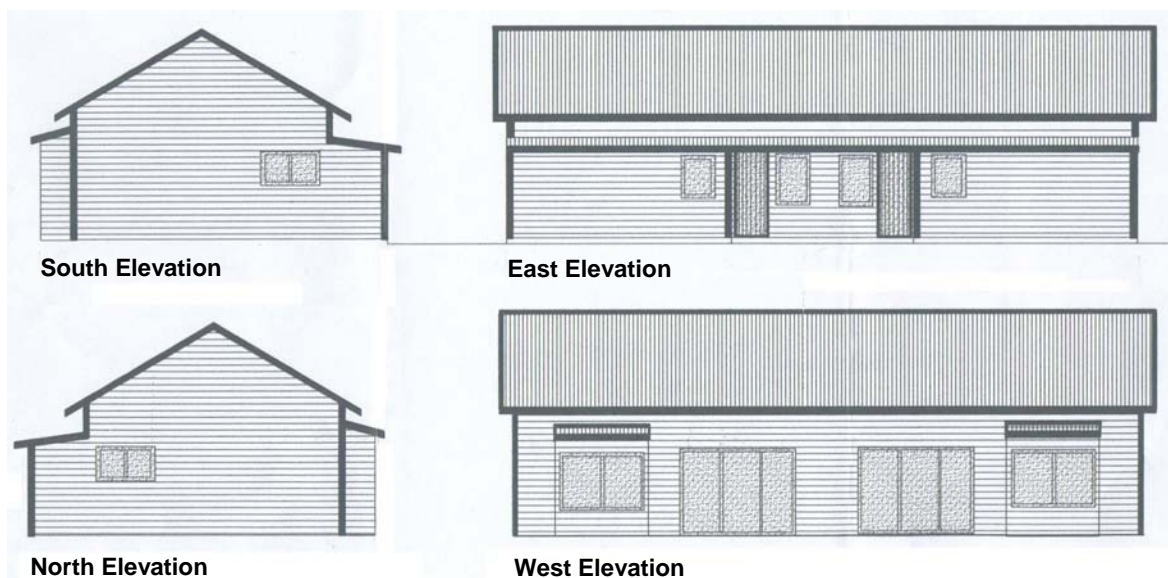
Figure 1: Elevations of the 114m<sup>2</sup> dwelling

- 4.3 The flashing detail installed by the applicant is not fitted back against the framing and under the building wrap. In the event of moisture ingress any water will find its way into the building framing. This detail could only be considered adequate where the top of the windows are located close to protective eaves.

- a) the head flashing detail, as installed in the gable ends of the dwellings (typified by the South and North elevations of the 114 square metre house shown in Figure 1) does not comply with the Building Code.
- b) the head flashing detail, as installed above windows in the side walls of the dwellings (typified by the East and West elevations of the 114 square metre house shown in Figure 1) does comply with the Building Code.
- c) the head flashing detail as installed over the ranch-slider doors (typified by the West elevation of the 114 square metre house shown in Figure 1) does not comply with the Building Code.
