## Worked Examples

### Assessment of foundation solutions for residential technical category 3 properties

These worked examples are to accompany revised Section 15.3 and Appendix C4 of MBIE Guidance for repairing and rebuilding houses in the Canterbury region following the 2010-2011 earthquake sequence.

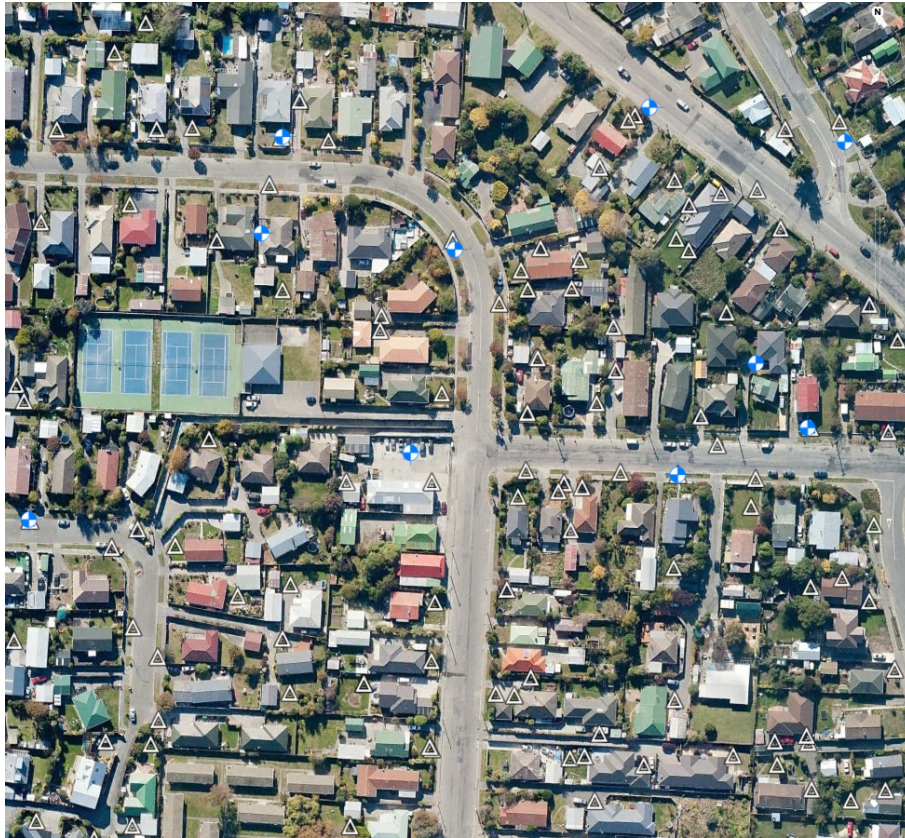
Figure 2 shows the Borehole (BH) and Cone Penetration Test (CPT) locations within the vicinity of the project site as shown on the CGD. A large number of ground investigations have been carried out in TC3 areas, and it is possible that a particular property may already have one or more investigations located on it. This information can help inform a general characterisation of the ground conditions in the project vicinity.

**Figure 2. CGD screenshot showing existing geotechnical investigations**

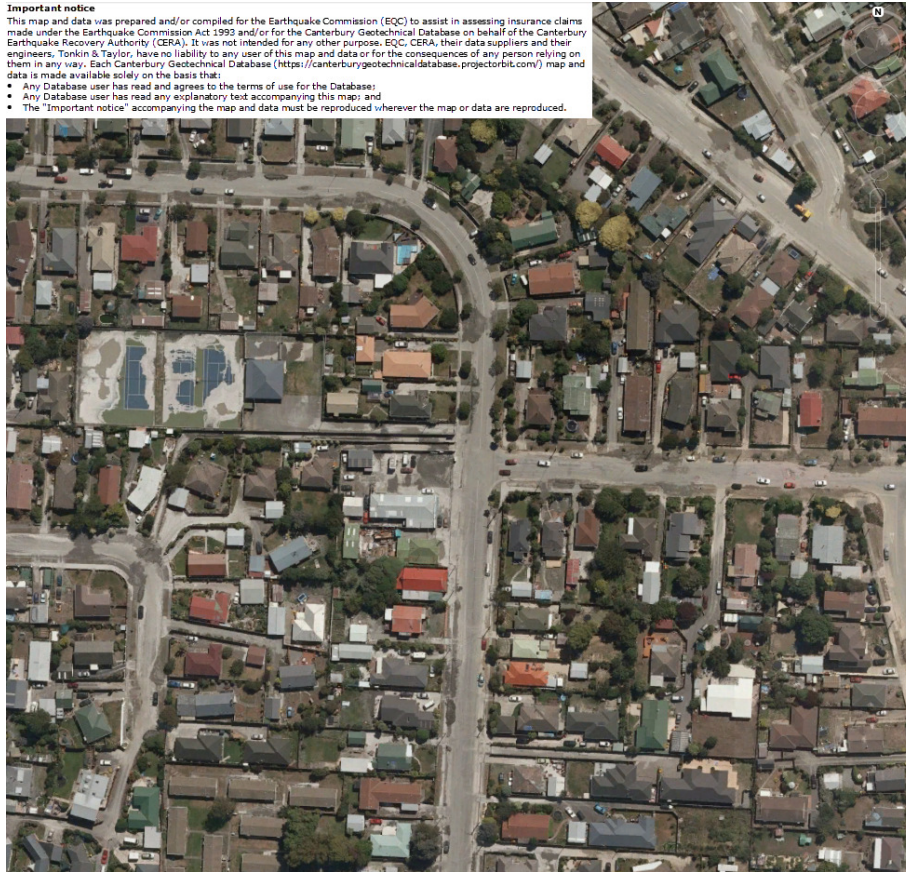
Aerial photos taken of Christchurch after each of the four main earthquakes can be useful for helping to assess whether surface manifestation of liquefaction (ie, ejecta, ground cracking, slumping, etc) occurred on or near the project site. Figure 7 shows the aerial photograph of the example site area from 4 September 2010, taken several hours after the earthquake. No liquefaction ejecta is visible on the roads or properties. Figure 8 shows the aerial photograph of the same area taken on 24 February 2011; two days after the February earthquake. Notable liquefaction ejecta is visible on the roads and tennis courts; including the road in front of the example project site.

**Figure 8. Aerial photo taken 24 February 2011**

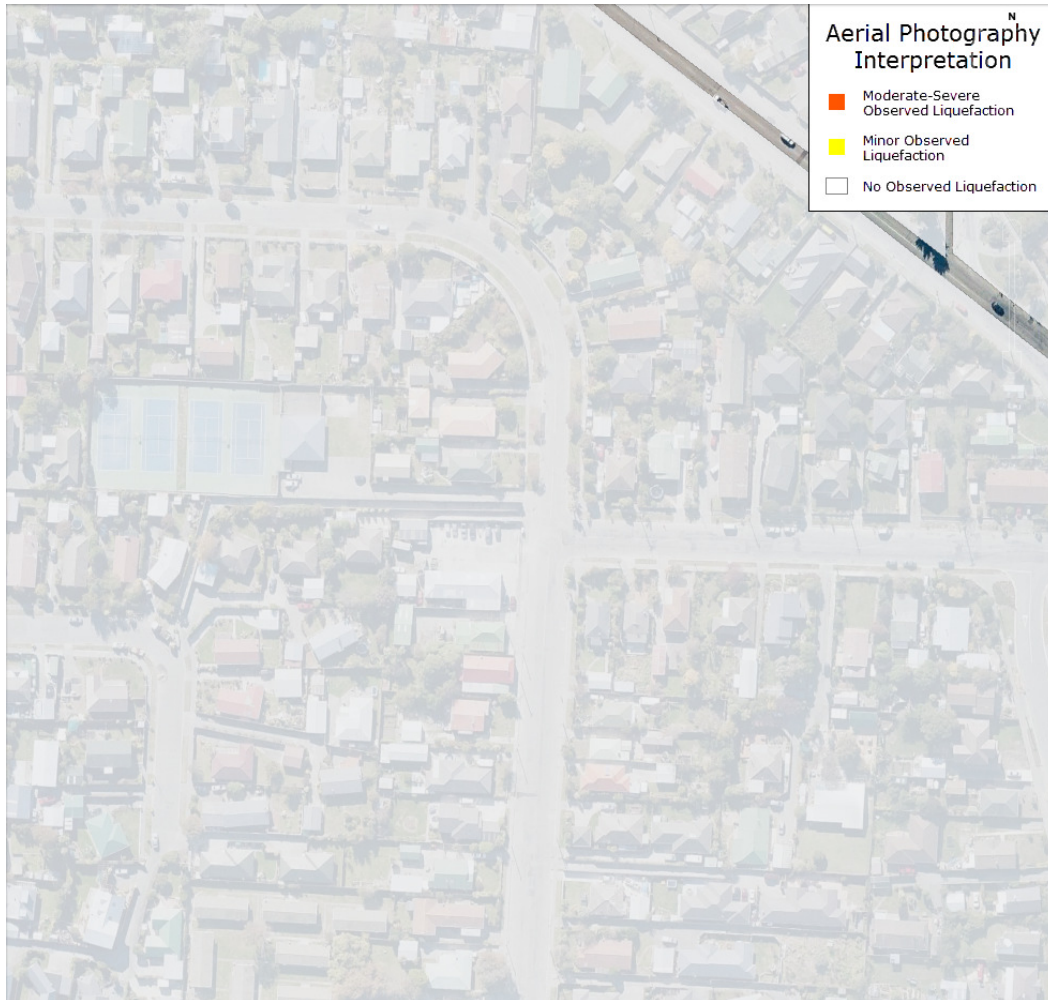
Figure 9 and 10 shows the recorded land damage across the example project site area after the 04 September 2010 and 22 February 2011 earthquakes. Figure 9 is from an interpretation of the aerial photography as the EQC land-based observation mapping doesn't cover the site area. For this example, no land damage was mapped as a result of the September earthquake.

**Figure 9. Interpreted land damage from aerial after the 04 September 2010 earthquake**

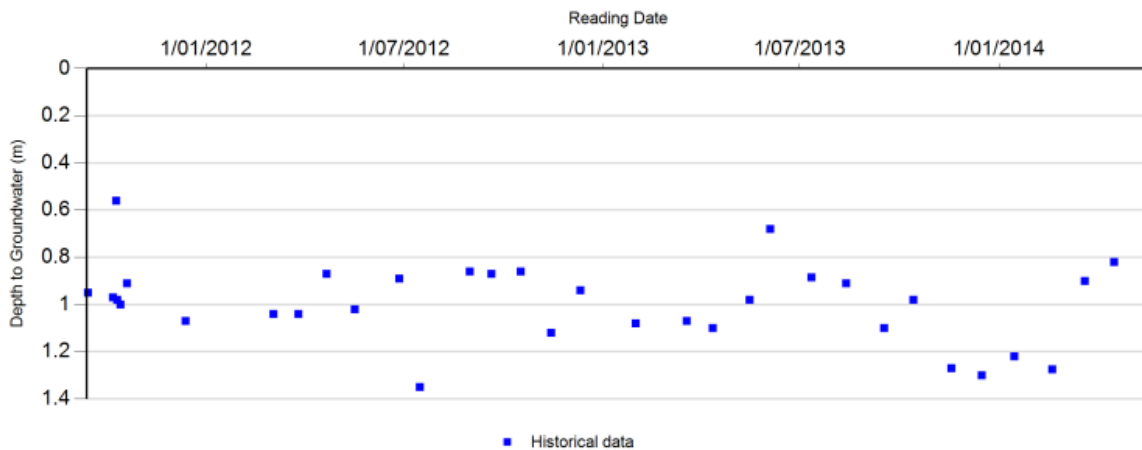
**Figure 14. Groundwater level at red monitoring well**

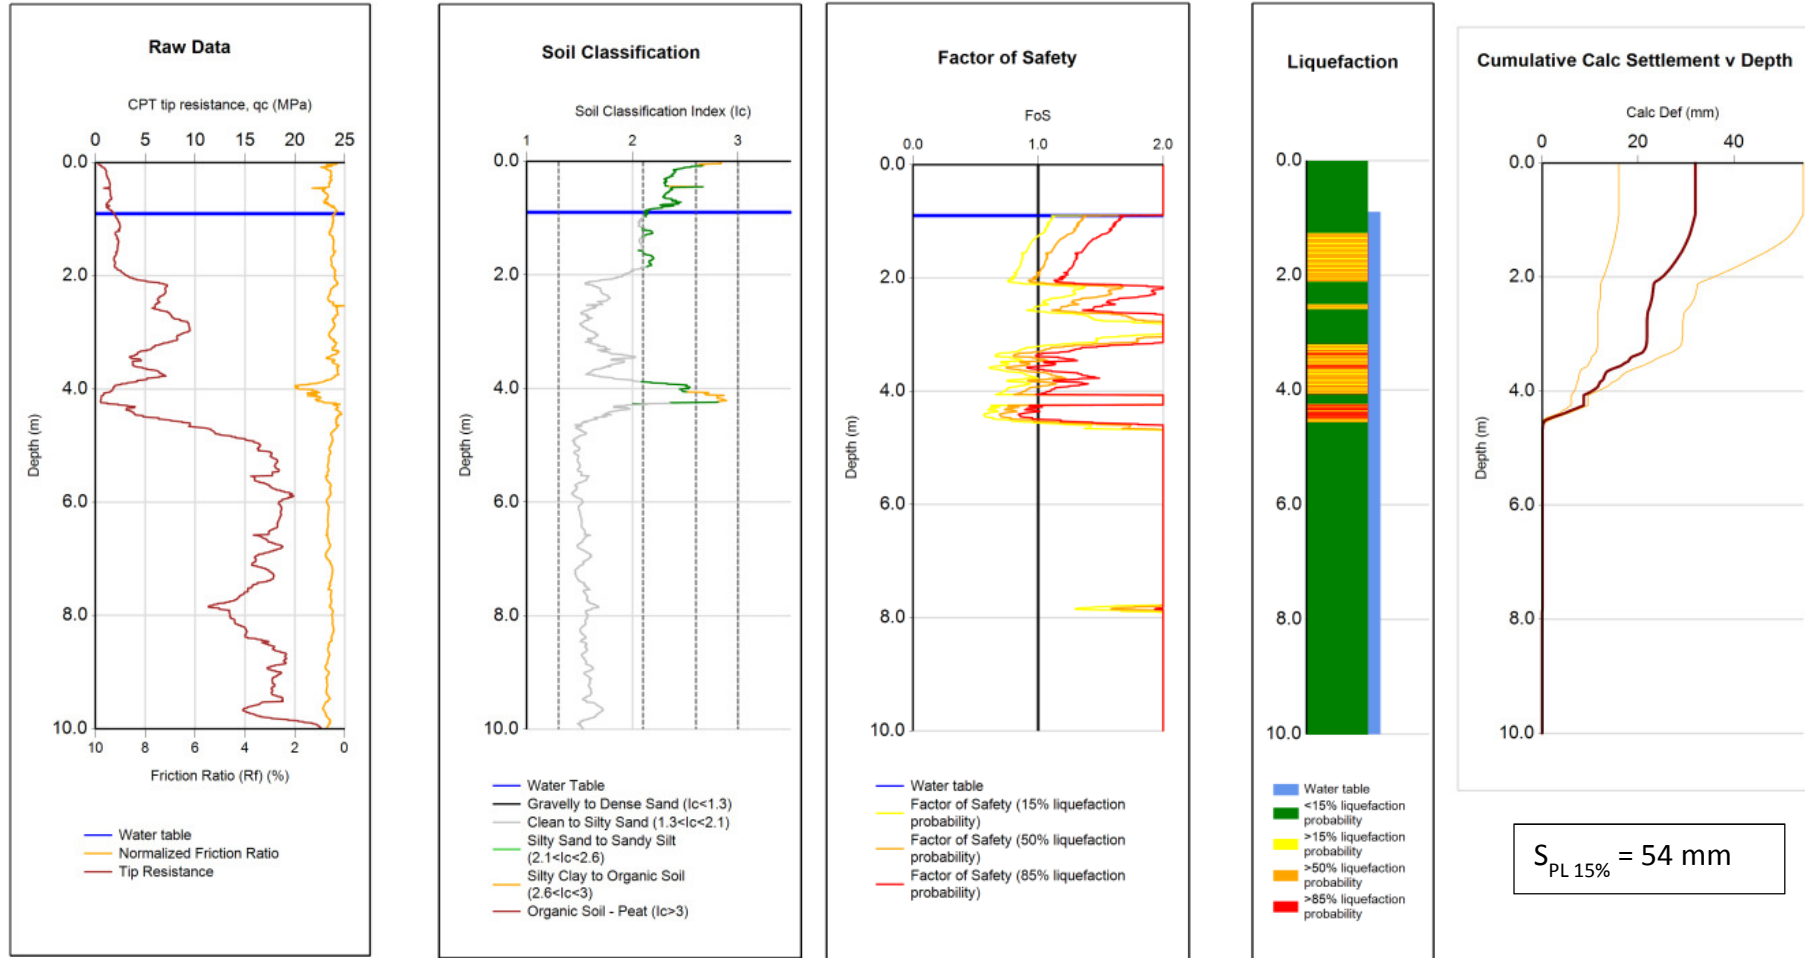
Figures 15 and 16 (a through d) present the graphical results of the liquefaction analyses of both CPT soundings for the three design cases plus the IL case described above. For the ILS case, only the M6 analysis (larger settlements than M7.5 scenario) is presented. Also shown are the CPT tip resistance ( $q_c$ ), friction ratio ( $R_f$ ) and  $I_c$  values, as well as the calculated liquefaction-induced settlements (discussed in Section 2.5).

The plots of  $I_c$  and factors of safety against liquefaction ( $FS_{liq}$ ) are useful for assessing where in the soil profile, liquefaction is predicted to occur, as well as the thickness of the susceptible layers. For example, in CPT A it is clear that the majority of the liquefaction is predicted to occur above a depth of about 4.5 m, with a significant portion of the liquefaction occurring above a depth of 2 m. The depth of predicted liquefaction is a key parameter to consider when selecting shallow ground improvement and foundation options as discussed in Section 2.6.

Figure 15 a). CPT A: SLS, M = 6, PGA = 0.19g

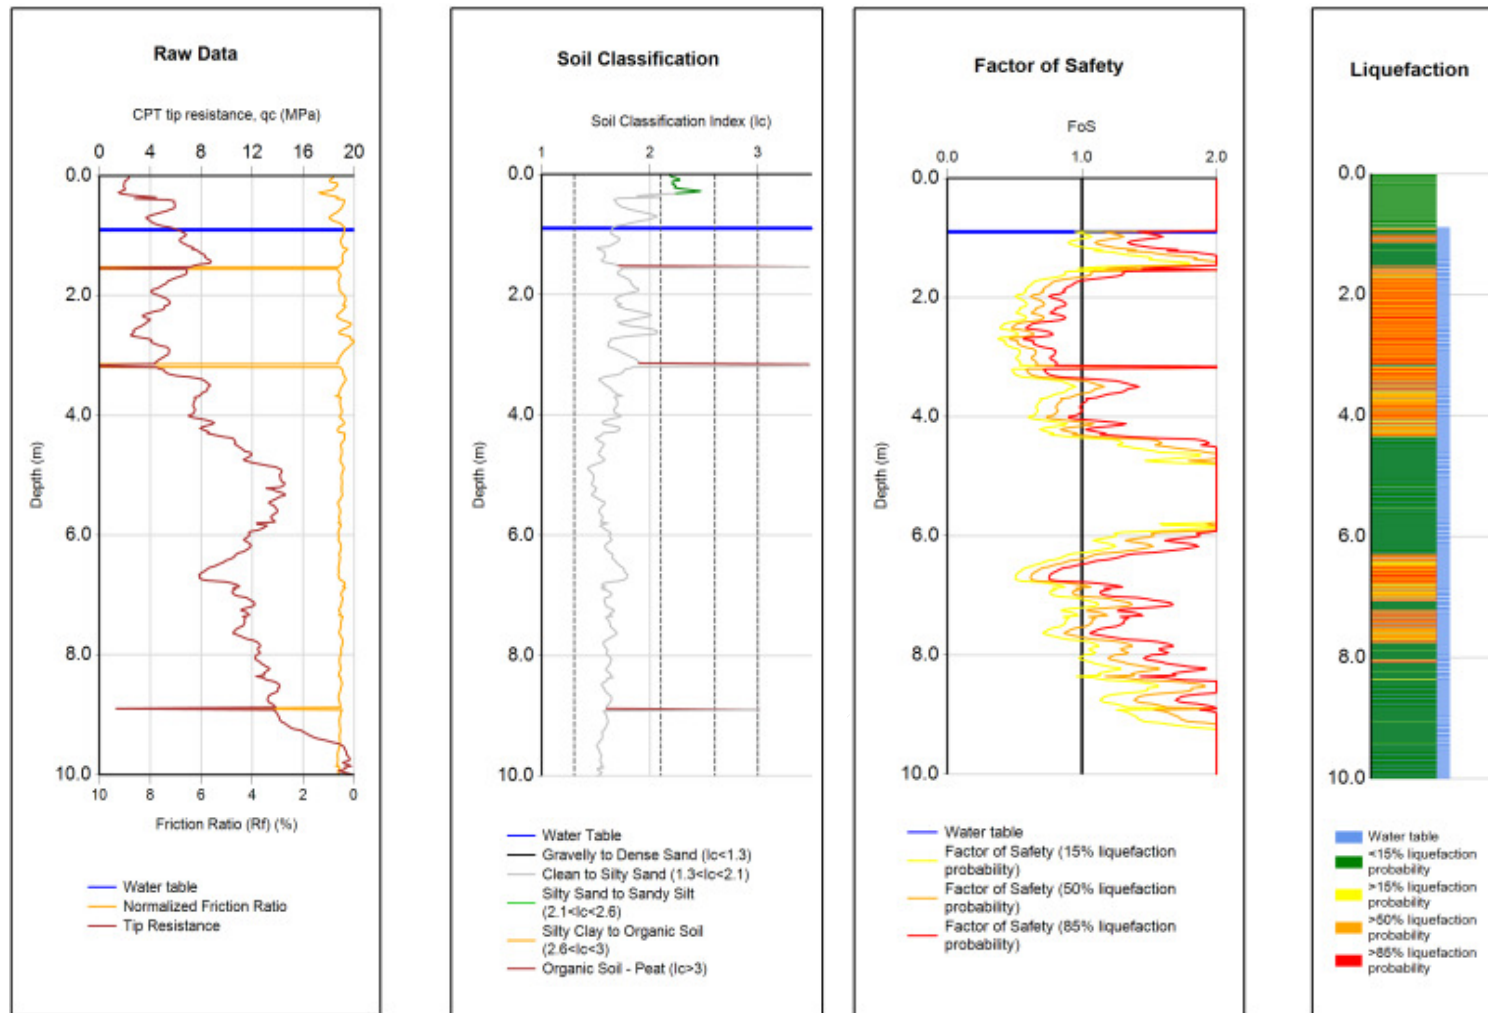
$$S_{PL 15\%} = 94 \text{ mm}$$

Figure 16 d). CPT B: ILS, M = 6.0, PGA = 0.30g

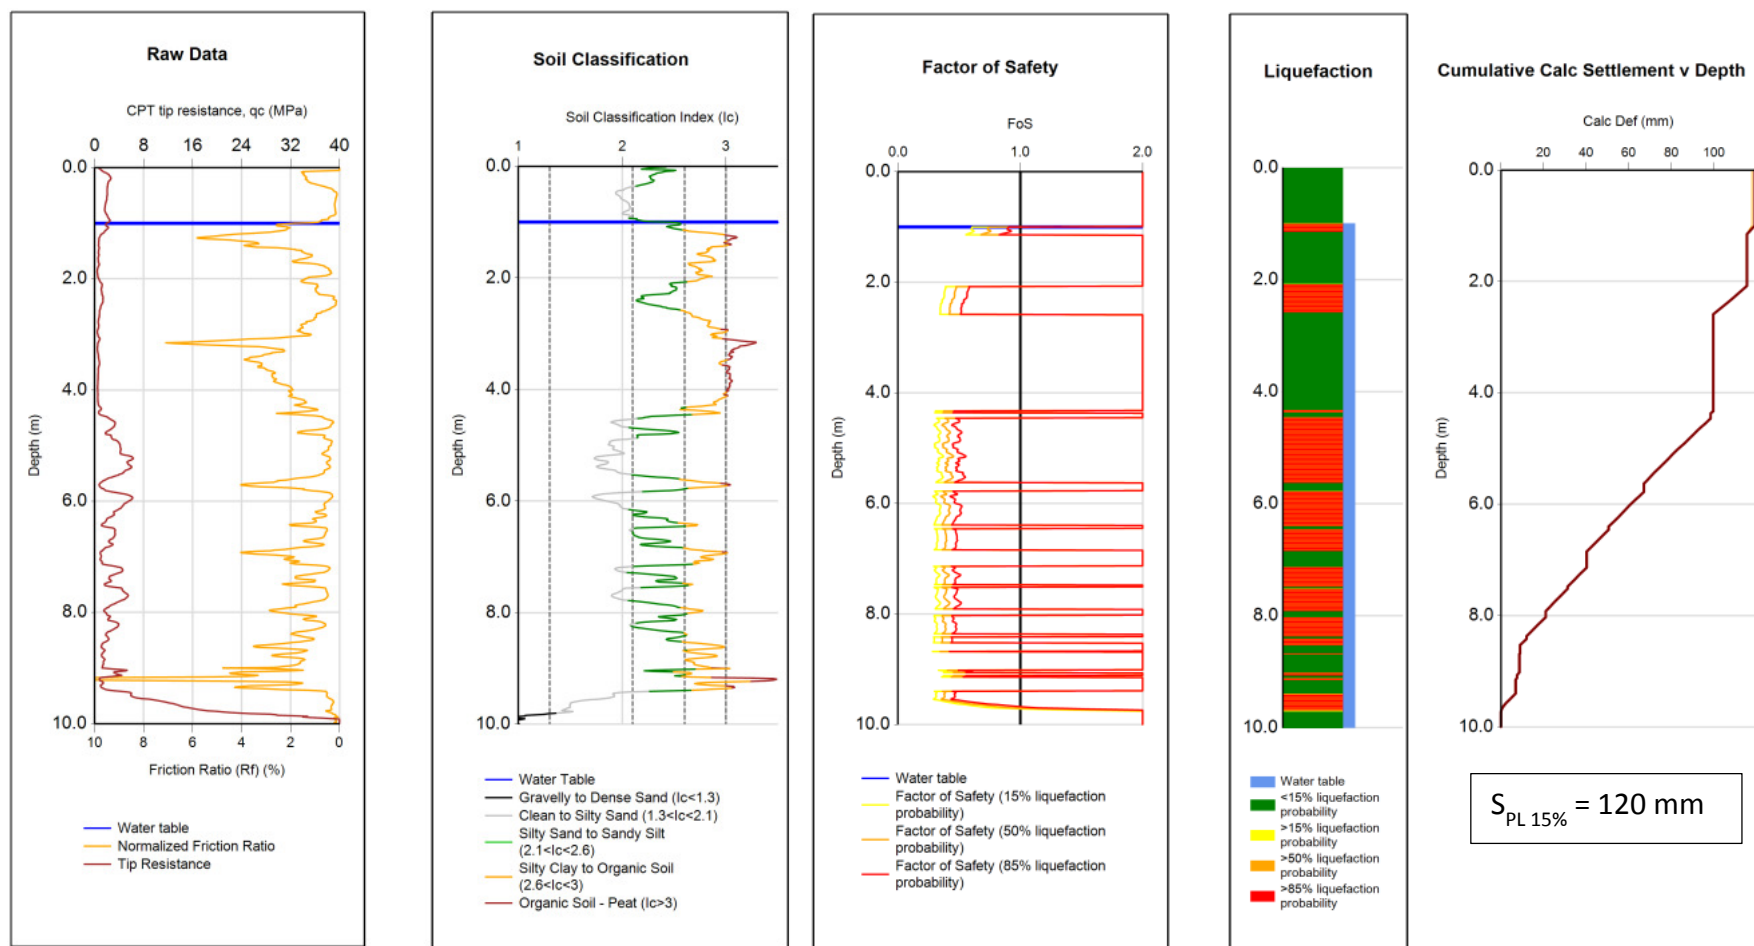
Figure 18 c). CPT A: ULS, M = 7.5, PGA = 0.35g
