# Determination 2022/005

## **Regarding the compliance of building work at 1D Fifeshire Crescent, Stepneyville, Nelson, with Building Code clauses B1 Structure and E1 Surface Water, that provide protection of other property at 18 Poynters Crescent, Stepneyville, Nelson**

### **Summary**

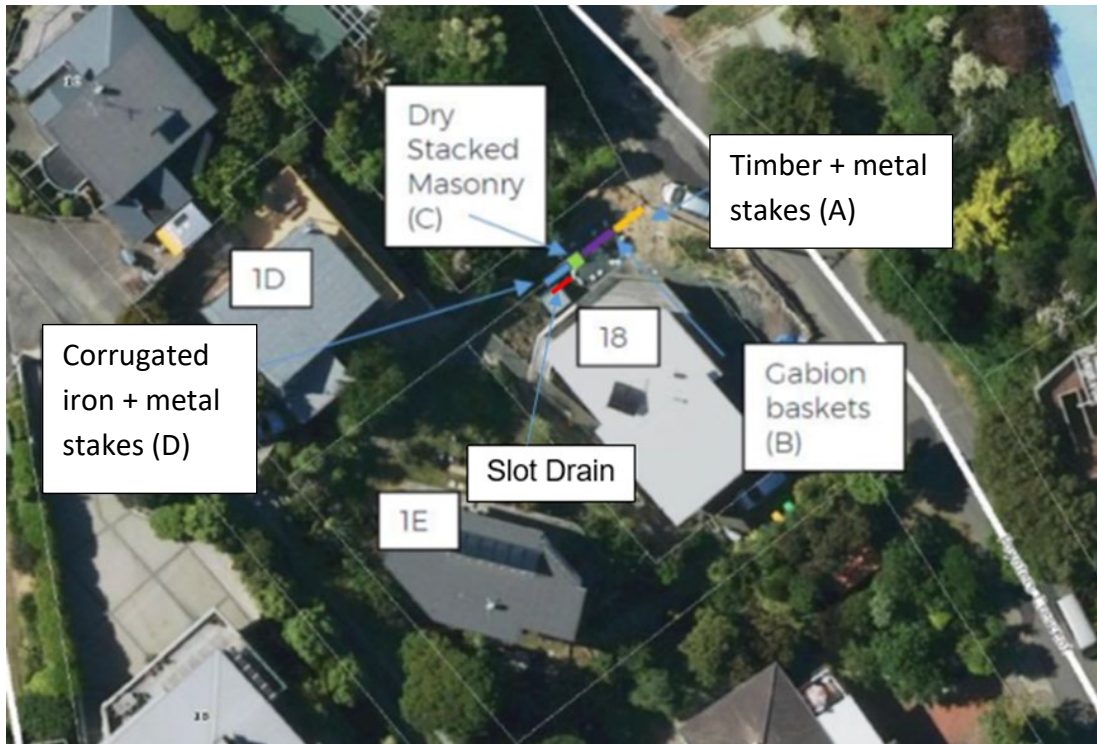
**Figure 6: Plan of approximate location of structures A (shown in yellow), B (shown in purple), C (shown in green), and D (shown in blue), and the slot drain (shown in red) [Not to scale]**

2.17. A series of structures have been erected along the boundary, against and above the cut slopes described above. In total these structures extend for approximately 10.5m in length (refer to figure 5 and figure 6). In ascending order, starting from Poynters Crescent, these can be described as follows.

2.18. There is a narrow drain (“the slot drain”)<sup>11</sup> next to the upper end of the structure D, on the applicant’s side of the fence/retaining wall (refer to figure 6 and figure 7). The slot drain is about 3m long, 90mm wide and 75mm deep, and has a longitudinal grade of 0.7 degrees. It is orientated in the direction of the slope and is located in a flat area created by the applicant. It drains surface water away from this area to the Poynters Crescent stormwater infrastructure, and was installed by the applicant in approximately 2011. The slot drain is lower (in part) relative to the natural ground level on the access leg.
