# Determination 2022/014

**Regarding the authority's decision not to issue a notice to fix for earthworks and a retaining wall**

**101B and 101C Grafton Road, Thames**

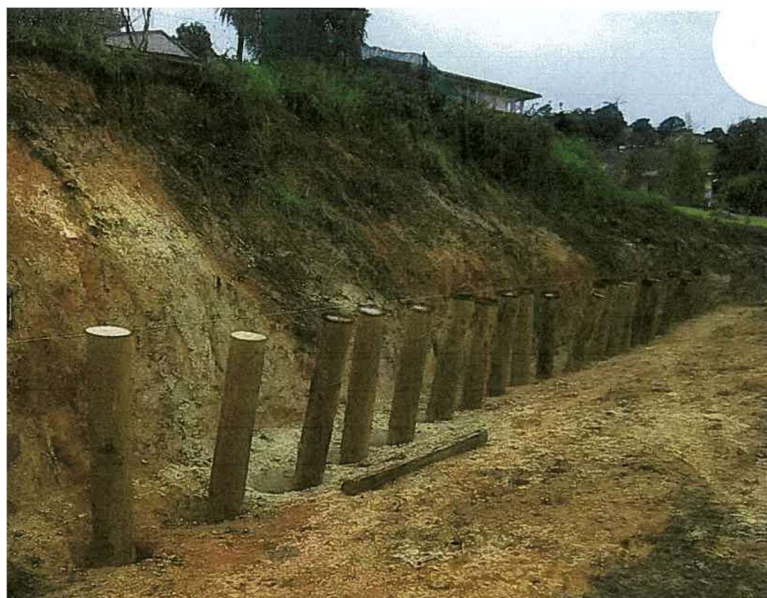
This determination considers whether the authority was correct to refuse to issue a notice to fix for site works that occurred over a period of years. The determination also considers the compliance of the work and the status of the developer as a specified person.
