# Determination 2022/017

**Regarding the refusal to issue a code compliance certificate for weathertightness remedial work on a townhouse**

**12 Marina View, Paremata, Porirua**

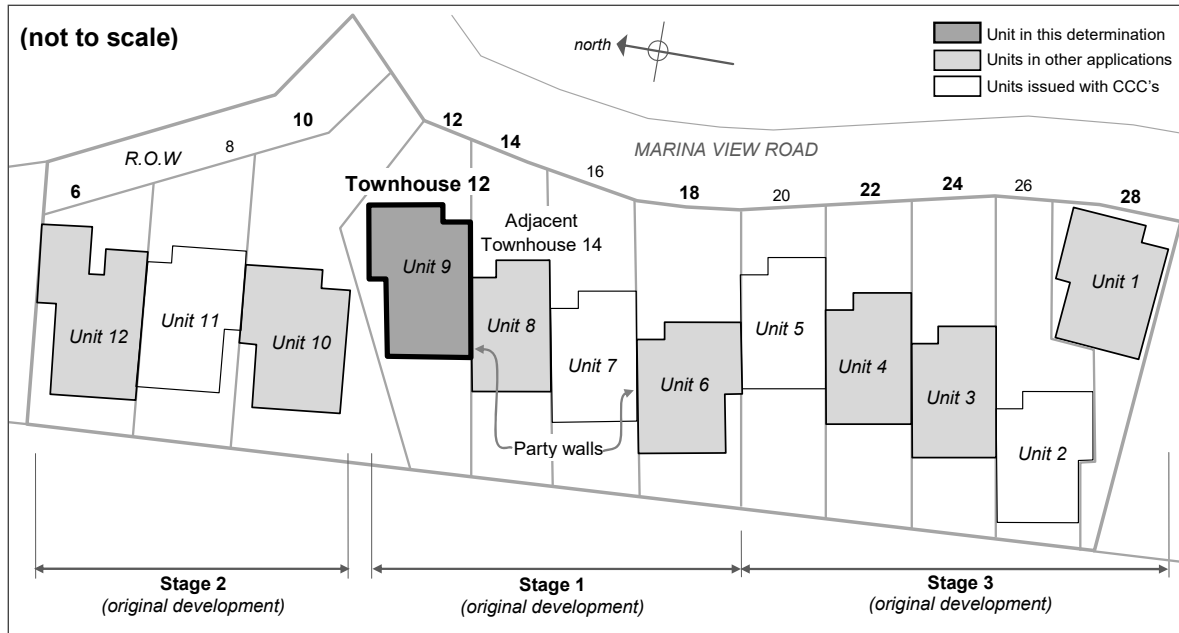
Figure 1: The townhouse development

- 2.1. The 12-unit townhouse development is situated on a near level, harbourside building site, in a sea spray zone and very high wind zone<sup>3</sup>. The development is made up of two blocks of semi-detached terrace houses and one detached house, as shown in Figure 1.
