# Determination 2024/001

**Regarding the issue of a dangerous and affected building notice for a residential dwelling**

**307 Lakes Boulevard, Pyes Pa, Tauranga**

## Summary

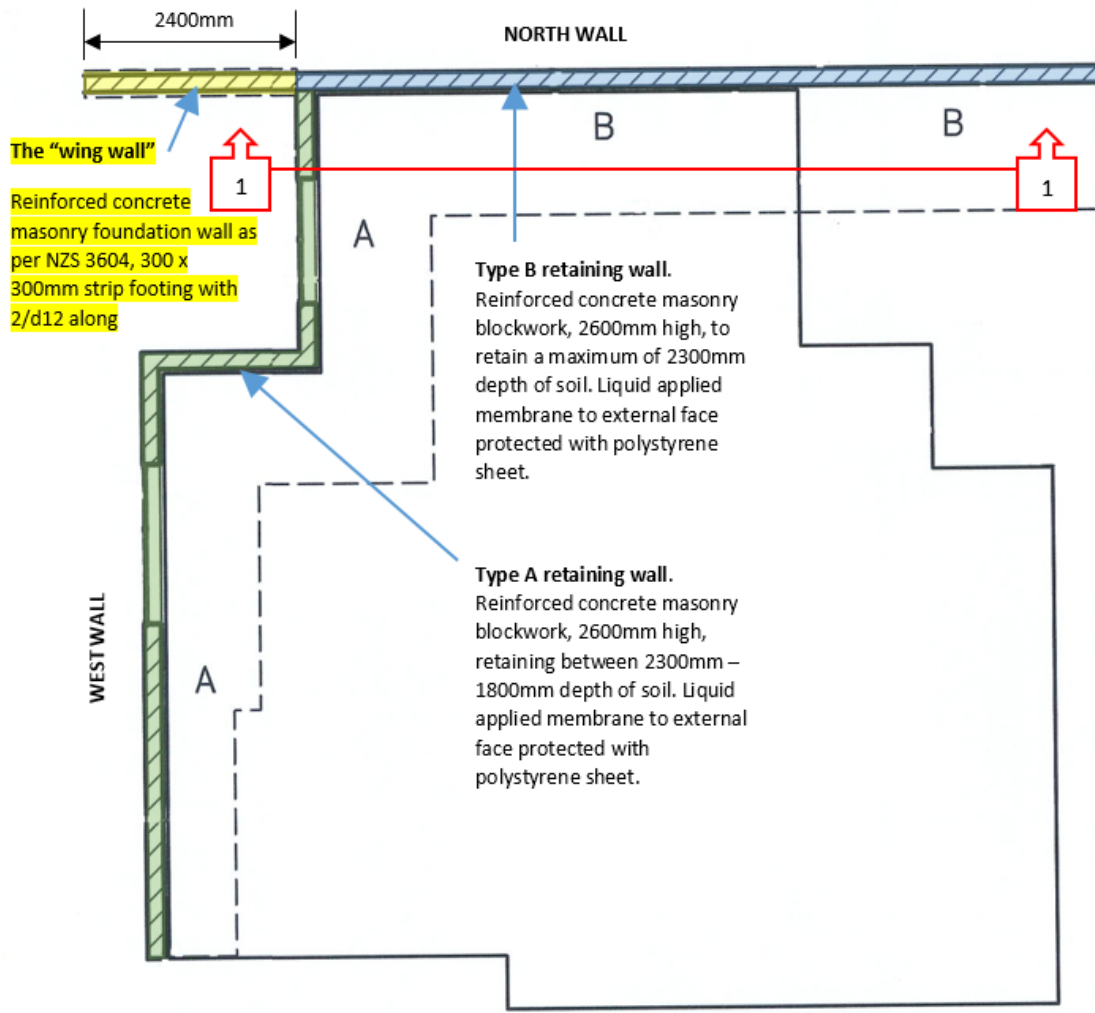
**Figure 3: Retaining wall setting out (note to scale)<sup>40</sup>**

- 2.12. Type A and Type B<sup>27</sup> reinforced concrete masonry retaining walls on the lower (ground) level to the north and west of the dwelling were built approximately 2800mm in height. The layout of these walls is shown in figures 3 and 4.<sup>28</sup>

- 2.14. Building consent plan 104 revision A specified a 2400mm long reinforced concrete masonry wall at the western end of the north wall (“**the wing wall**”), located directly below a 7.44m<sup>2</sup> timber-framed deck (see figure 6). The wing wall connects at the junction where the Type A and Type B walls intersect (see figure 3).

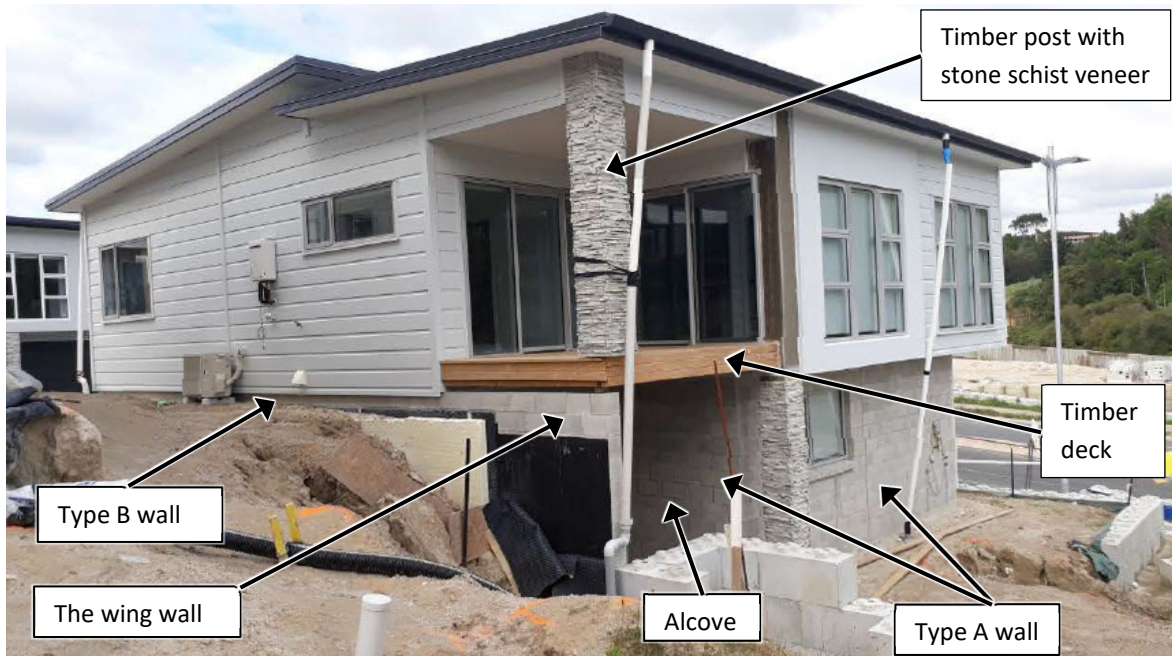
**Figure 6: 307 Lakes Boulevard (northwest corner)**

- 2.18. The plans also indicate the area (or “alcove”) between the wing wall and the north face of the Type A retaining wall was to be backfilled with material to approximately half the height of the Type A wall.<sup>34</sup> However, as built the Type A wall did not retain any fill material or natural soils in the alcove (see figure 6).

- 2.21. The west end of the wing wall supported a timber post, which was secured in place using a proprietary steel bracket fixed into the top of the wall. The post in turn supported, in part, the timber bearers and joists which formed the timber deck.<sup>37</sup> The timber post was finished with a stone schist veneer. The top of the post supported one end of a timber beam which in turn supported a part of the roof structure above the deck.<sup>38</sup> See figures 6 and 7.

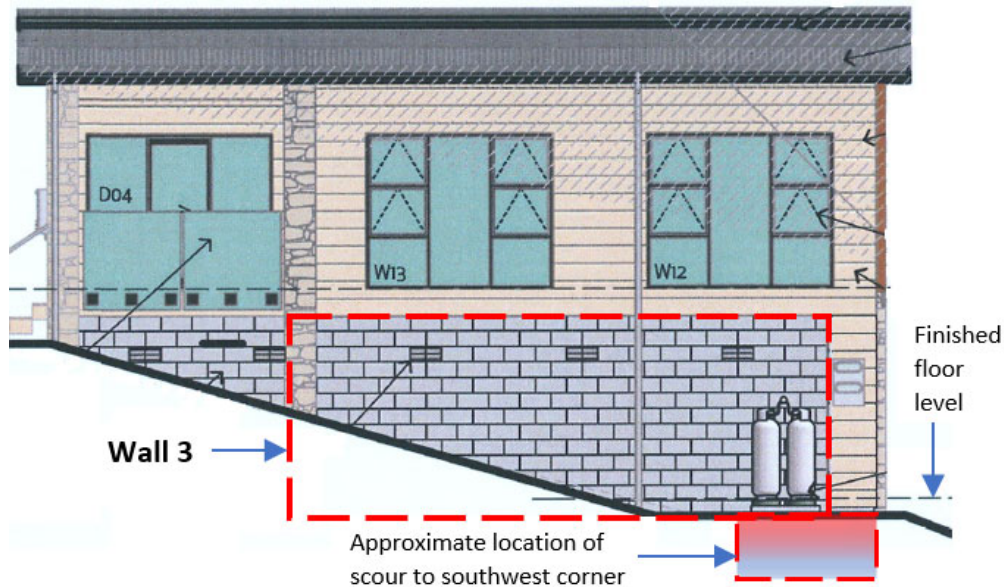
**Figure 10: West elevation of 307A Lakes Boulevard (not to scale)<sup>117</sup>**

- 7.4.3. Based on observations by several engineers who visited site there was “a deep scour adjacent to and directly under part of the building”.<sup>111</sup> Photographs provided by engineer 2 as part of the submission show evidence of scouring to west side and southwest corner of 307A Lakes Boulevard between it and 305 Lakes Boulevard (refer to figure 1), and one area south of 307A Lakes Boulevard and the northwest corner of 307 Lakes Boulevard.

<sup>117</sup> Figure 10 has been reproduced in part from plan 302 revision B. The area highlighted only shows the approximate location of the scour and is not intended to represent the size or extent of the scour.
