BRANZ

TEST REPORT

SC1221/1

CAPILLARY TEST ON TAILINGS WITH LIQUEFACTION SAND FILLING THE VOIDS

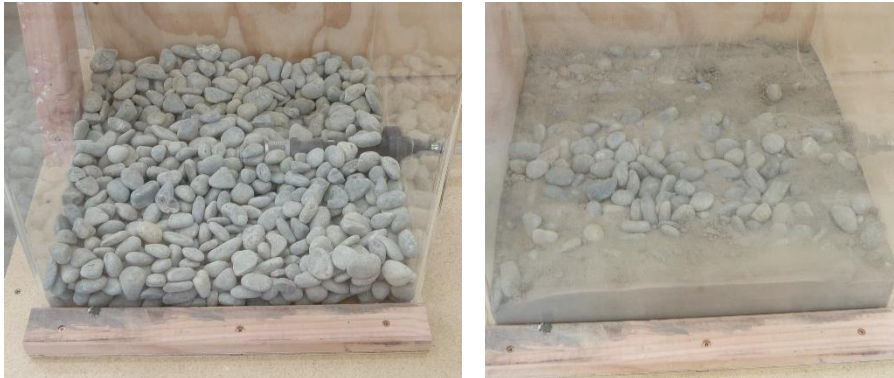
1. The rounded aggregate was supplied in a clean and dry state. The liquefaction material was dried in an oven to drive off free moisture.
2. A layer of rounded aggregate (tailings) approximately 50 mm thick was placed in the bottom of the acrylic square tube followed by the dry liquefaction material (Figure 2). A concrete vibrator was then used to ensure the fine sand/silt settled into the voids between the rounded aggregate. This process was continued alternating aggregate and fine sand/silt in 50 mm thick layers until a height of aggregate and fine sand/silt filling the voids had reached 830 mm.

Figure 2. Tailings and fine sand (liquefaction material) layering

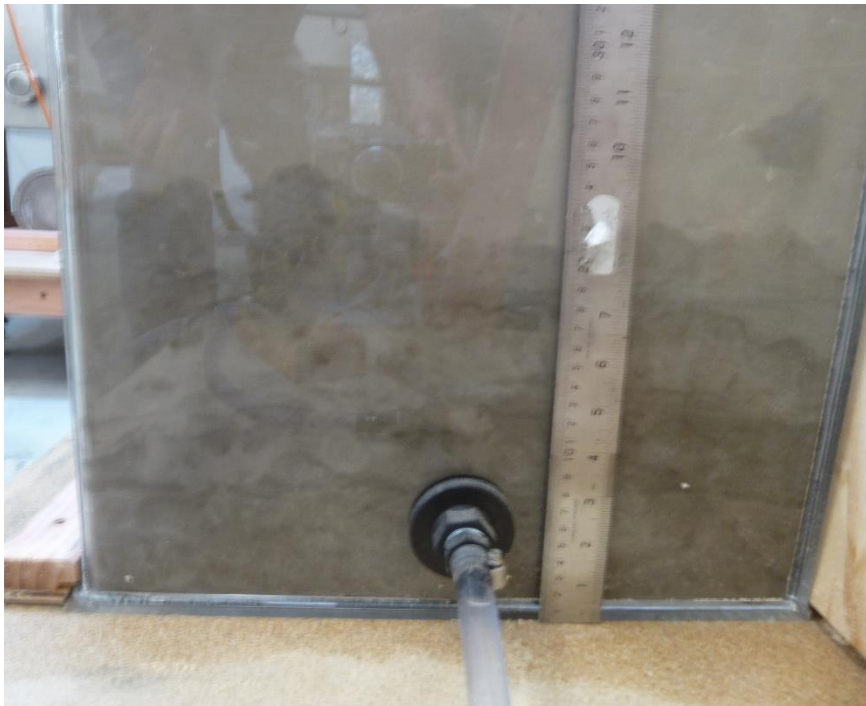
darkening of the tailings/sand mix. An indication of the discolouration caused by the rising moisture is given in Figure 3.

Figure 3. Water height visible in the column of tailings and sand mix

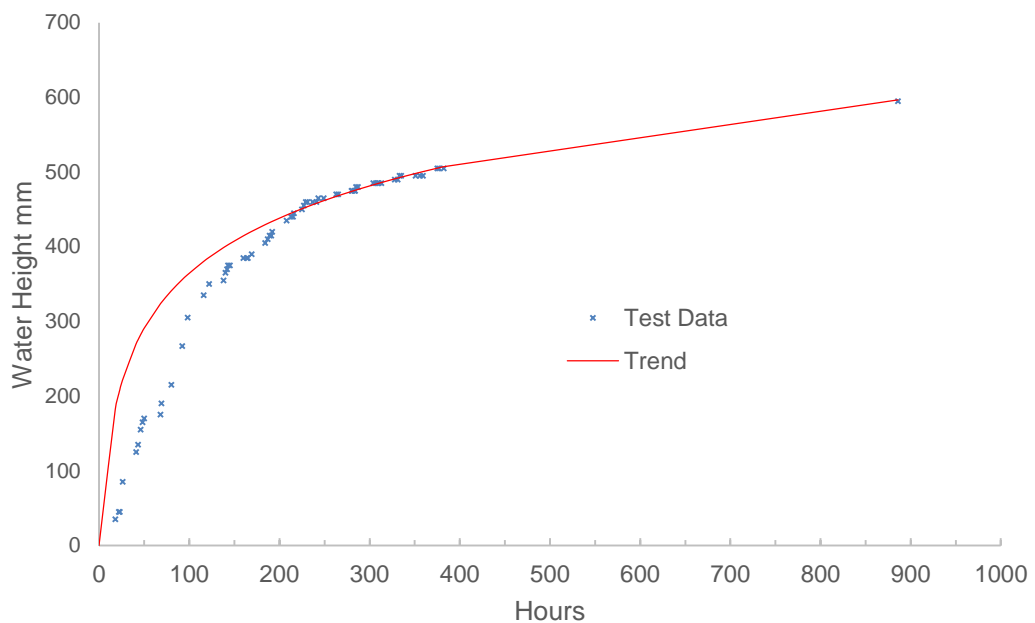
Figure 4 shows the recorded height of damp tailings/sand/silt (mm) above the initial set point of 165 mm, being the simulated water table height, against time (hours) from the start of the experiment. The dots are actual readings of height and the trend line is a natural logarithmic best fit to the data.

Figure 4. Graph showing the height of damp tailings/sand/silt above the initial water table height against time

It was found that the fitted model has the following form:

$$-125.473 + 10.6656 \ln [x^{9.97448}]$$

which means that the predicted height of the dampness (mm) above the water table will be equal to:

$$(-125.473 + 10.6656 \ln [\text{Time from start (hr)}^{9.97448}])$$
